3. GEOTECHNICAL ASPECTS

3.2. Large soil cracks in San Luis

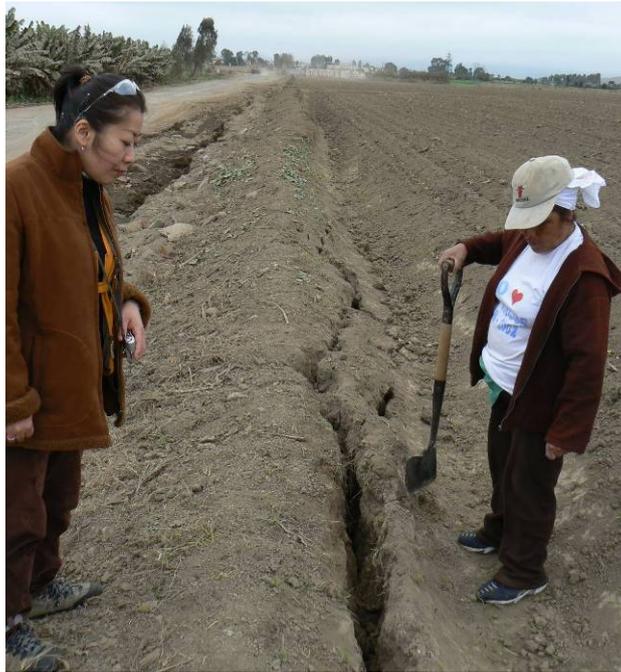
There are 3 clusters of cracks in Fig. 3.3. The first cluster of points 37 to 40 indicated smaller lateral spreading failures along the dirt road (road 746) leading from the Pan-American Highway to Nuevo Monte Rico. There was drainage ditch on the north side of the road towards which lateral spreading occurred over a length of over 200 meters. On the south side of the dirt road there was a sewage pipe, leading from Nuevo Monterrico towards the ocean, which broke, likely due to the lateral spreading, and related soil displacement induced a lot of cracks in the cotton field next to the road (see Fig. 3.4). These cracks cause a lot of trouble for the farmers to irrigate their fields, since the water went into ground through the cracks, instead of being distributed through small irrigation canals to the whole field.

Fig. 3.4. Cracks in cotton field causing trouble for the farmers to irrigate their fields.

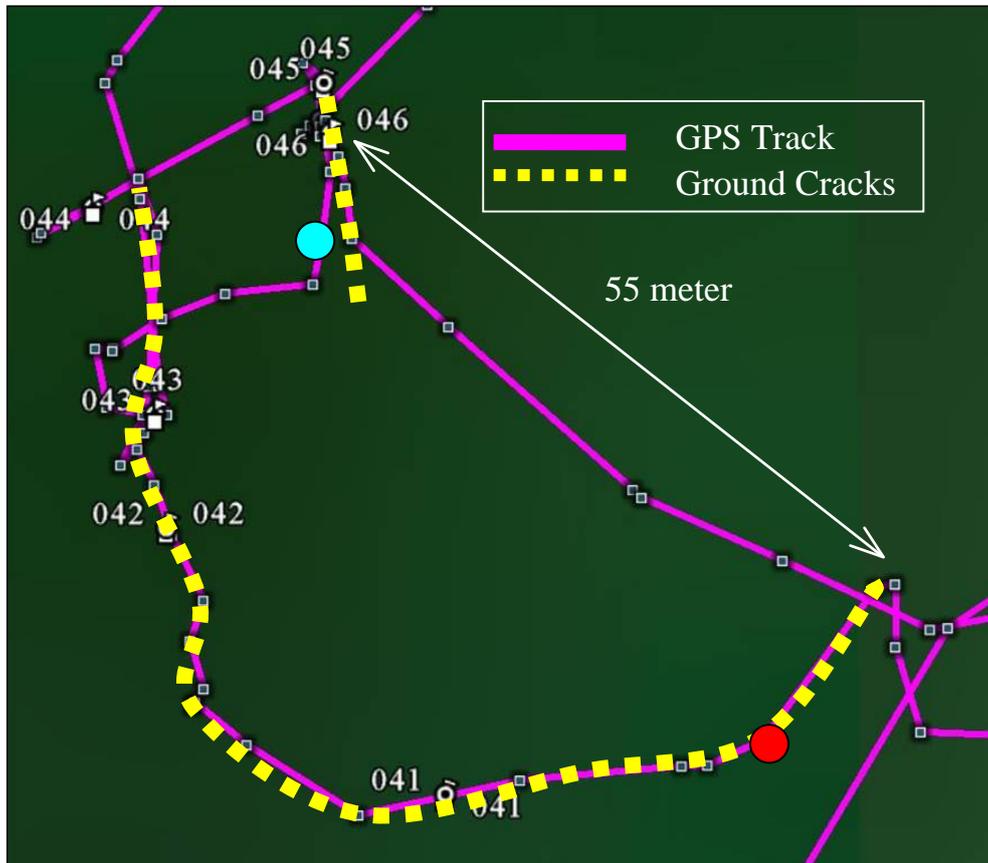
At the cluster of points 40-44 in Fig. 3.5, an approximately 70 meter long crack were found. A close up is shown in the map in Fig. 3.6 and photo in Fig. 3.7. Another shorter crack was also found nearby, at point 46 in Fig. 3.5, with large vertical offsets of up to 40 cm (see Fig. 3.8). There were some indications of liquefaction since soil seemed to have been fluidized and finer grains settled on the top, but we saw no clear sand boils in the area. These “liquefaction traces” might have rather been due to irrigation of field in the weeks after the earthquake. Some of the fields in this area had already been plowed so many cracks had been erased. This shows how important it is to get into the field directly after the earthquake hit.

Fig. 3.6. Close up of ground cracks and GPS tracks at point 41-46. Photos taken at light blue dot and red dot are shown in Fig. 3.7 and Fig. 3.8. Cracks were some 70 meters long.

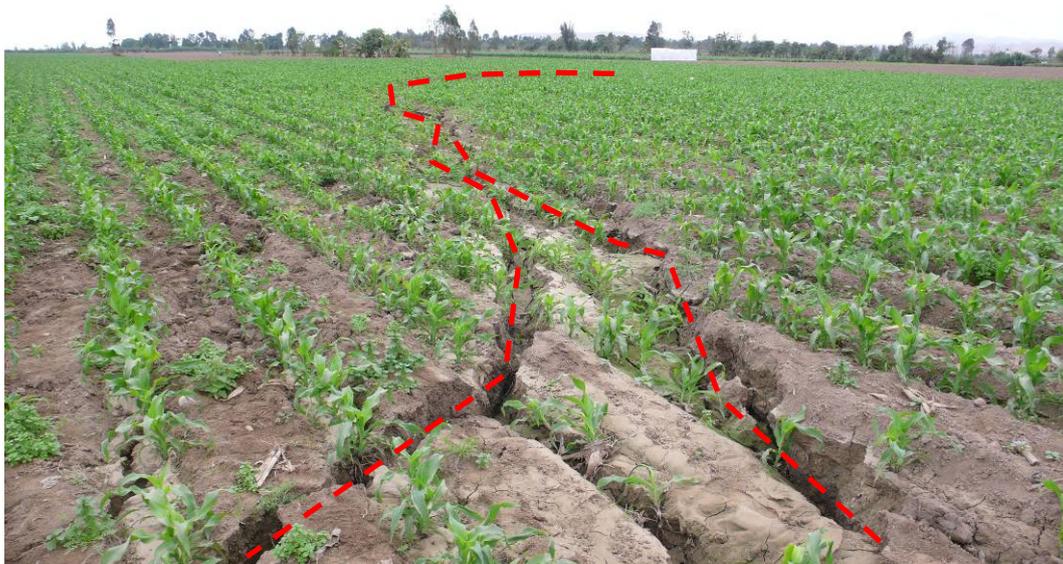
Fig. 3.7. Photo of large ground cracks at GPS points 41-46 in Nuevo Monterrico agriculture field. (Photo taken at red dot in Fig. 3.6.)

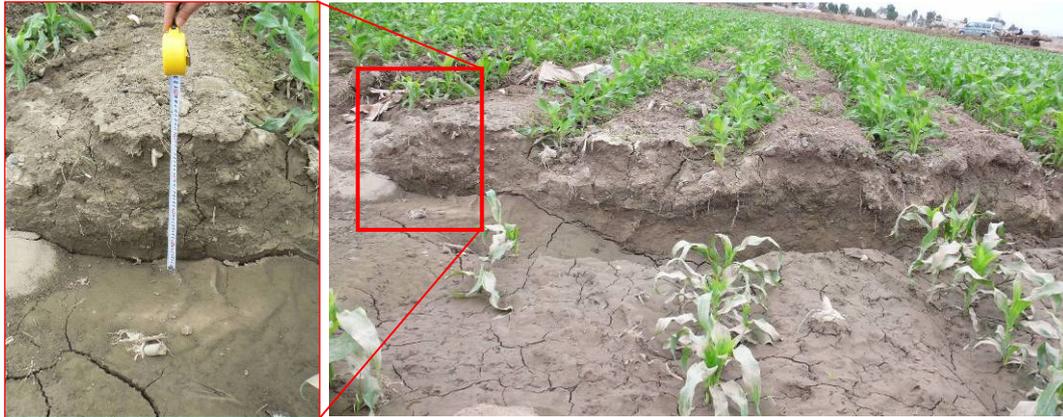
Fig. 3.8. 40 cm offsets of ground cracks in Nuevo Monte Rico agriculture field. (Photo taken at blue dot in Fig. 3.6.)

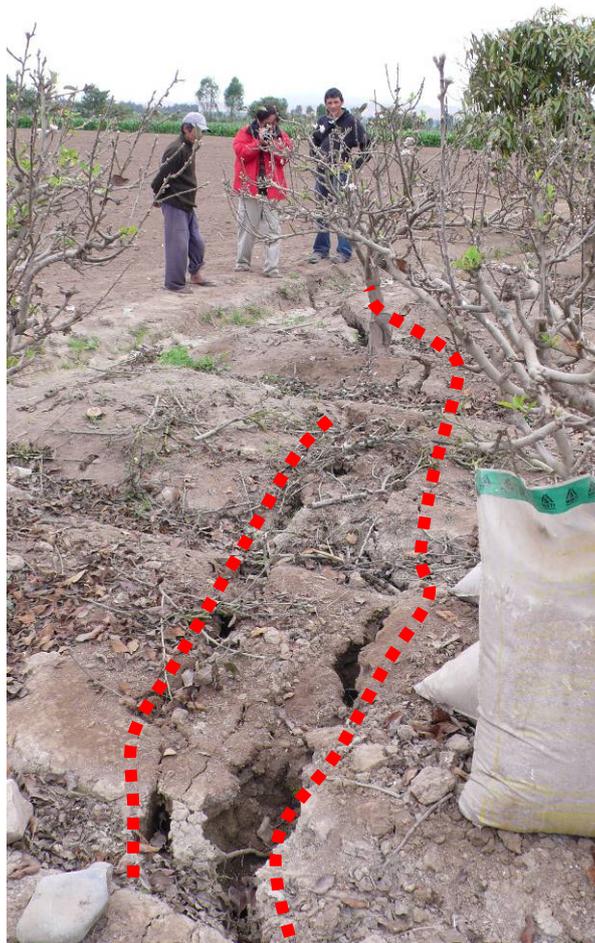
Another farmer had also irrigation problems in an apple plantation at GPS point 57 in Fig. 3.5. due to large cracks (see Fig. 3.9)

Fig. 3.9. Apple plantation ground cracks in Nuevo Monterrico. (Photo taken at point 51 in Fig. 3.5.)

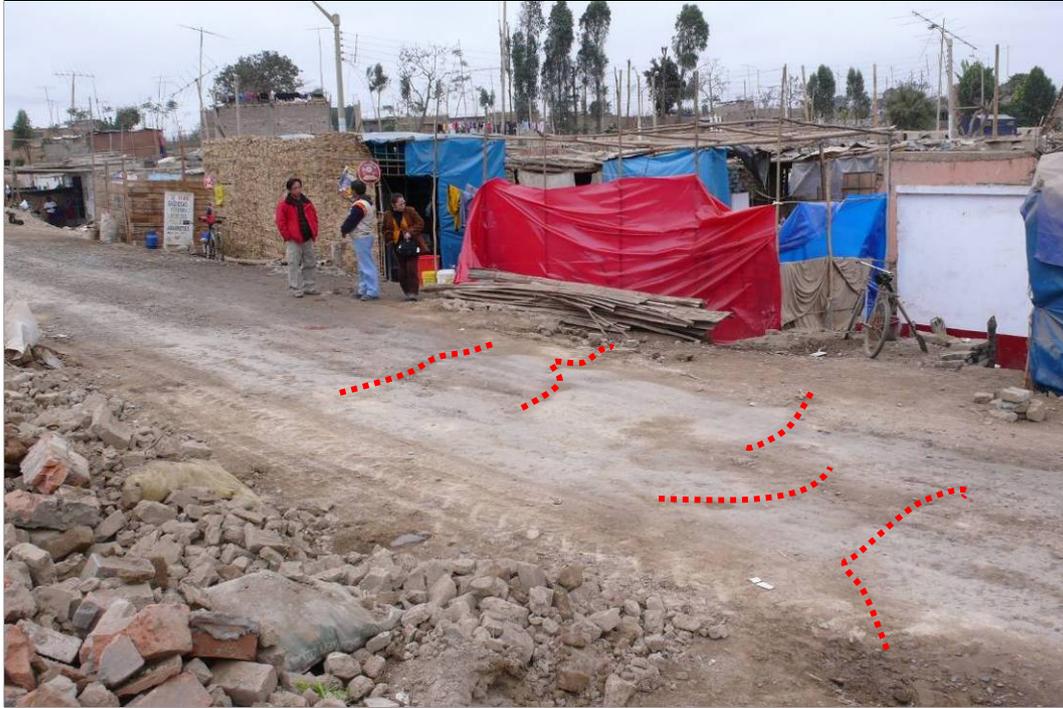
More ground cracks were scattered further NNW, at point 61 there were cracks in the road and also at point 62 where the cracks damaged some houses (see Fig. 3.10). At our visit in this area many ground cracks were already gone and we relied upon local people stories and our own judgment. Fig. 3.11 shows a collapsed adobe house

Fig. 3.10. Large ground cracks in Nuevo Monterrico crossing road at point 61 with destroyed houses in the back ground.

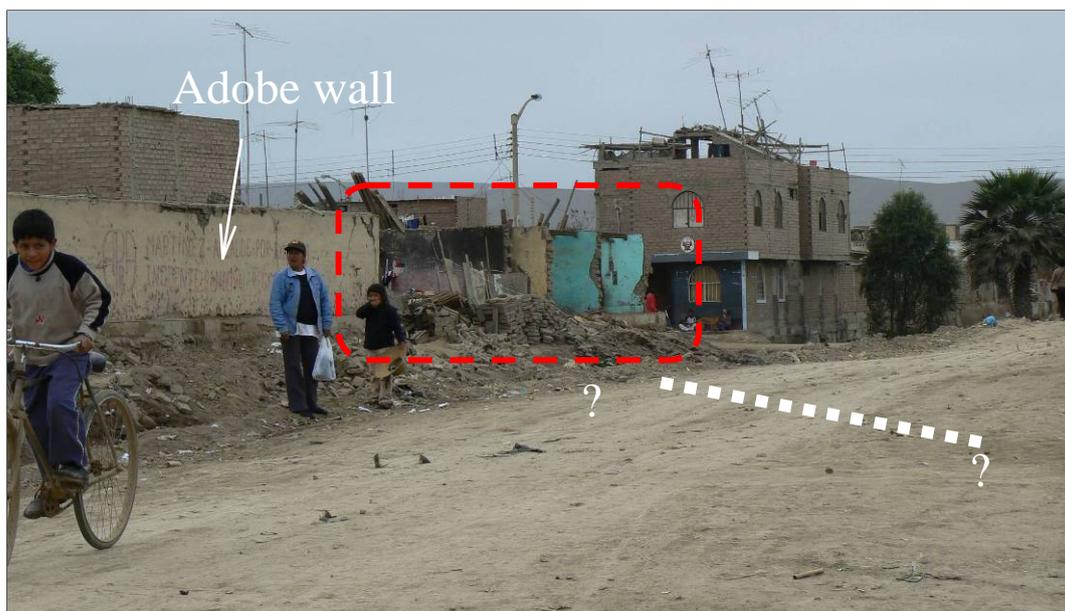
possibly due to large ground cracks; A local construction company person told us the crack crossed the street and reach the adobe house. Noting that the adobe wall to the left was not damaged it is possible that the damage of the right part was due to the crack and less due to shaking. However this needs to be confirmed.

Fig. 3.11. Collapsed adobe house due to large ground cracks in Nuevo Monterrico. The local people told us the crack crossed the street. The adobe wall to the left did not collapse.

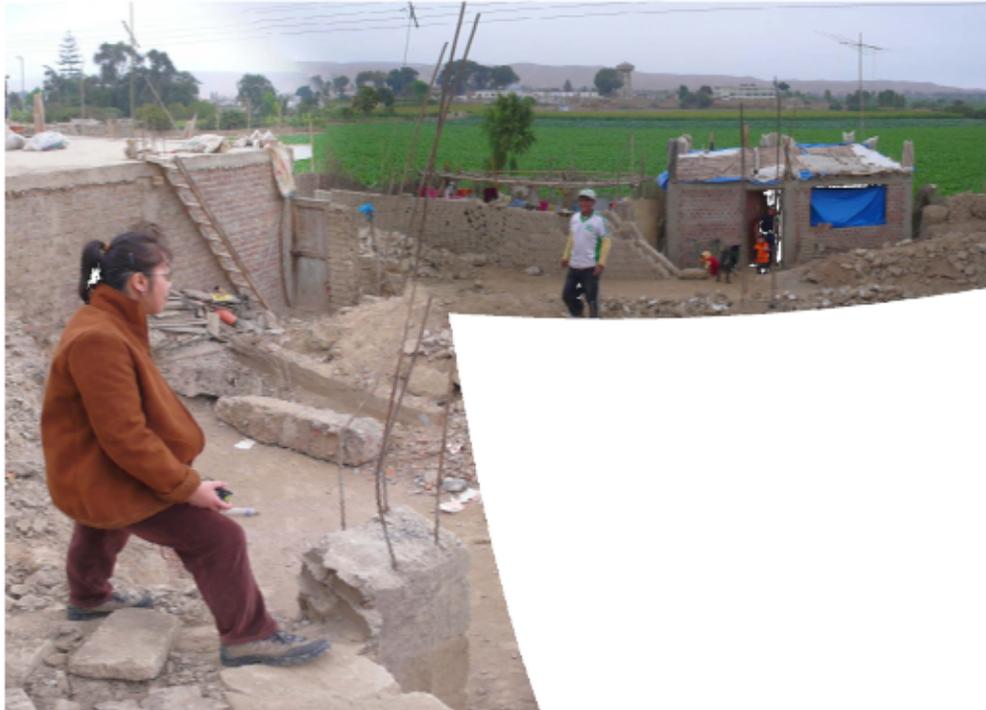
Fig. 3.12. Damage house located at point 79 in Fig. 3.6.

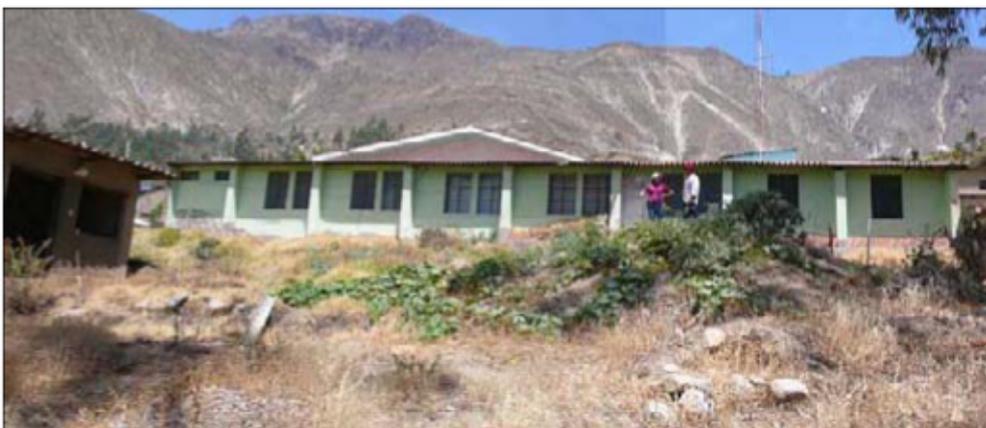
Fig. 3.13 Health center in Huaytara with cracks in walls due to foundation differential settlement.

The health center was built on a slope, which likely exaggerated the soil movements and their effects on the slab foundation.

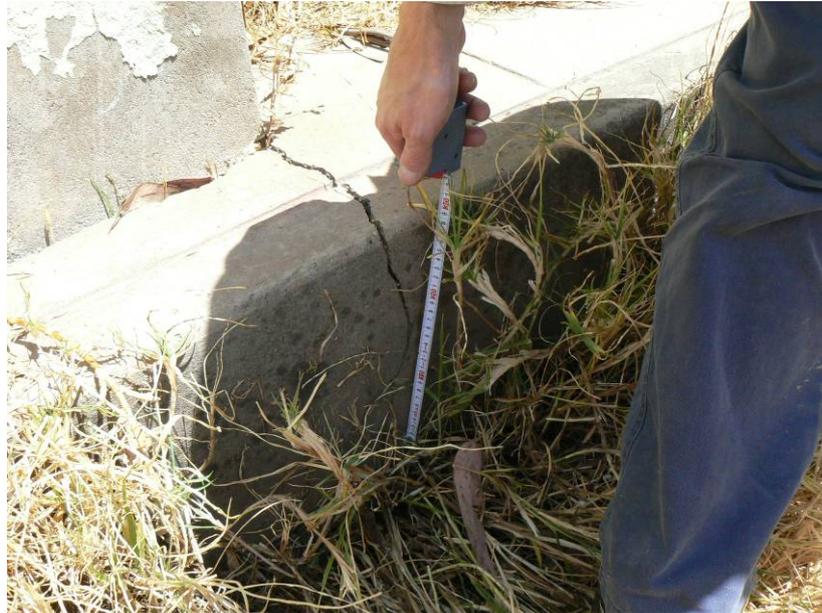
The health center in Huaytara suffered cracking of walls due to a foundation problem. At the construction there was a sewage canal, which is not in use any more, and on top of which an unreinforced foundation slab was placed. Due to the earthquake there was some soil movement around the canal and there was uneven settlement of the slab, causing it to crack as seen in Fig. 3.14.

Fig. 3.14. Huaytara health center foundation slab with 1cm wide crack due to differential settlement.

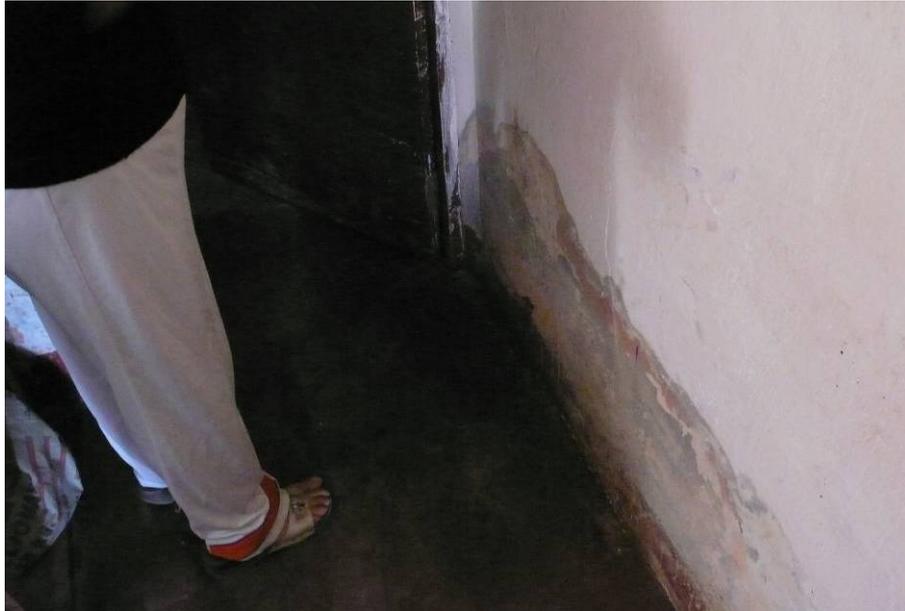
Guadalupe is located on kilometer 290 of the Pan-American Highway. There was a lot of damage to adobe house in this area ranging from completely collapsed house to houses with cracked walls. There was greater amount of damaged houses on the east side of the Pan-American Highway, possibly related to higher moisture content of the soils weakening the adobe walls. The adobe walls absorb the moisture from the surrounding ground, which thereby softens the mud bricks. This problem is wide spread in many locations in Peru and likely in other countries as well. The moisture absorption was evident inside one house as shown in Fig. 3.15.

Fig. 3.15. Foundation problems in Guadalupe: Miscoloring due to moisture absorption by adobe wall. The moisture weakens the structural properties of the wall, thereby the earthquake resistance of the house, and it also constitutes general health threat.

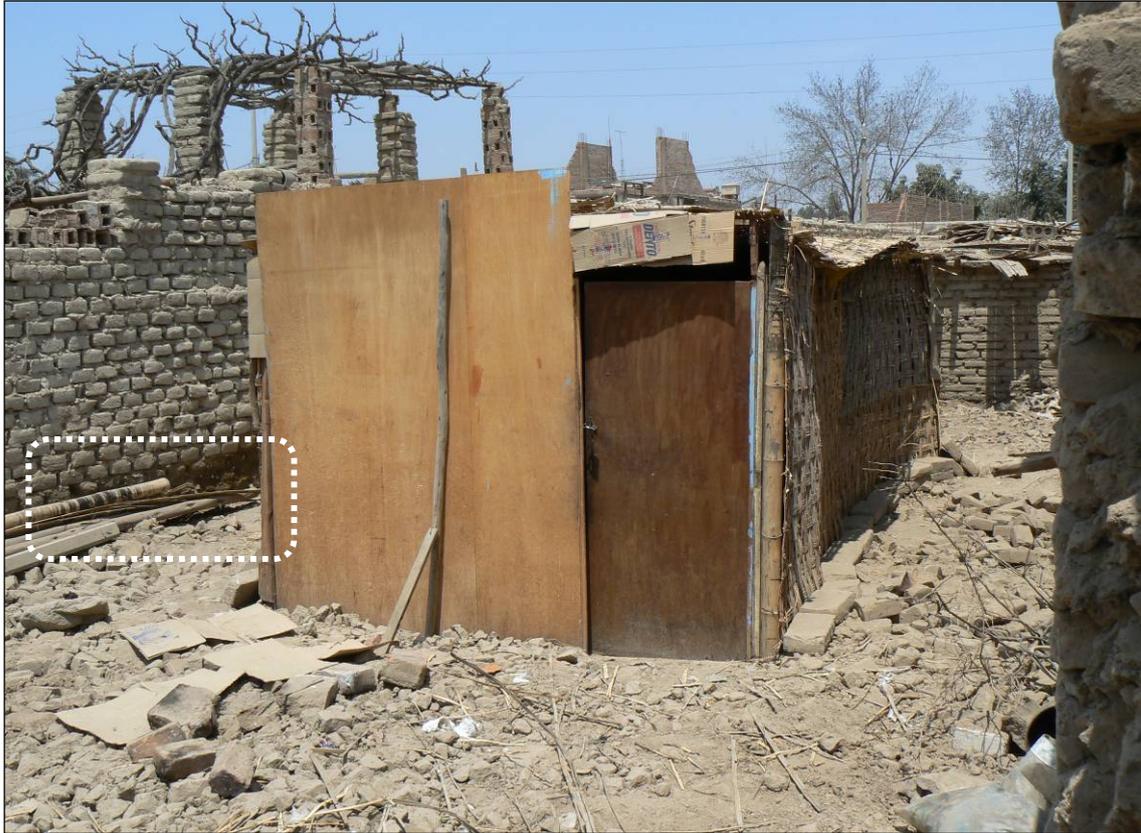
A typical foundation method for the adobe houses consists excavating a narrow trench and putting the adobe blocks inside trench, right on top of the soil. With time the buried part of the adobe wall absorbs moisture becomes soil again, i.e. the wall is virtually placed on the ground. It is questionable if it is of any help to excavate the trench in the first place. An example of such a wall is shown in Fig. 3.16. The moisture also accelerates decomposition of organic materials within the adobe blocks, further reducing the strength of the blocks, since the organic materials function as sort of “fiber reinforcement”. In addition to reducing the earthquake resistance of an already earthquake vulnerable building type, the moisture also constitute a general health problem. With the above in mind it is necessary to convey the message of proper foundations preventing moisture to be absorbed in the walls. The adobe moisture absorption is a big problem in the “Barrios Altos” area in Lima and the vulnerability of these houses will show itself in the next big earthquake in Lima.

Fig. 3.16. Temporary self-built house. The original house collapsed in the earthquake. The dashed box shows how the lower part of the wall is darker due to moisture absorption.

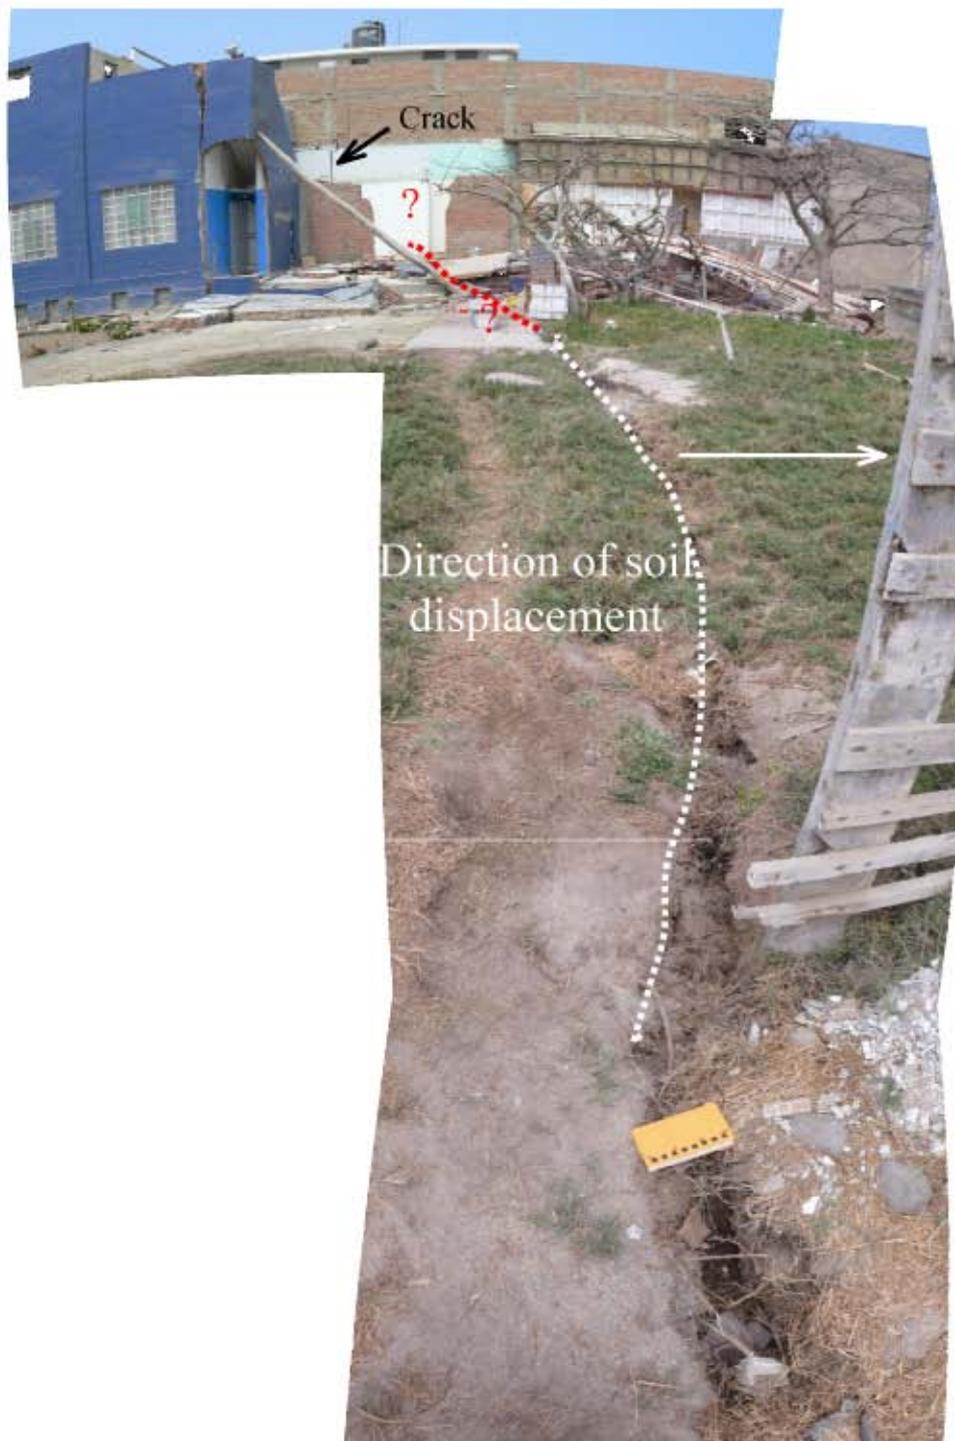
We found two buildings with good performance even though damage to buildings around them was severe. The location is indicated in Fig. 3.17. This area was severely damaged by liquefaction as seen in the ground cracks in Fig. 3.18. Lateral spreading caused the soil to displace towards the ocean and the creating some 10-15 cm wide cracks in the soil. The crack probably continues in front of and/or beneath the blue building and then up through the confined masonry wall as marked by the black arrow in Fig. 3.18. The soil settled some 10-15 cm next to the blue house as shown in Fig. 3.19.

Fig. 3.18. Soil displacement crack next to old building. (blue mark in Fig. 3.17). The crack probably continues in front of and/or beneath the building and then up through the confined masonry wall as marked by the black arrow. (The curvature of the building top is due image distortion, it should be a straight line.)

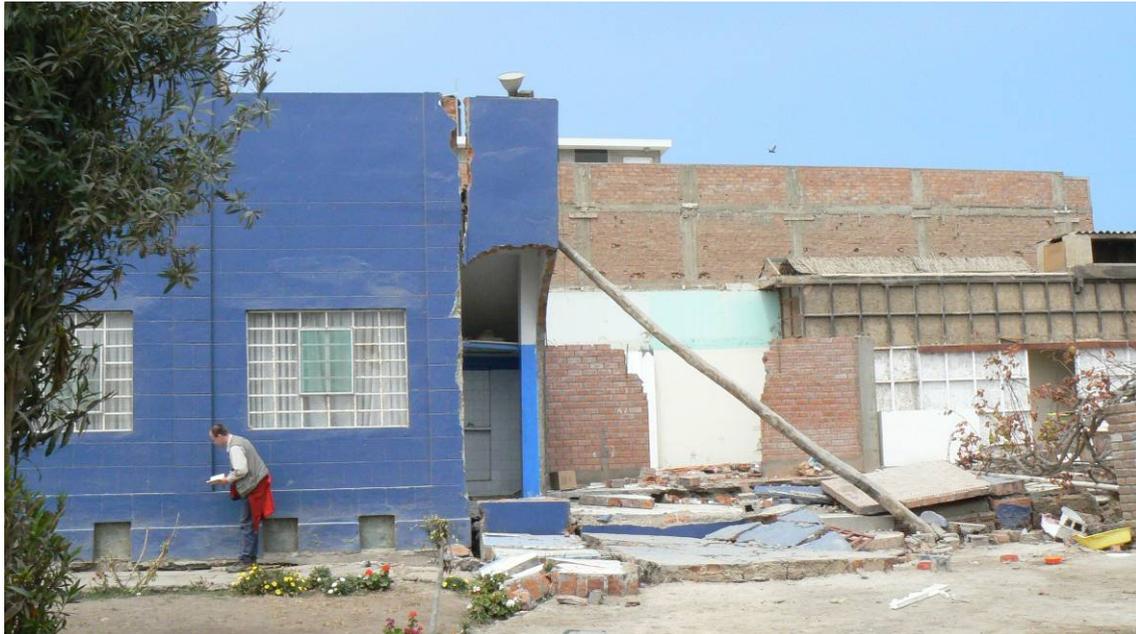
Fig. 3.19. 10-15 cm soil settlement around blue building on pile (?) foundation. Blue mark in Fig. 3.17

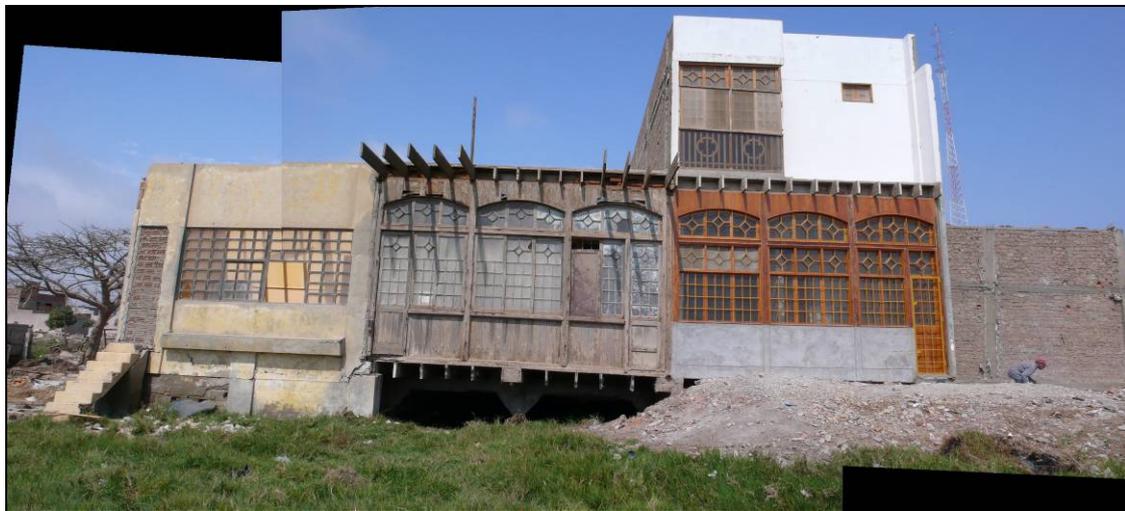
The old building was hybrid structure with confined masonry to the right and left as seen from the ocean side in Fig. 3.20. The central part is made of wood and stands on an elevated pile foundation. The small stair to the left in Fig. 3.20 came partially off the building due to the lateral displacement, but otherwise the building performed seemingly well.

Fig. 3.20. Old building located close to the ocean in Pisco that performed well even large liquefaction displacement was observed. In the central part a pile foundation is visible.

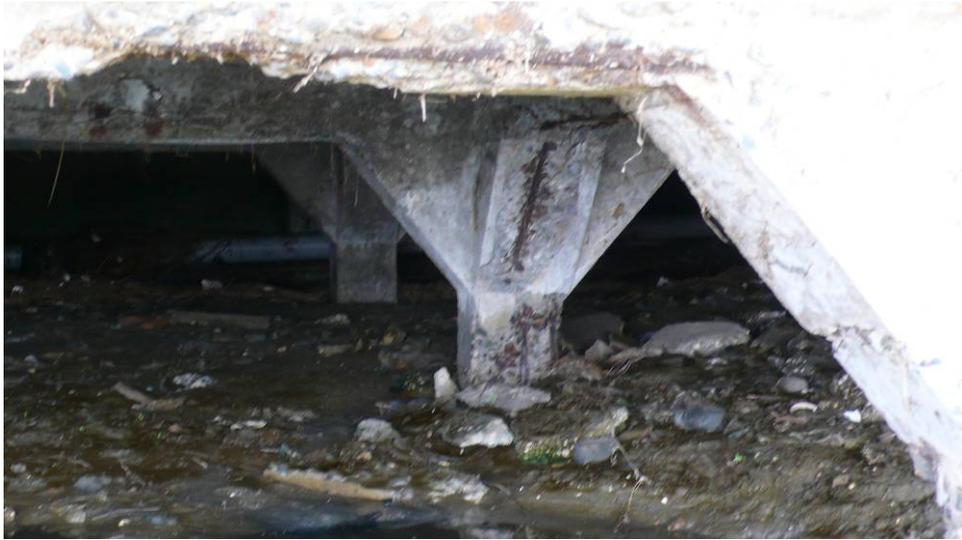
Fig. 3.21 shows a close up of pile foundation with corroded reinforcement bars. The age of building foundation is unknown, but many of the buildings in here were constructed 50 to 100 years ago, in connection with the establishment of the fishing industry here.

Fig. 3.21. Close up of pile foundation showing corroded reinforcement bars. The age of building foundation is unknown, but many of the buildings in these area were up to 100 years old.

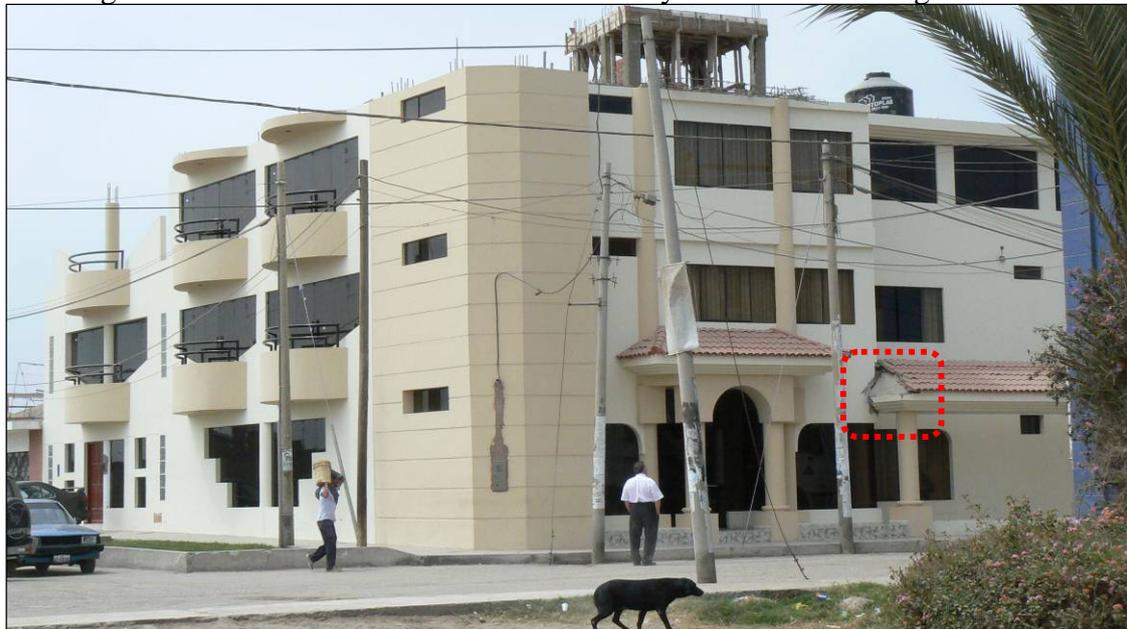
On the opposite side of the street away from the ocean there was a recently completed hotel that was about to open. It suffered only minor damages due to that its strong reinforced foundation could resist the liquefaction effects. A close up of hotel damage is shown in Fig. 3.23. Relative ground movement, due to liquefaction, between the columns of the exterior roof structure and the building, caused the cracks. In general well engineered structure like this one suffered only minor or no damage.

Fig. 3.22. New hotel which suffered only minor damages. A close-up of the part inside the red dashed box is shown in Fig. 3.23
