## 5. ROADS AND BRIDGES

## 5.2. Road Damage

### **5.3. Bridge Damage**

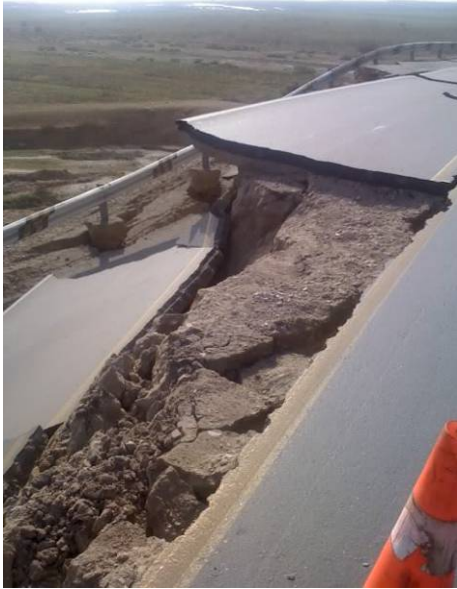
*Fig. 5.2. Slope failure caused by liquefaction induced lateral spreading*

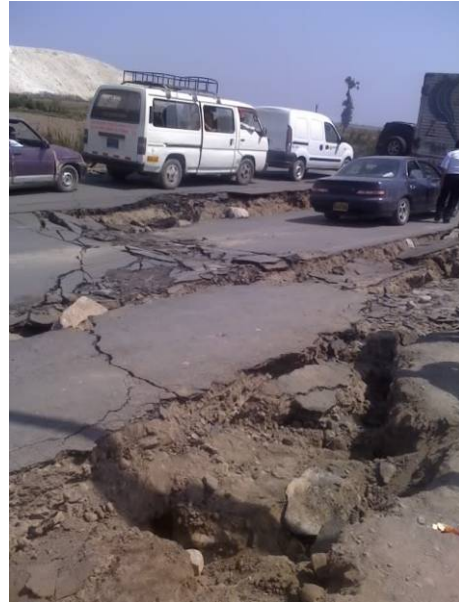
*Fig. 5.3. Liquefaction induced embankment failure*

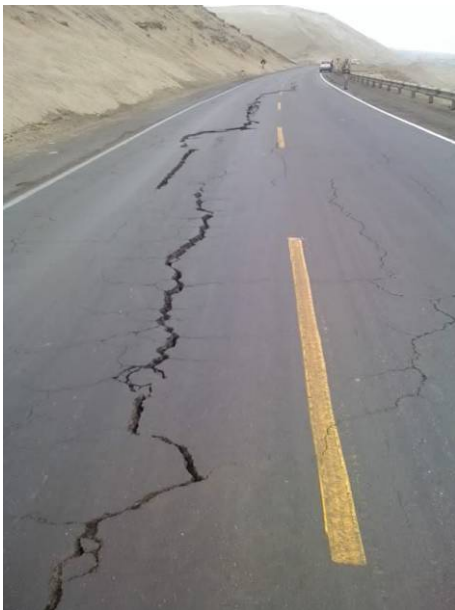
*Fig. 5.4. Cracking along the pavement due to landslide induced movement*

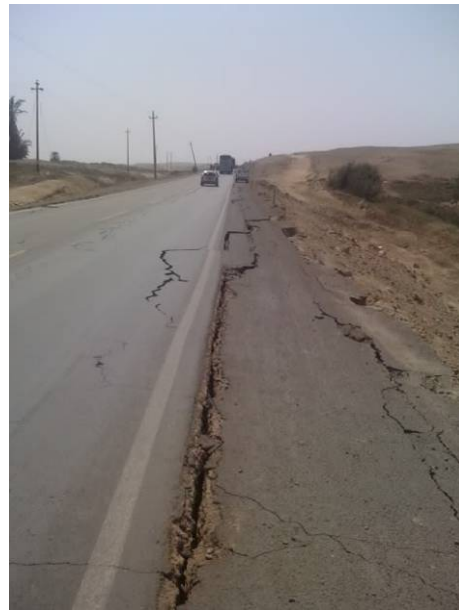
*Fig. 5.5. Shoulder settlement and displacement*

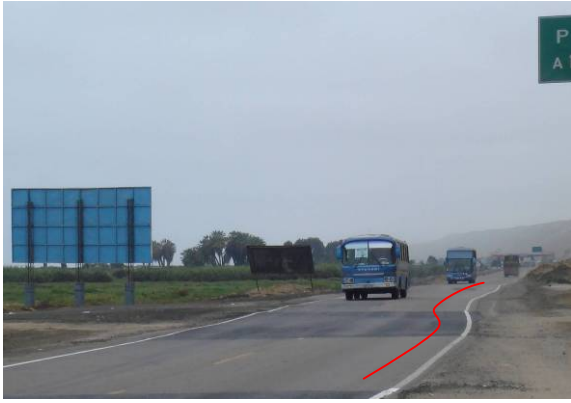
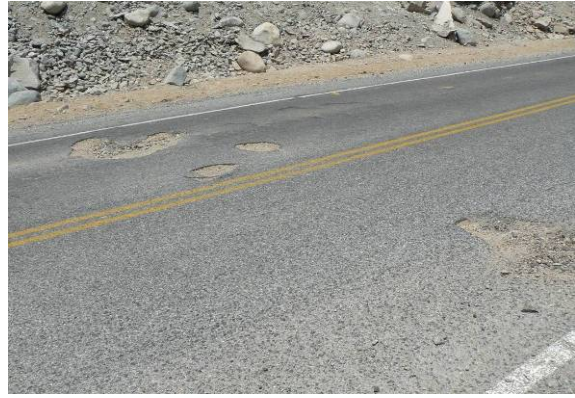
*Fig. 5.6. Road distortion due to liquefaction    Fig. 5.7 Pot holes caused by rock falls induced lateral spreading*

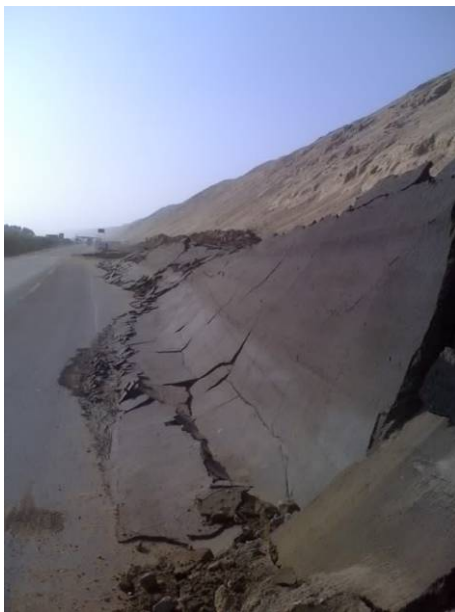
The South Pan-American Highway was heavily damaged where it turns west to enter Chincha City. This location coincides with the limit where the Canete Formation meets a marine deposit. The Pleistocene Canete formation consists of alternating layers of sand and silt stones, with marine or eolic deposits above it. Widespread liquefaction observed in this area may have caused much of the road damage. At this location, uplifting of the slope side shoulder occurred. This is likely due to loss of the base support of the slope, which then moved towards the road (see Fig. 5.8) lifting it up. Liquefaction /lateral spreading induced loss of base support caused the slope failure damage shown in Fig. 5.9.

*Fig. 5.8 Lifted shoulder at Playa Jahuary. South Pan-American Highway*

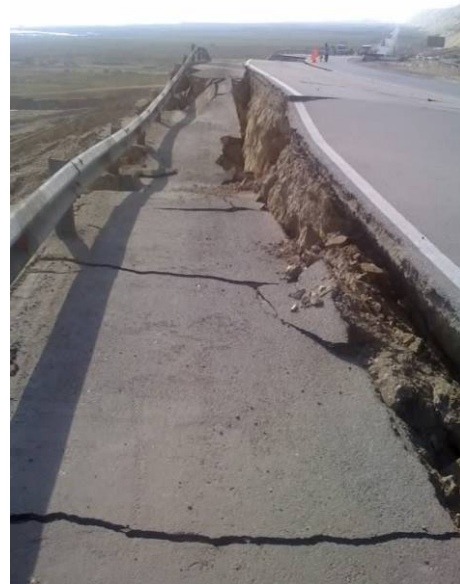
*Fig. 5.9 Road failure due to lateral spreading at the foot of the slope. South Pan-American Highway*

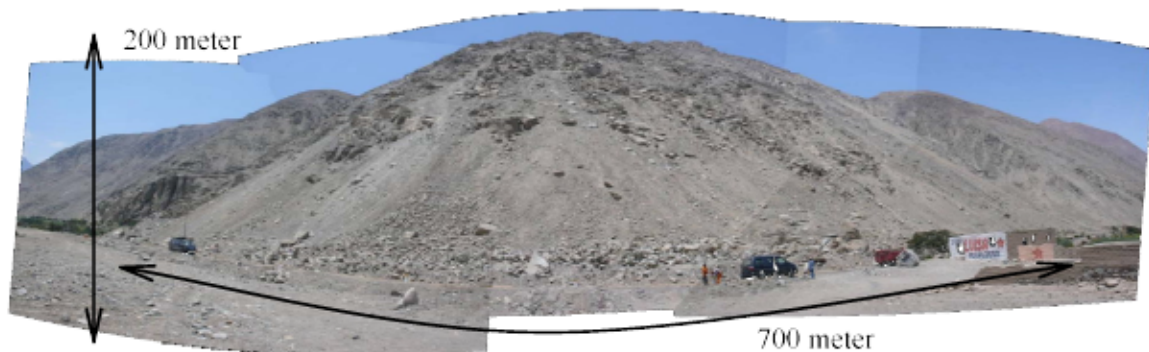
A massive rock fall occurred along the Canete-Yauyos road, as shown in Fig. 5.10, (S 12°54.778' W 76°05.852'). Debris completely covered the road surface disrupting traffic. The rock formation at this location is constituted by blocks of partially weathered igneous intrusive rock.

*Fig. 5.10. Rock Fall. Canete-Yauyos Road, 60km from epicenter.*

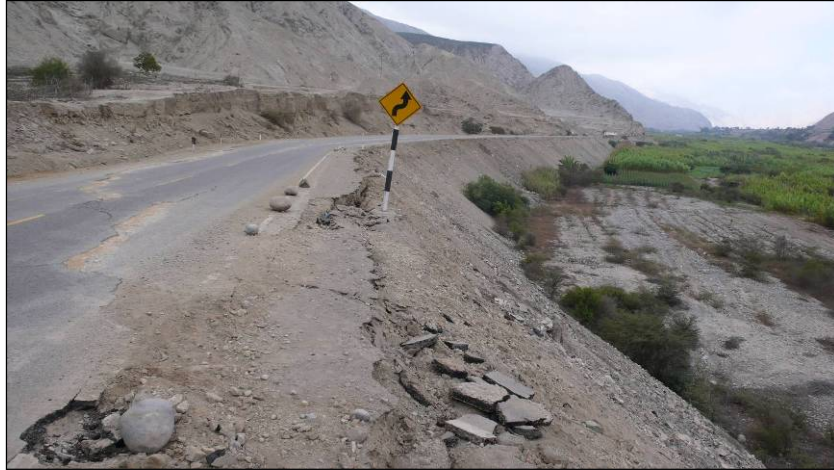
A slope failure was observed at the Km.23 of the Canete-Yauyos road. This is the exact point where the road and an irrigation channel meet. Although there was no evidence suggesting channel damage or water leakage, the possibility that its presence may have somehow affected the slope stability needs further assessment.

*Fig. 5.12. Slope failure at Canete-Yauyos road (Km. 23)*

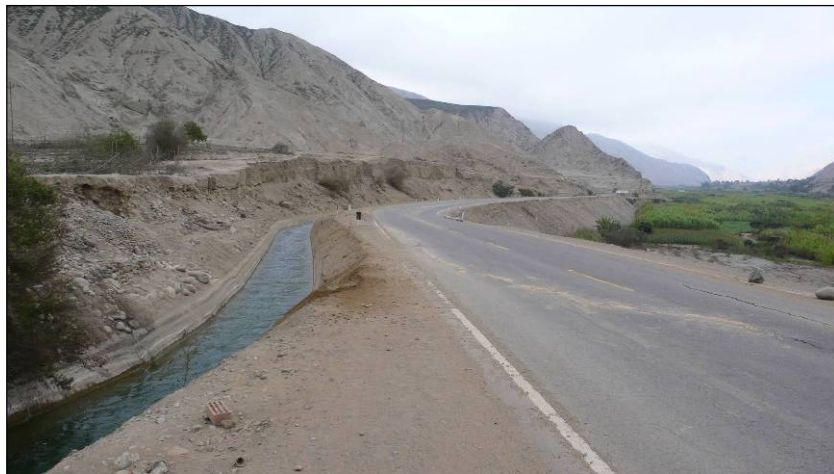
*Fig. 5.13. Slope failure at Canete-Yauyos road (Km. 23)*

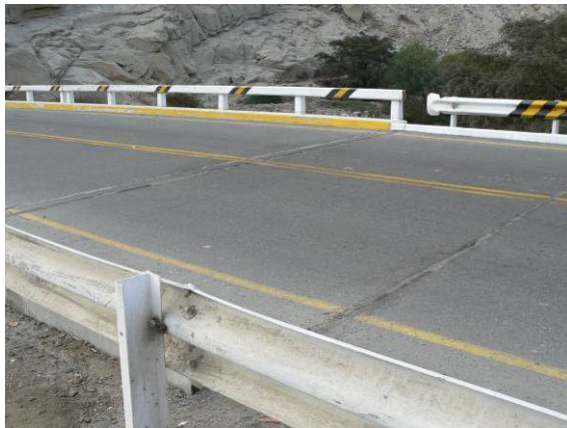
*Fig. 5.14 Mild settlement of the fill behind abutment (La Quinga Bridge, Los Libertadores Highway)*

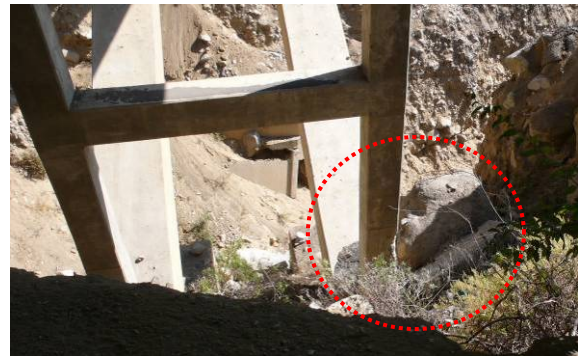
A few bridges were surveyed in the affected areas along the Pan-American Highway, Los Libertadores Highway, and the Canete-Yauyos Road. Most of the visited sites had little damage, mostly in the form of settlement of the fill behind the abutments. At one of the bridges, a rock impacted on the sub-structure, causing a spalling damage.

*Fig. 5.15 Rock impacted on bridge substructure (Tsej Tji Bridge, Los Libertadores Highway, close to Huaytara)*

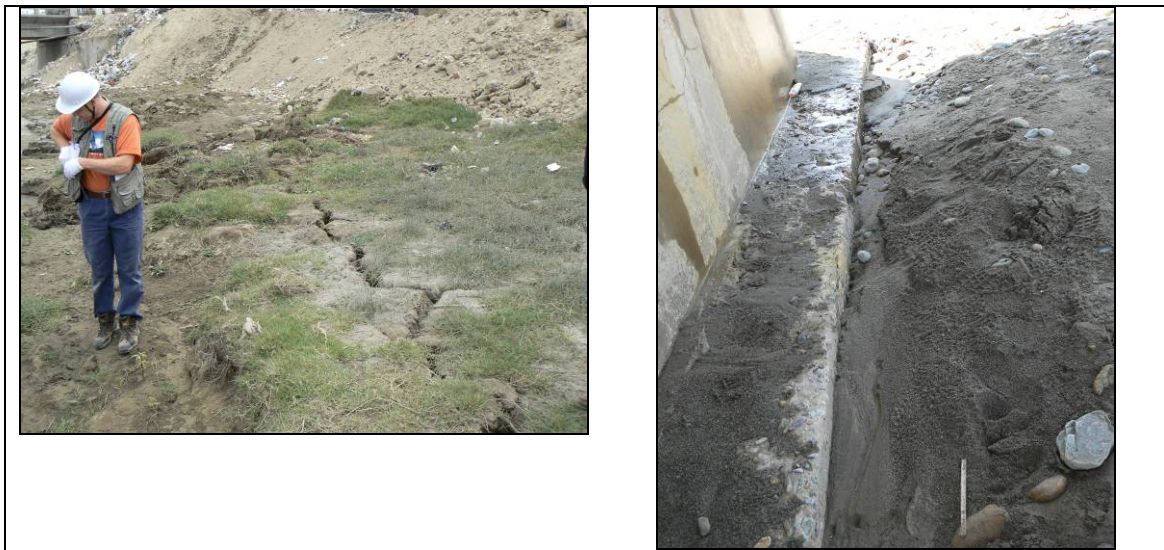
Liquefaction induced lateral spreading was observed in the northern upstream bank of the Pisco River and also south of the south embankment. Evidence of liquefaction was also found around the bridge pillars.

*Fig. 5.18 Liquefaction induced lateral spreading (Pisco River north upstream pillar bank)*

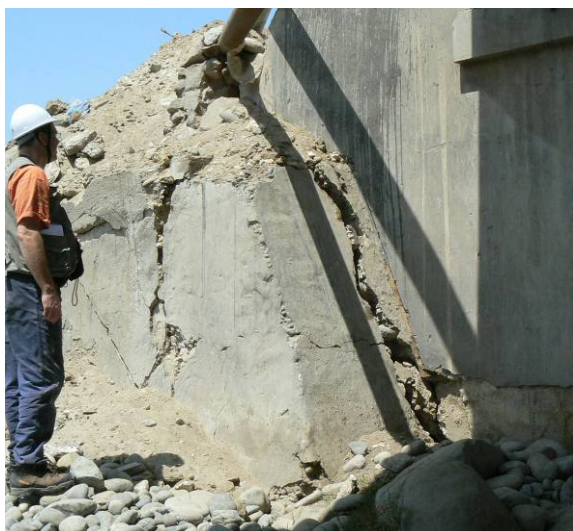
The southern abutment tilted towards the north some 7% due to the Pisco earthquake [5] and settlement and cracking of the embankment also occurred. The intermediate pillars also rotated. Although the north abutment was not as damaged as the southern, settlement of the backfill was observed there. The geological formation at the bridge north access belongs to the Miocene/early Pliocene age whereas alluvial deposits are found in the south.

*Fig. 5.20 South abutment, upstream*

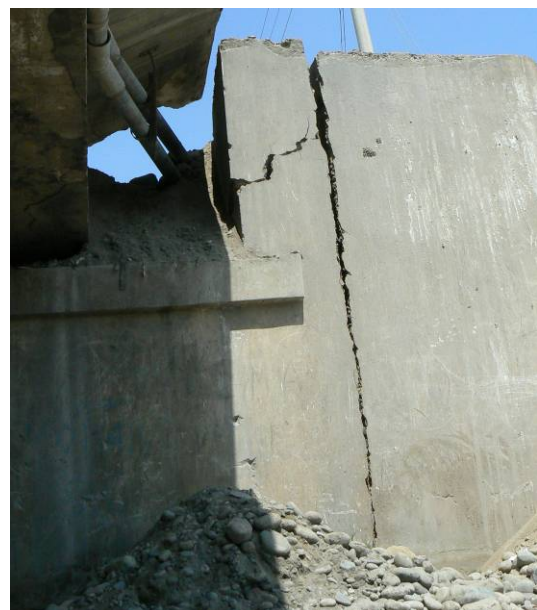
*Fig. 5.21 South abutment, downstream*

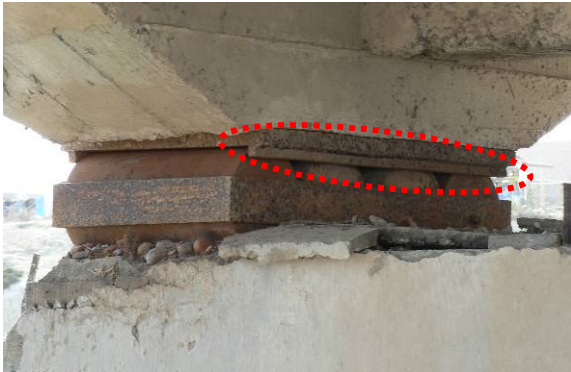
The bridge superstructure is supported on fixed and movable bearings as shown in Fig. 5.16. The movable bearings are made of steel rollers as shown in Fig. 5.22 and Fig. 5.23. Note the steel stoppers installed to prevent the movement in the bridge transverse direction. The steel bearings were quite corroded.

*Fig. 5.22 Movable bearings on the pillars*

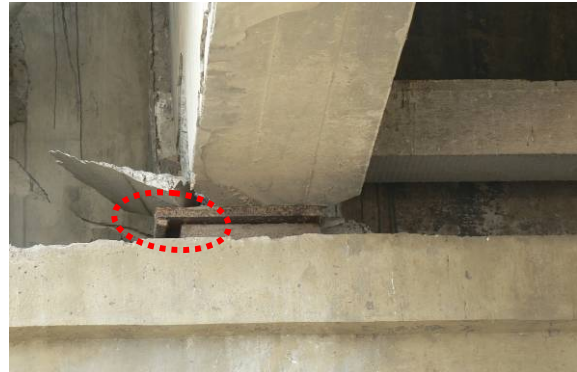
*Fig. 5.23 Movable bearing at the southern abutment*

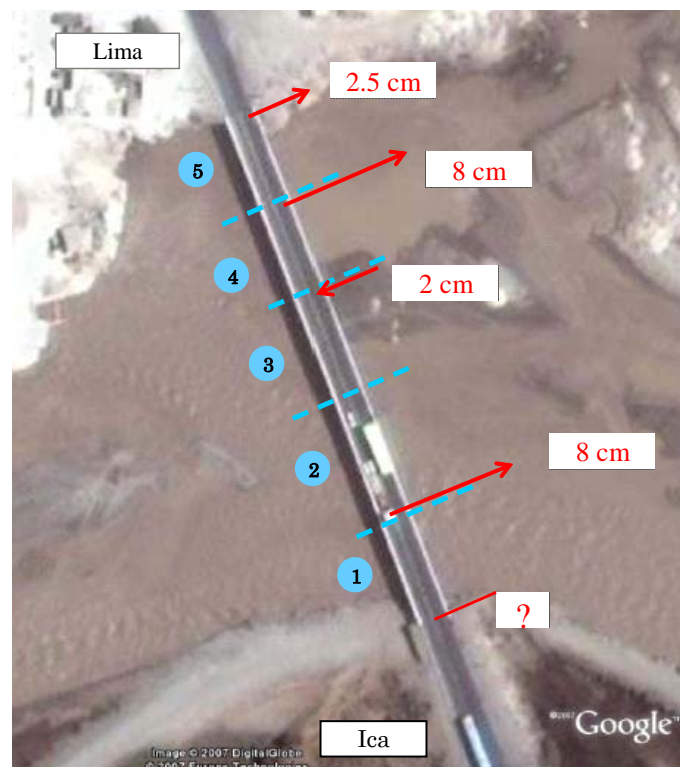
The bridge superstructure permanently moved upstream as shown in Fig. 5.24. The blue dots represent the superstructure sections and the measurements indicate relative displacements between adjacent sections or between superstructure and abutments. At the movable bearings on the abutment, the steel fittings separated from the concrete structure (Fig. 5.23). The stoppers on the pillar movable support, bottom, were not found. The lateral movement of the bridge caused damage to the concrete wings of the pillars, especially that with the movable bearing. These wings had very little steel reinforcement.

*Fig. 5.24 Google earth view of the displacement of the bridge superstructure.*

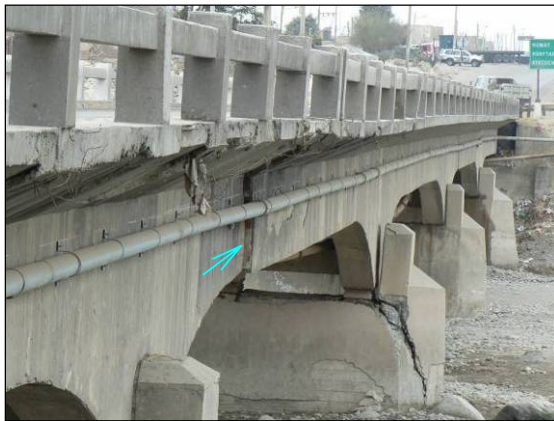
*Fig. 5.25 Bridge slab displacement (picture taken towards the north). Arrow indicates the gap corresponding to the southern 8 cm gap shown in Fig. 5.24*

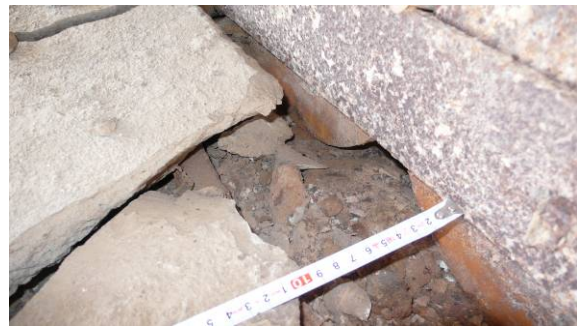
*Fig. 5.26 No bottom steel stoppers were found at the pillar movable bearing.*

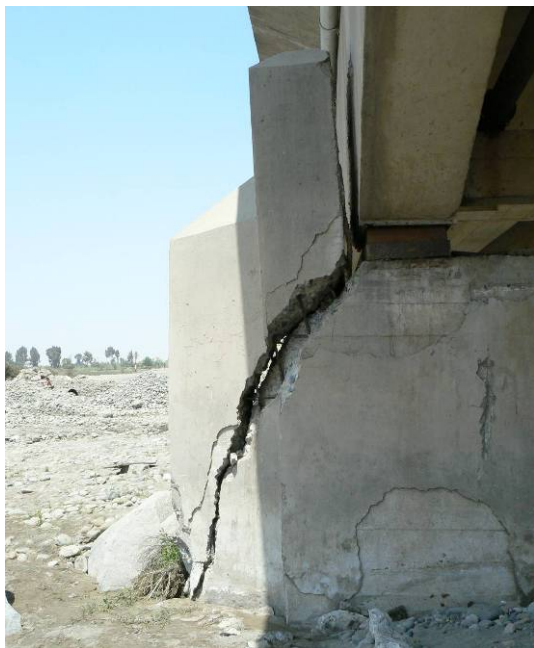
*Fig. 5.27 Failed wing with poor reinforcement (pillar with movable bearing)*

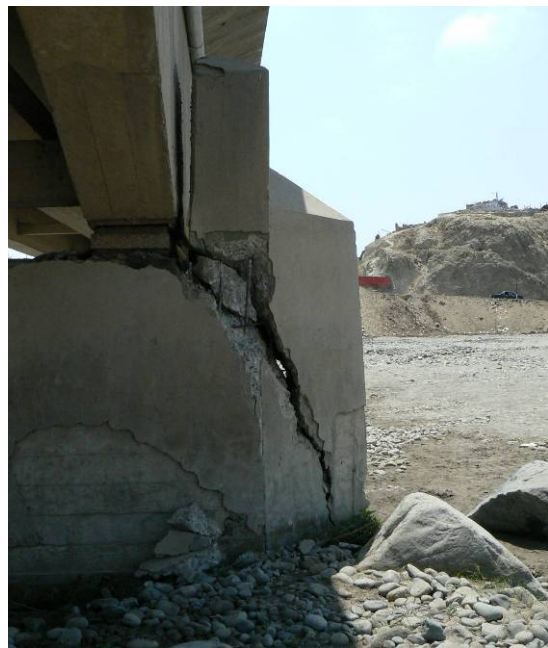
*Fig. 5.28 Failed wing with poor reinforcement (pillar with movable bearing)*

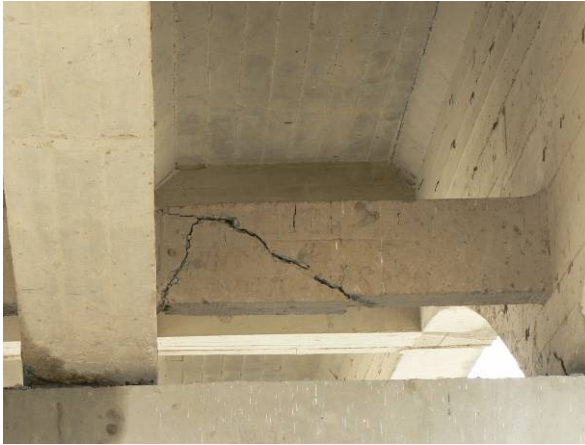
The displacements and rotations of the bridge segments concentrated stresses on the superstructure transverse beams which suffered cracking.

*Fig. 5.29 Damaged transverse beams*

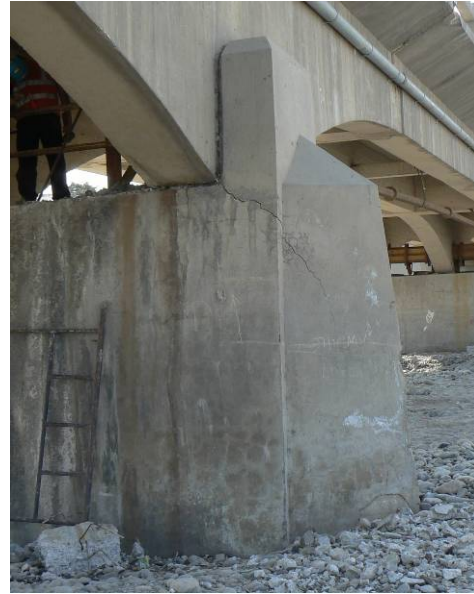
*Fig. 5.30 Cracks in the wing of the pillar with fixed bearing*

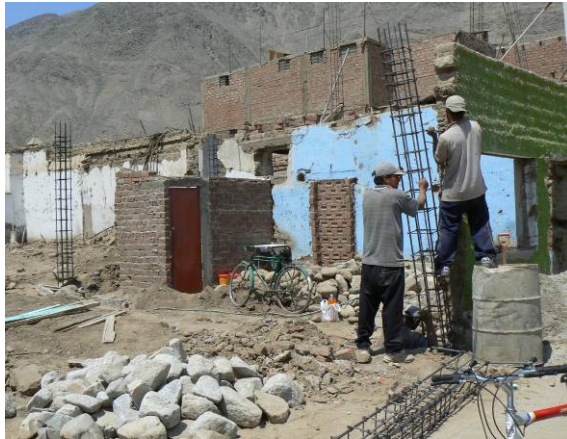
*Fig. 6.11 Front adobe wall, which did not collapse during the earthquake, is reused in the new structure with some “reinforcement”*
