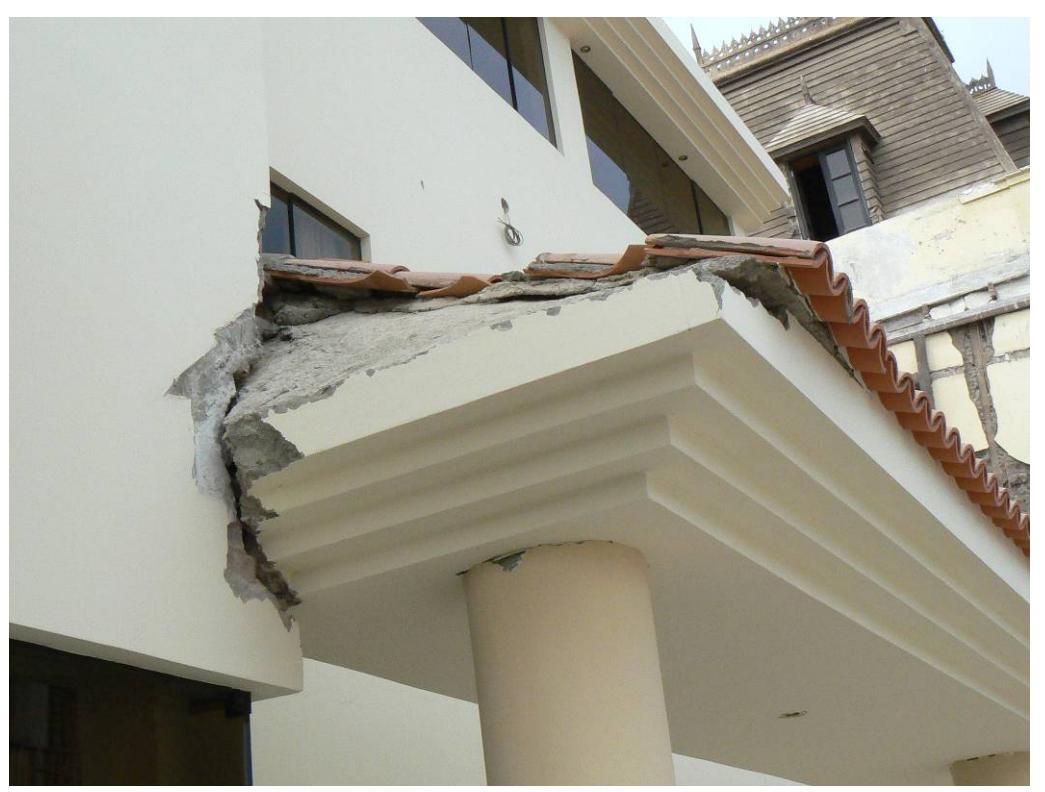
Fig. 3.23. Close up of hotel damage. Relative ground movement, due to liquefaction, between the columns of the exterior roof structure and the building, caused the cracks.

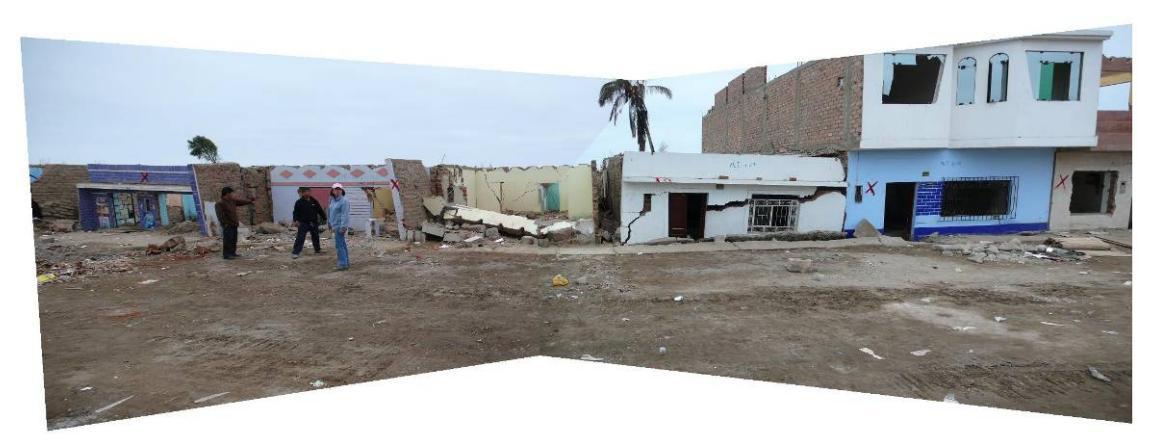
Severe settlement of buildings and foundation damage, due to liquefaction induced ground failure and lateral spreading, caused the collapse of adobe houses and severe cracking of walls of confined masonry buildings. The damage resulted in the death of 5 persons; Out of 1447 dwellings, 465 houses were completely destroyed, 308 were severely affected, another 467 were affected, and 121 were lightly affected [4]. This left only 121 unaffected houses.

Fig. 3.25. Settlement of 0.7 m of building in front of palm tree.

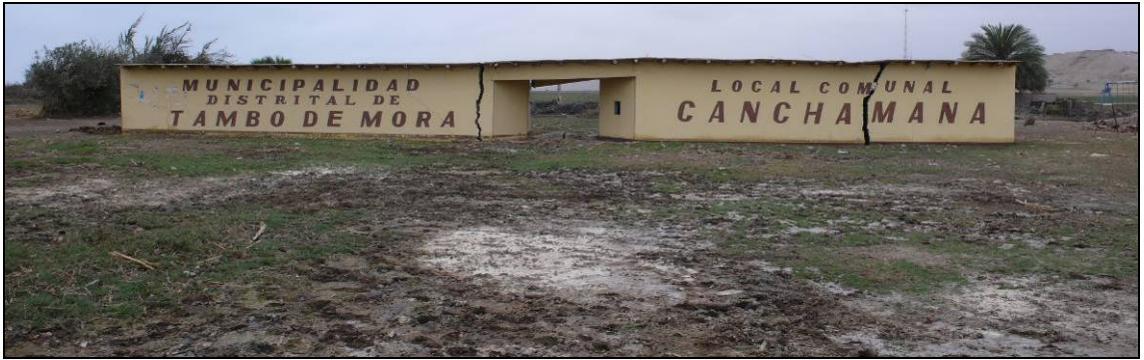
At Canchamana in the northern part of Tambo de Mora (0.5 km north of microtremor point 1.), a masonry community building (see Fig. 3.26) was severely damaged by

lateral spreading and an adobe school building was partially collapsed, while a newer school building with proper foundation behaved well (Fig. 3.27.)

Fig. 3.26. Severely damaged community building in Canchamana, with liquefaction traces in the foreground.

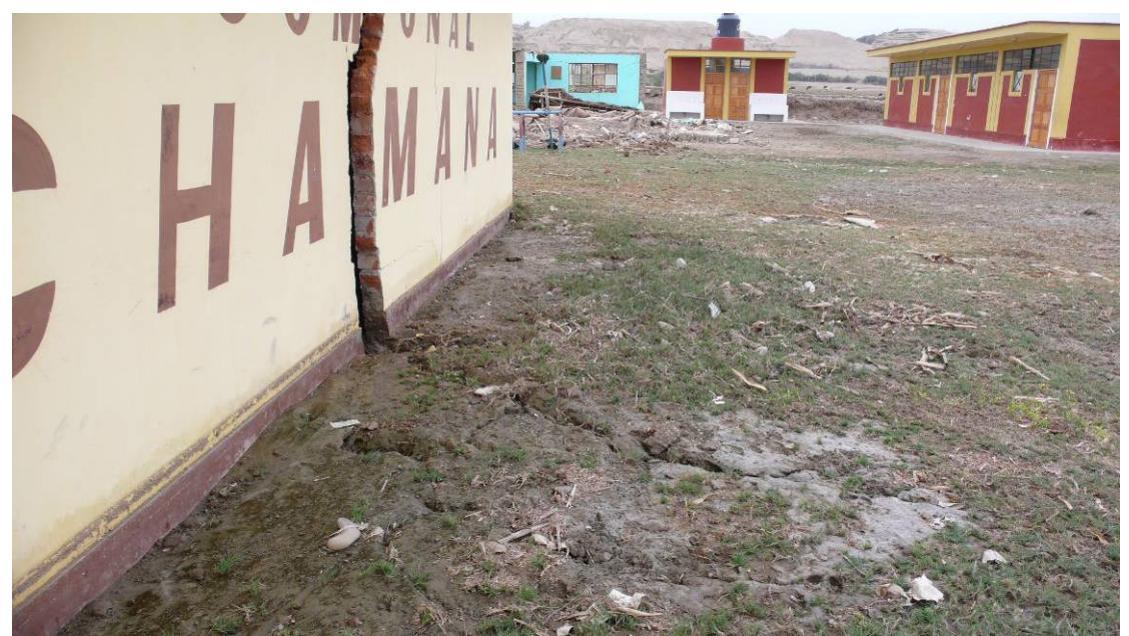
Fig. 3.27. Severely damaged community building in Canchamana, with liquefaction traces in the foreground and well behaved red school building in the background.

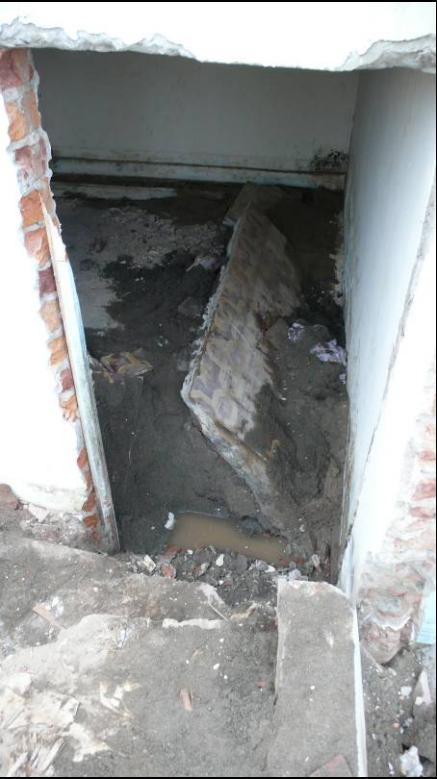
Fig. 3.28. Foundation pushed up due settlement the building.

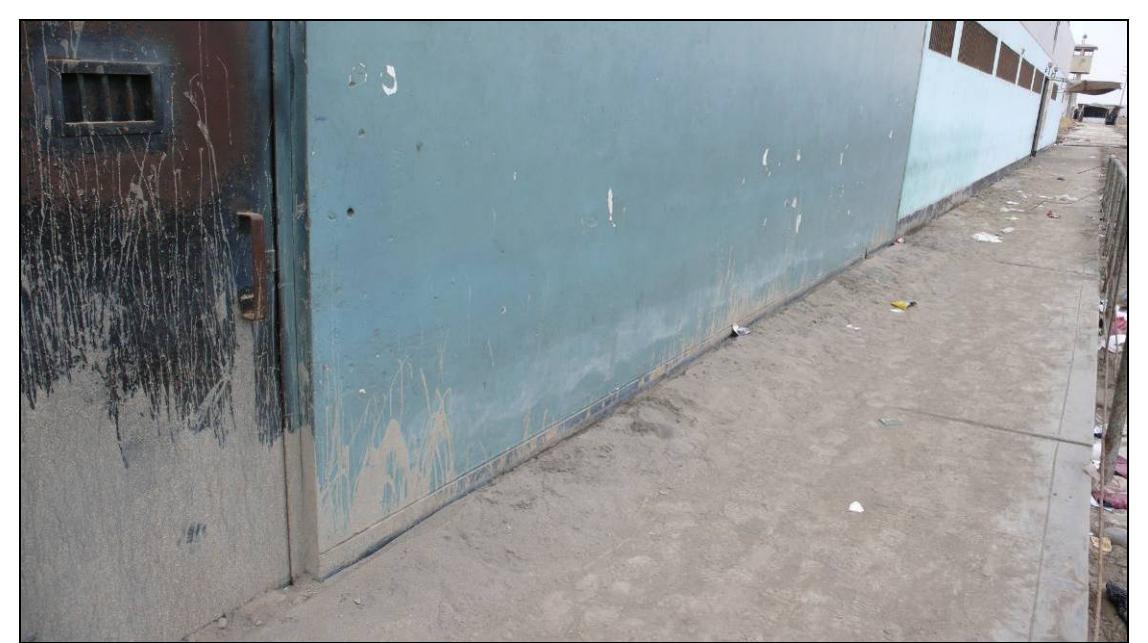
Fig. 3.29. Liquefaction splashed all the way to the top of Prison building door.

It is worthy to mention that Chincha Prison, located in the North of Tambo de Mora, suffered extensive damage due to liquefaction. The surrounding wall collapsed (see Fig. 3.30) and the prison cells exhibited large settlements (see prFig. 3.31). Due to the risk of additional damages, the local government decided to set free the prisoners. This fact suggests that location of this public building deserve further review as long as the social consequences of its failure were also considerable.

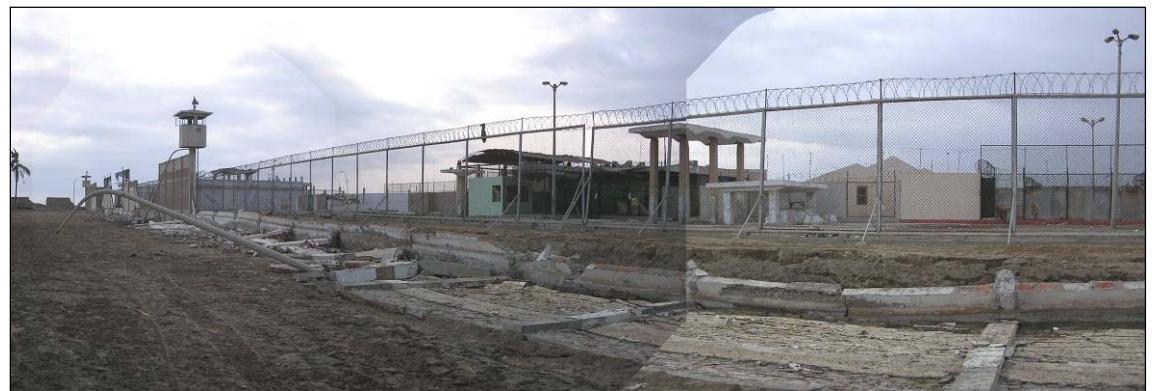
Fig. 3.30. Collapsed wall at Chincha prison due to large ground deformation

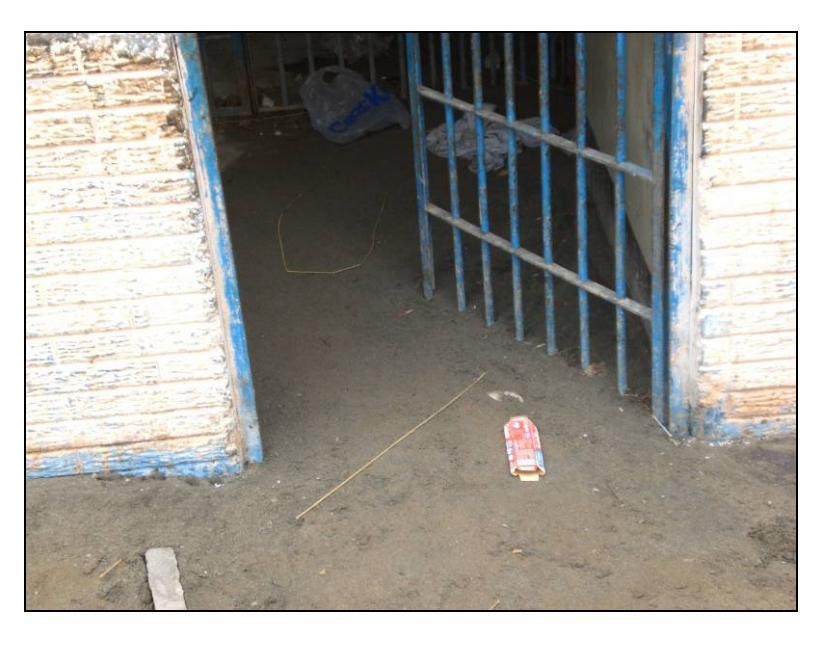
prFig. 3.31. Sand inside prison cell. (Courtesy of Julio Kuroiwa)

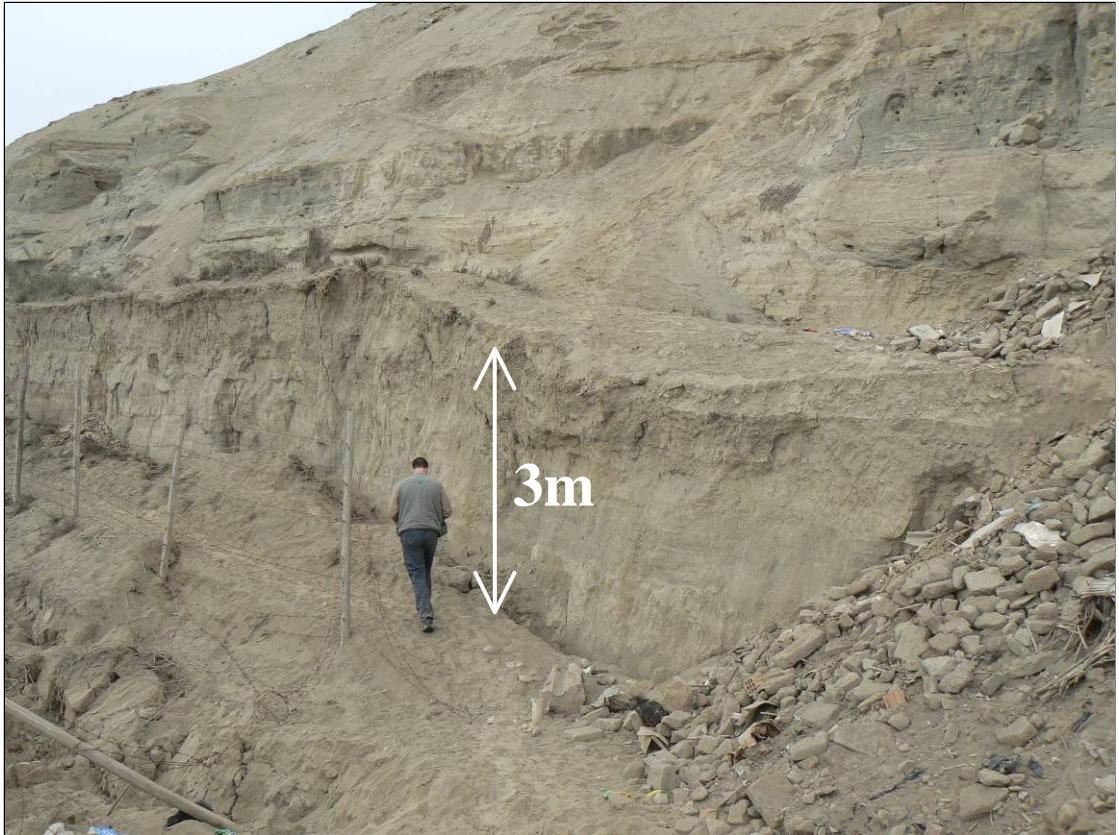
In the northern part (close to Microtremor point 1) a lot of over 20 meter long cracks with grayish sand ejecta were observed. Cracks and up to 3 meter differential settlements (see Fig. 3.33) where seen closer to the Canete formation. Here light brown/beige seemingly liquefied soil covered parts of some of the vertical scarps. The liquefied area extends from the central park (Plaza de Armas) of Tambo de Mora all the way to Pan-American highway in the north, which is distance of more than 7 km. A large block moved seemingly had moved downwards from the Canete formation and this movement downward continued as marked by the dashed lines as seen in Fig. 3.34. However there was vegetation between the block and the slope so this movement did not happen in the 2007 earthquake.

Fig. 3.33. On the border between the Canete formation and the marine deposit, there is a 3 meter differential vertical offset.

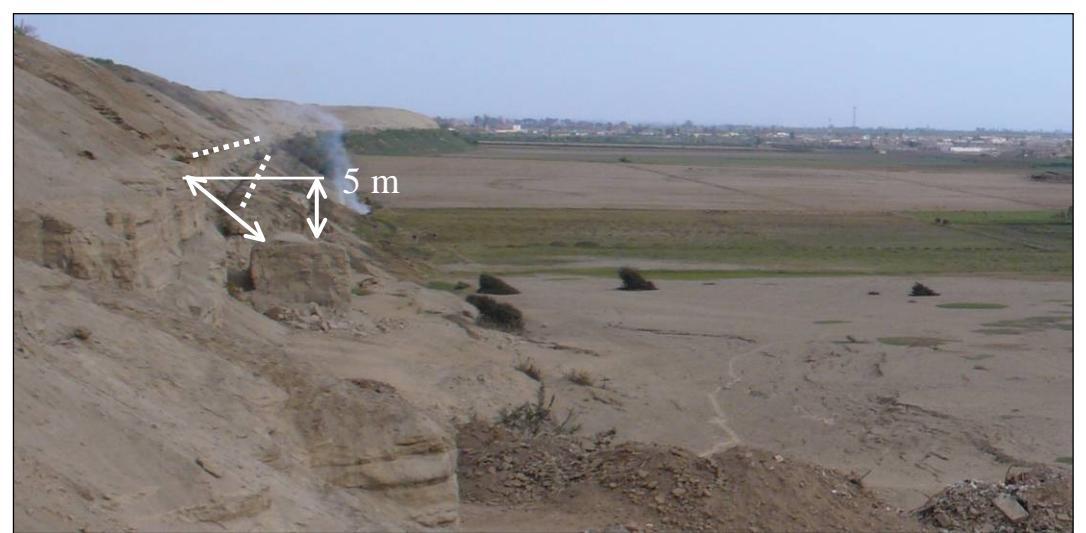
Fig. 3.34. Block moved seemingly moved down and towards ocean some 5 meters, however there was vegetation between the block and the slope, so this did not happen in the 2007 earthquake.

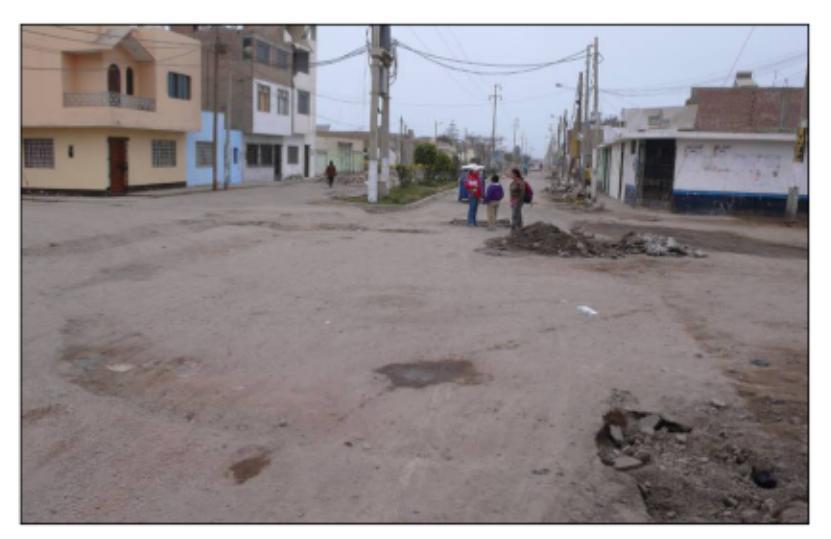
The sewer system in Pisco, whose conditions were already poor before the earthquake, was drastically affected due to ground deformation and liquefaction. As shown in Fig. 3.39 and Fig. 3.40, central and southwest areas of Pisco had broken sewer pipes due to ground settlements and dislocated manholes were wide spread. Fig. 3.41 (Rodriguez et al [16]) also shows a lateral spreading movement along the coastline in the south of Pisco.

Fig. 3.39. Central Pisco (S13 42.542 W76 12.516). Settled ground as evidence of broken sewer pipes.

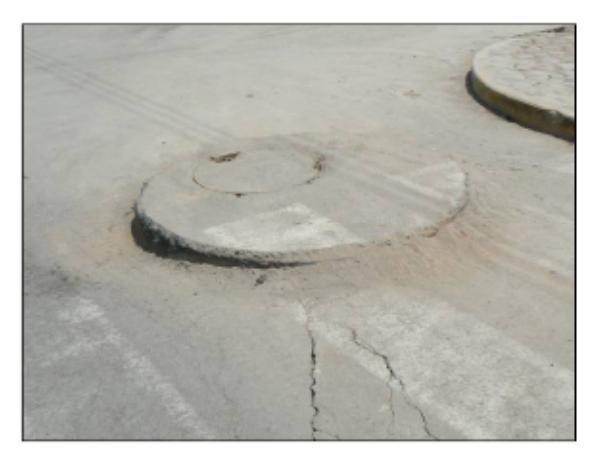
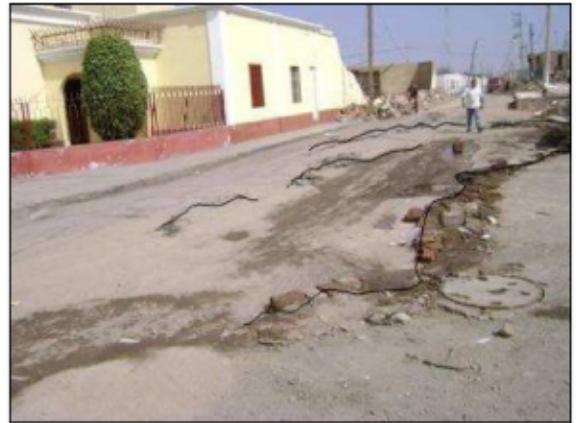
surrounded byNorthwest of Pisco (S13 42.343 W76 Pisco (Rodriguez et al [16]) 13.029)

Fig. 3.40. Manhole pushed up and Fig. 3.41. Sub parallel cracks with lateral ejected fine sand. spread along the streets in the southwest of

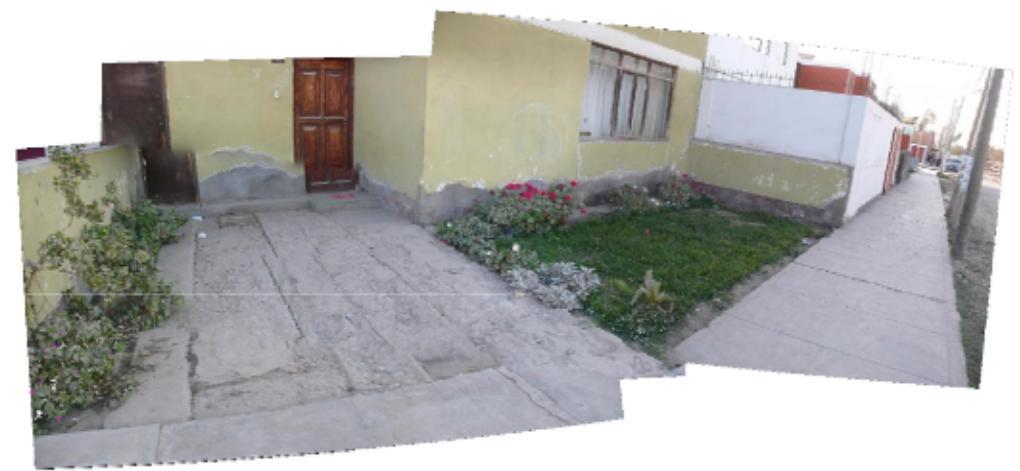
These points located along the coast and central part of Pisco, are within the area presented in Fig. 3.36 as prone to liquefaction. However, we observed liquefaction outside this "liquefiable zone" as indicated with an arrow in Fig. 3.36 and shown in Fig. 3.42. The extent of potentially liquefiable areas may deserve further review.

Fig. 3.42. Liquefaction traces were observed north-west of the intersection between Valdelomar Street and Las Americas Avenue.

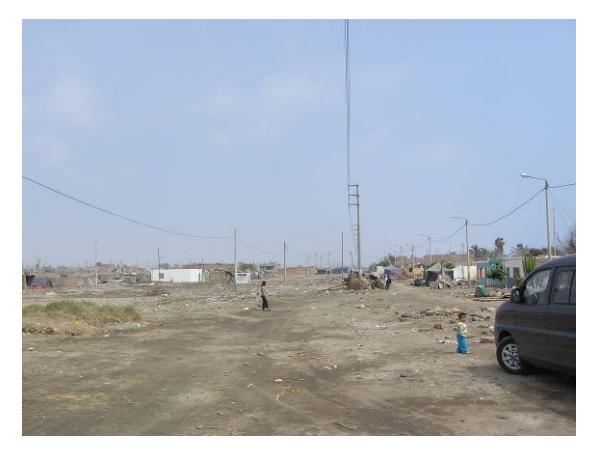
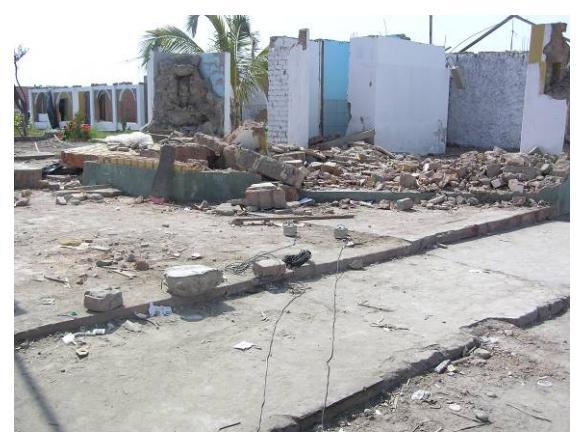
Fig. 3.47. (Point 2_UT) The number of Fig. 3.48. (Point 5_UT) At San Martin Av. standing buildings is small, high level of damage.

where many nearby adobe houses were about to collapse

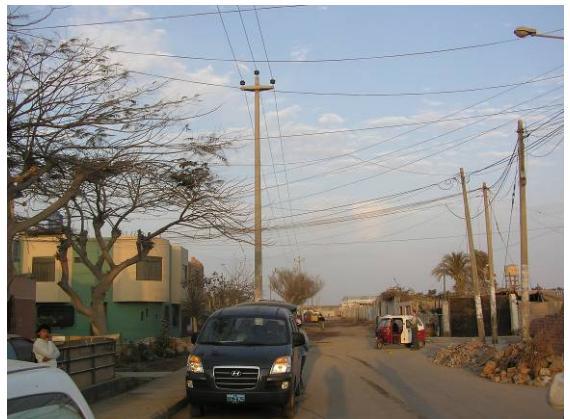
Fig. 3.53. (Point 15_UT) Two blocks from the main square. Contrasting large amounts of debris from nearby collapsed buildings on the right side while almost undamaged houses on the left.
