4. BUILDING DAMAGE

4.2. Building damage

4.2.2. Housing damage

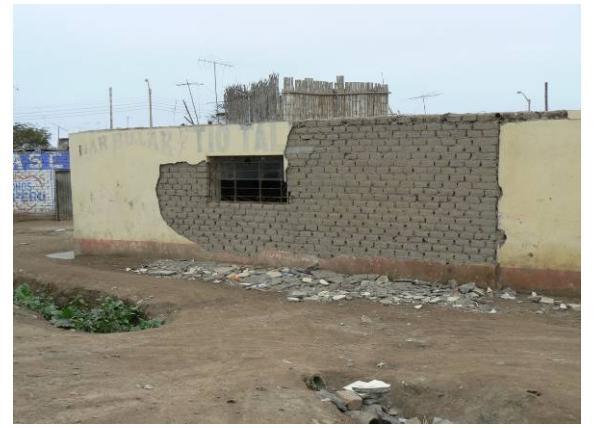
Fig. 4.17 Adobe house with plaster spalling (*San Luis, Canete*)

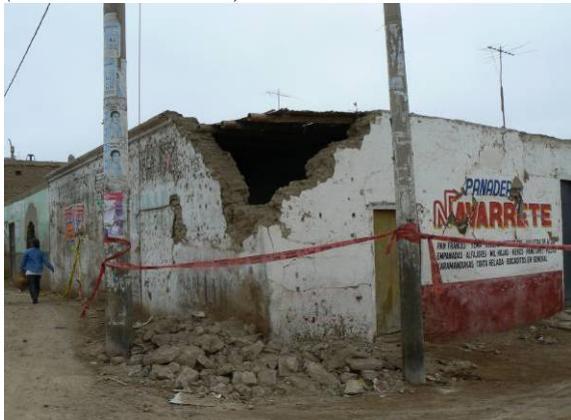
Fig. 4.19 Corner collapse in adobe house (San Luis, Canete)

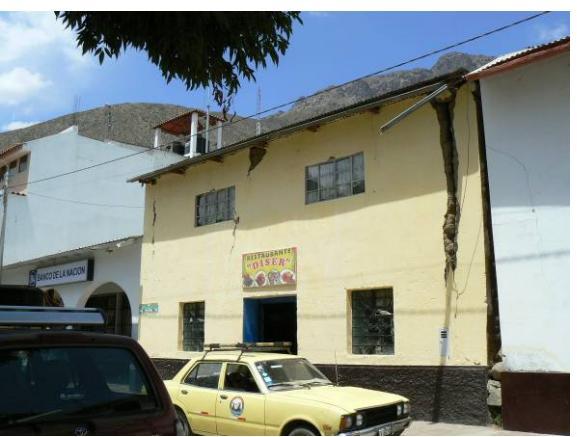
Fig. 4.18 Adobe house with cracks at wall intersections (Huaytara, Huancavelica)

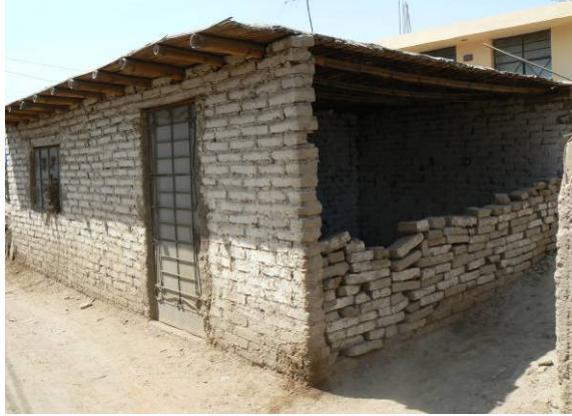
Fig. 4.20 Wall partial collapse. Walls supporting the roof are standing. This was observed at several locations (Ica).

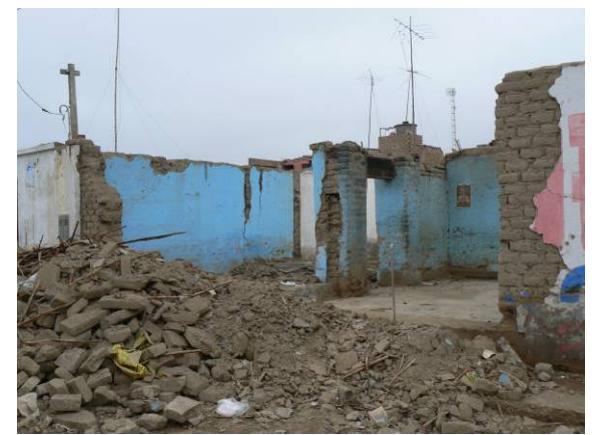
Fig. 4.21 Collapsed adobe house (Nuevo Monterrico, Canete)

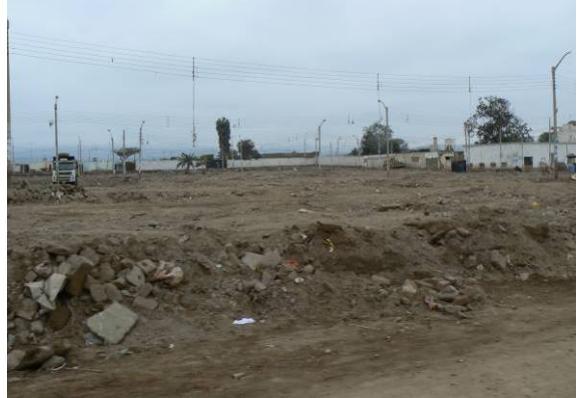
Fig. 4.22 Totally collapsed adobe houses (Hualcara, Canete) – The hanging electric lines show the location where houses used to be.

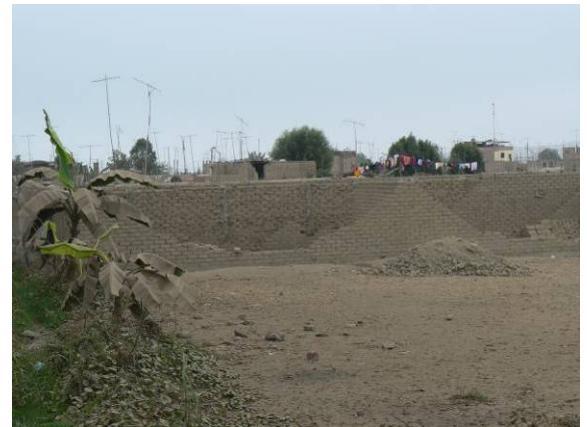
Fig. 4.23 RC confined adobe wall (in the back), survived the quake, and unconfined adobe wall (front) failed out-of-plane (San Luis, Canete)

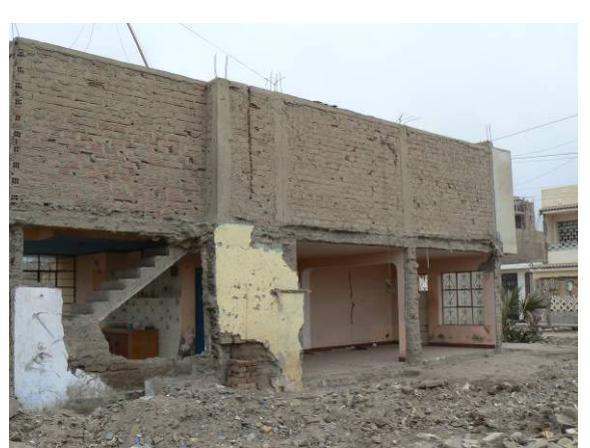
Fig. 4.24 The house shown "borrowed" the wall of the neighboring adobe house, which collapsed. Only the RC columns built to support the 2^{nd} floor survived. (Pisco, Ica)

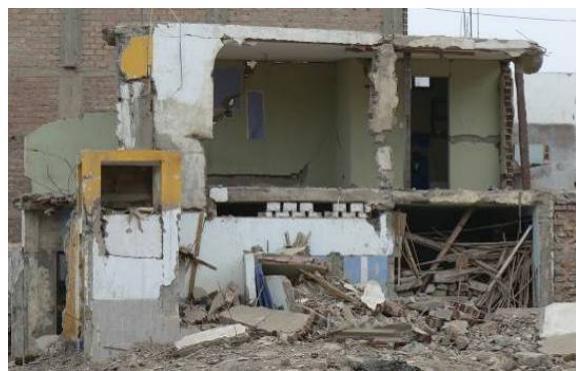
Confined masonry houses designed and built according to the building code did not suffer major damage. All the damaged structures had some type of deficiency. The most common were the use of bricks with horizontal alveolus for load bearing walls (locally called *pandereta* and prohibited by the code in this region), lack of confinement of parapets and façade walls, insufficient wall density, badly distributed stiffness (in plan and elevation), and a poor understanding of the confined masonry construction procedure. Another deficiency found was the lack of steel reinforcement in the confining beam or the lack of confining beam altogether.

Fig. 4.25 Load bearing wall made of pandereta bricks and poor steel reinforcement in the confinement (Pisco, Ica)

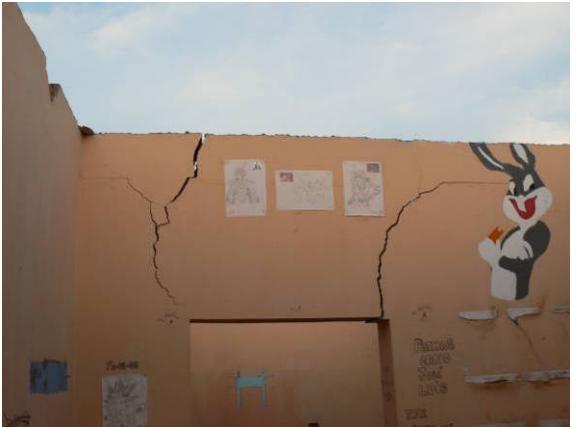
Fig. 4.27 Lack of confining beam (Tambo de Mora, Chincha)

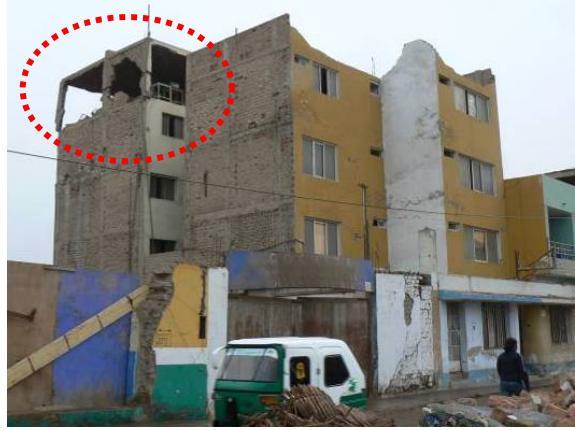
Fig. 4.29 5-story confined masonry building apparently built in several stages (Pisco, Ica)

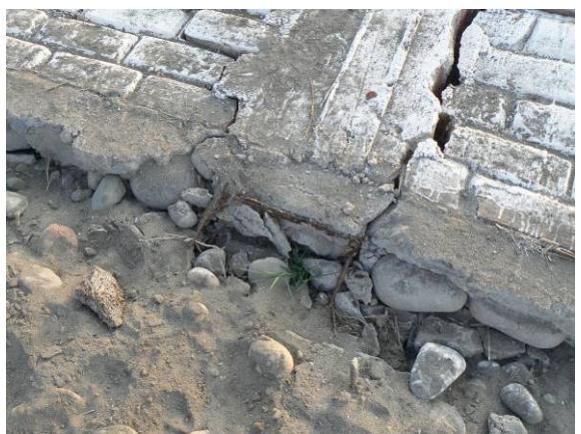
Fig. 4.28 Corroded column reinforcement (Tambo de Mora, Chincha)

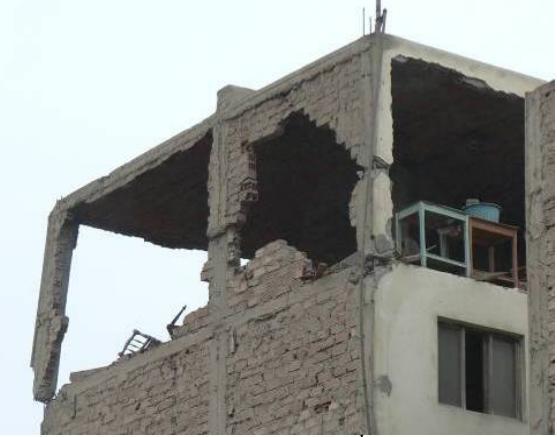
Fig. 4.30 Detail of the 5^{th} story of the building to the left. Note the small amount of reinforcement in the columns. The failure pattern suggests that the columns were built first and then the brick wall.

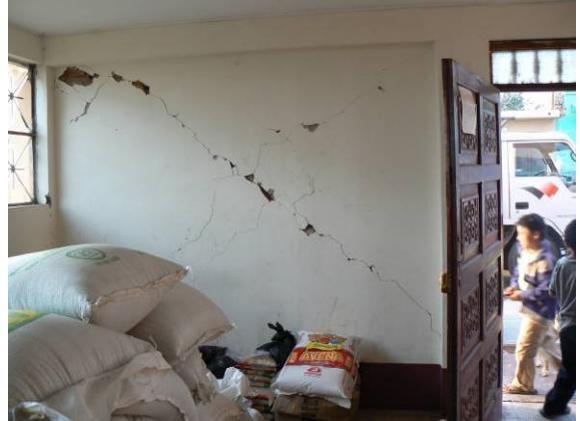
Fig. 4.31 Shear failure of masonry wall due to excessive interstory drift

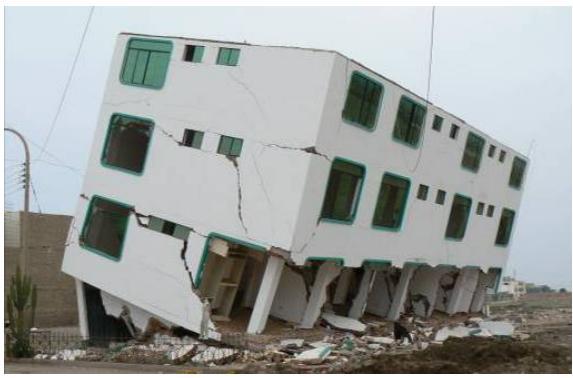
A few apartment buildings made of RC were found in the affected areas and in some of the cases, the structure was a mixture of confined masonry and RC. Fig. 4.32 shows an apartment building with a car parking in the first floor. The RC columns used to leave space for the cars to access had smaller stiffness than the back wall, a solid

confined masonry element. This generated a torsion effect imposing the columns a demand larger than their capacity.

Fig. 4.32 Apartment building with inadequate stiffness distribution (Pisco, Ica)

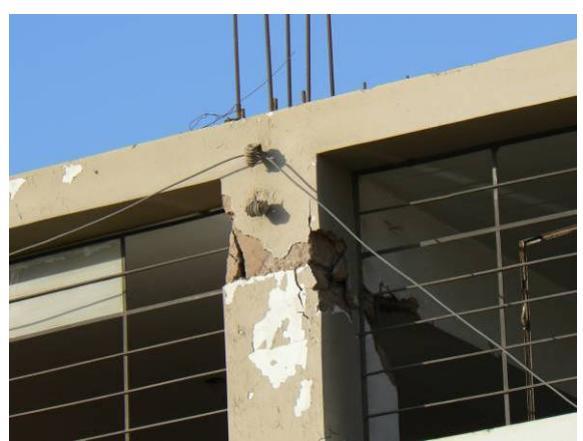
Fig. 4.36 Shear failure of beam-column joint (Parcona, Ica)

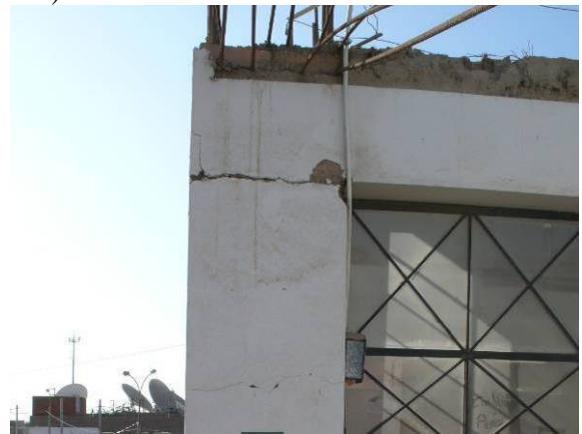
Fig. 4.37 Weak cold joint between column and beam/slab (Parcona, Ica)

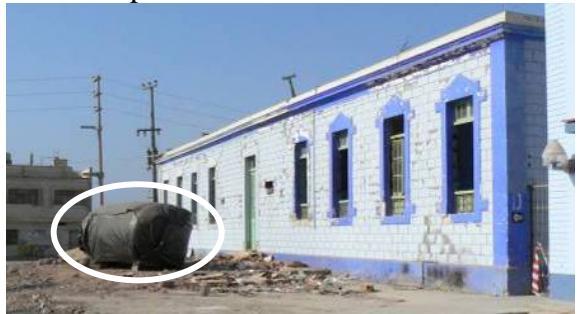
Fig. 4.39 Heavily damaged building. Note the hyperbaric chamber on the back

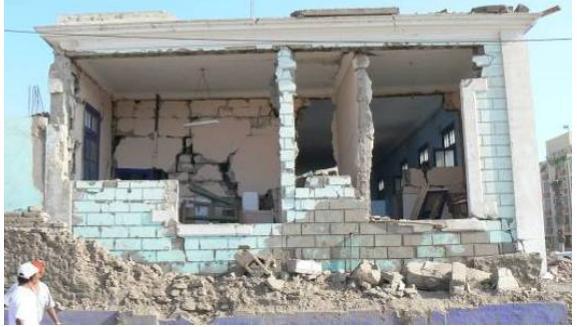
Fig. 4.40 Concrete block wall collapsed out-of-plane

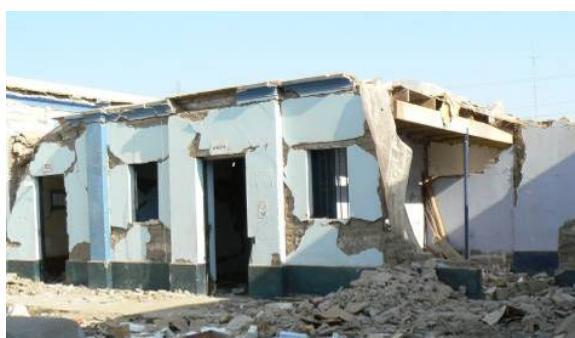
Fig. 4.41 A hospital building made of nonreinforced adobe was heavily damaged

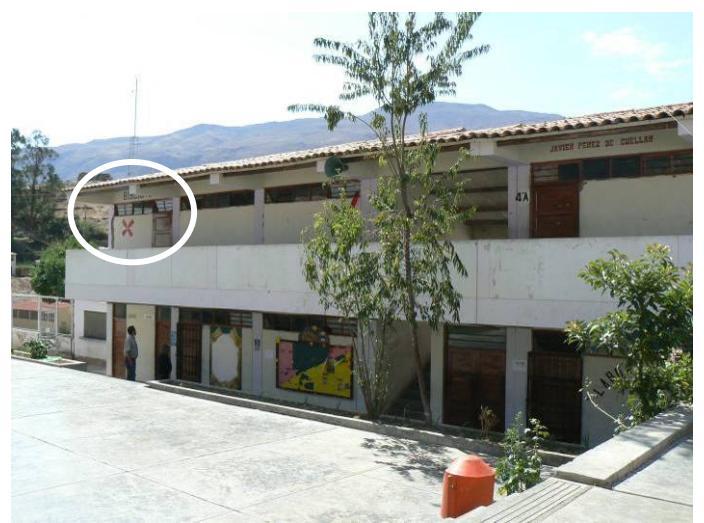
At San Juan Bautista School no major structural damage was observed. However, the masonry partition walls, which were correctly separated from the main RC structure to prevent short column effects, did not have confinements and therefore were not anchored to the beams underneath. As a result, the connection between walls and beams, most likely provided just by cement mortar, failed. Although the walls did not collapsed, they were very unstable posing risk to the people nearby. The classrooms

Fig. 4.42 Masonry panels in the second floor were damaged, (San Juan Bautista school, Huavtara)

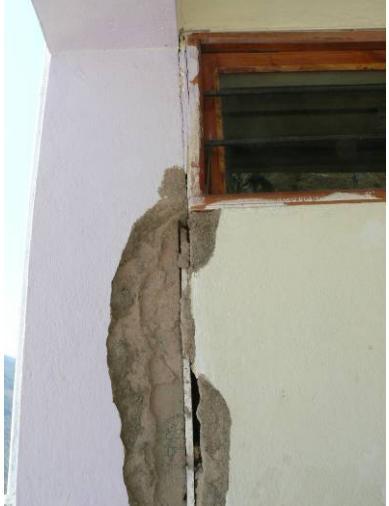
Fig. 4.43 Detail of the joint connection, (San Juan Bautista school, Huaytara)

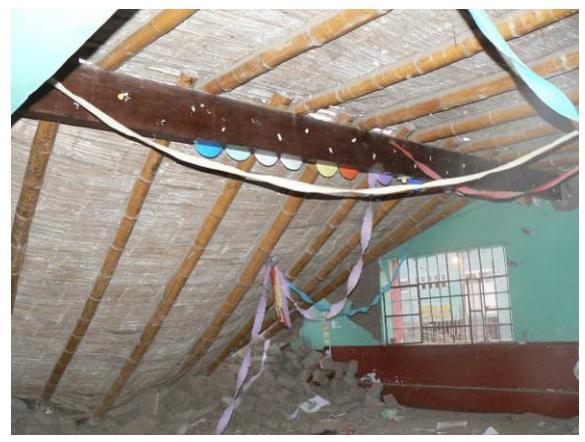
All of the adobe classrooms at Beatita de Humay School were left useless. Adobe walls and straw mat roofs collapsed. Fortunately, at the time of the earthquake there were no students in the facility and therefore nobody was injured there. The columns of a RC building with masonry panels exhibited mild shear failure.

Fig. 4.46 Elementary school classrooms made of adobe were heavily damaged (Beatita de Humay School, Humay)

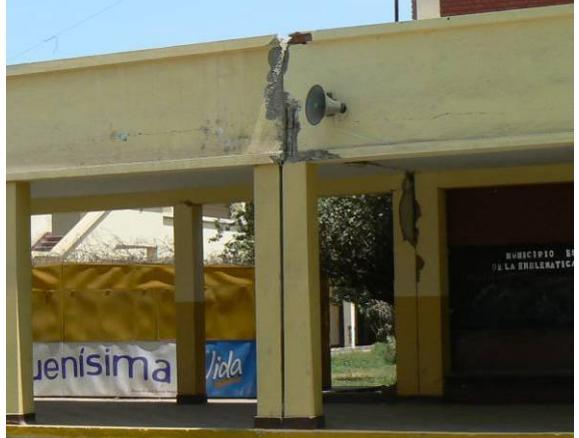
Fig. 4.48 Pounding between buildings (San Luis Gonzaga School, Ica)

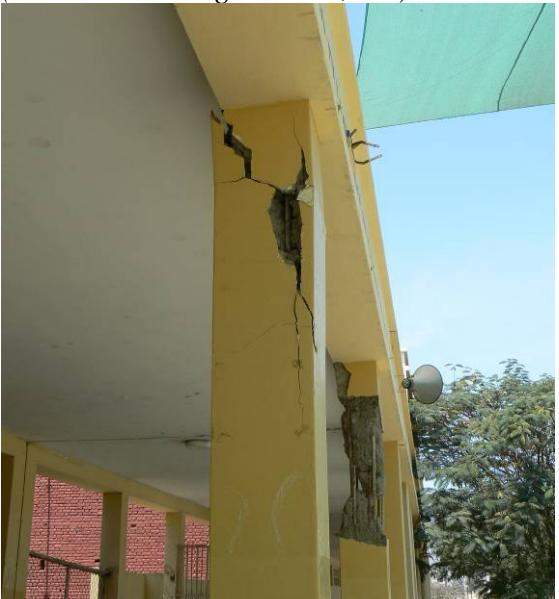
Fig. 4.50 Lack of shear reinforcement in columns (San Luis Gonzaga School, Ica)

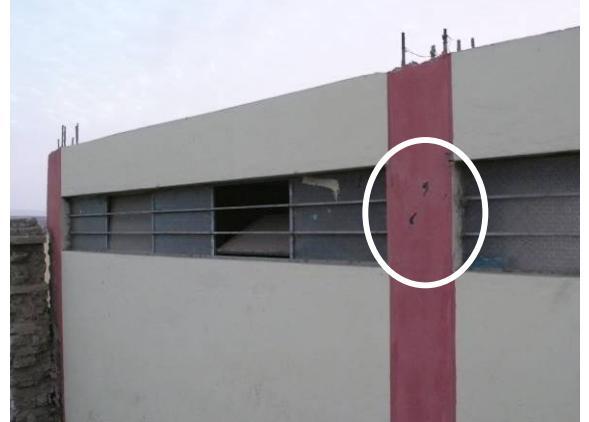
Fig. 4.47 RC-buildings with masonry panels suffered slight shear damage (Beatita de Humay School, Humay)

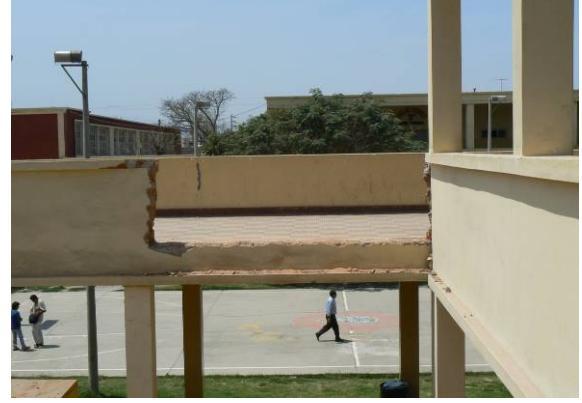
Fig. 4.49 Parapet overturning (San Luis Gonzaga School, Ica)

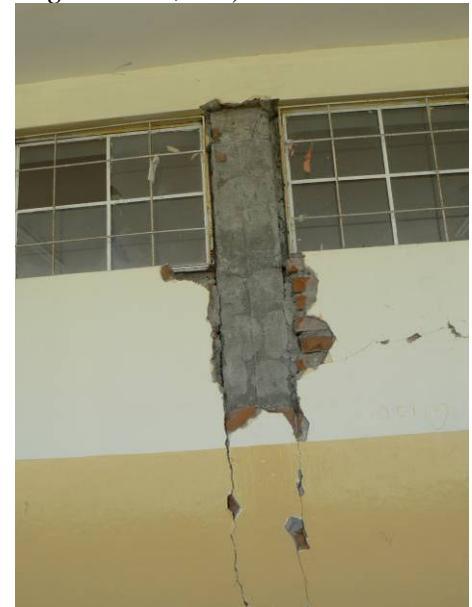
Fig. 4.51 Insufficient clearence between masonry panels and RC structure (San Luis Gonzaga School, Ica)

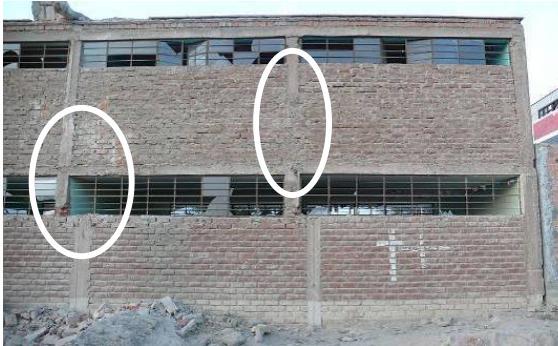
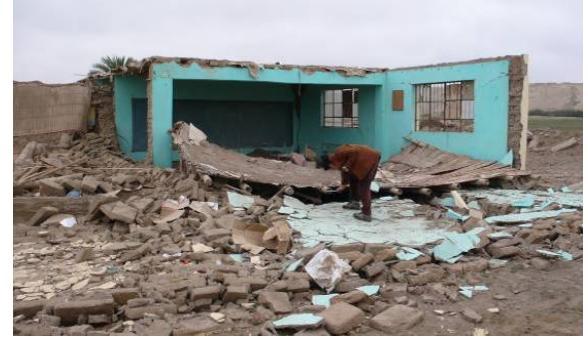
In general, the design/construction quality of the schools visited during the survey was very varied. For example, at Los Molinos in Ica, a very new and well constructed school (shown in Fig. 4.6) was found next to another which obviously did not followed any design or construction standard. Fig. 4.52 shows one of the building walls in which it is seen that columns in the 1^{st} floor are not aligned with the columns in the 2^{nd} floor. Furthermore, one of the columns is interrupted

Fig. 4.52 Bad construction example in LosFig. 4.53 Classroom at Tambo de MoraMolinos, Icamarine deposits, Ica.

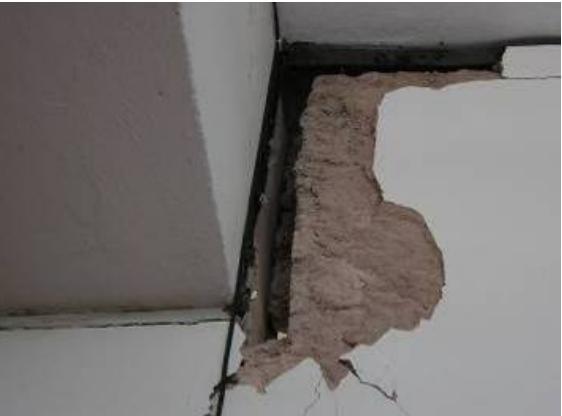
The RC frame structure was built in two stages: the first floor in 1998 and the second floor in 2002. Although it did not suffer major structural damage, some of the brick partitions cracked and needed repairing. In the 1st story, where partitions suffered more damage, the joint left between structure and wall was not wide enough in some cases and in others filled with mortar. This limited the freedom of the structure to deform. The joints in the second floor were wider and thus partition damage here was less.

Fig. 4.55 Joint between brick partition and RC structure filled with mortar

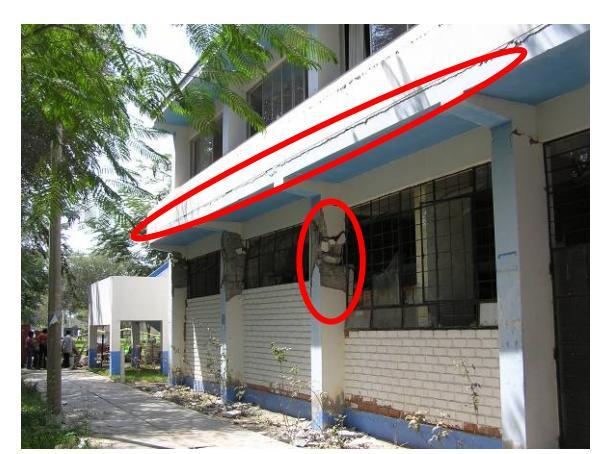
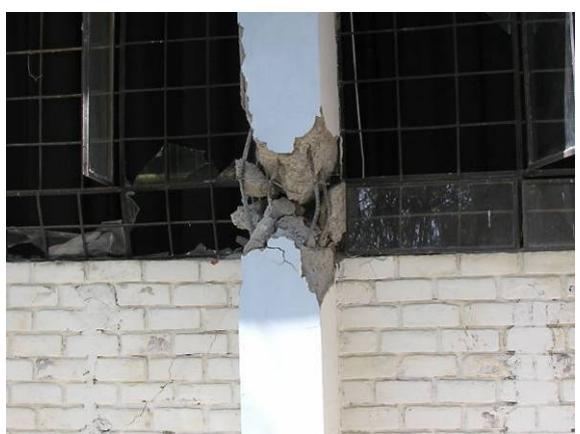
One of the most damaged buildings in the campus was that of the Chemistry Faculty. These were among the first buildings in the university constructed more than forty years ago. In here, short column effect and poor shear reinforcement detailing were observed. Also, parapets with no anchorage to the structure were damaged although they did not collapse.

Fig. 4.58 Chemistry Faculty Building with Fig. 4.59 Insufficient shear reinforcement short column failure and parapet damage

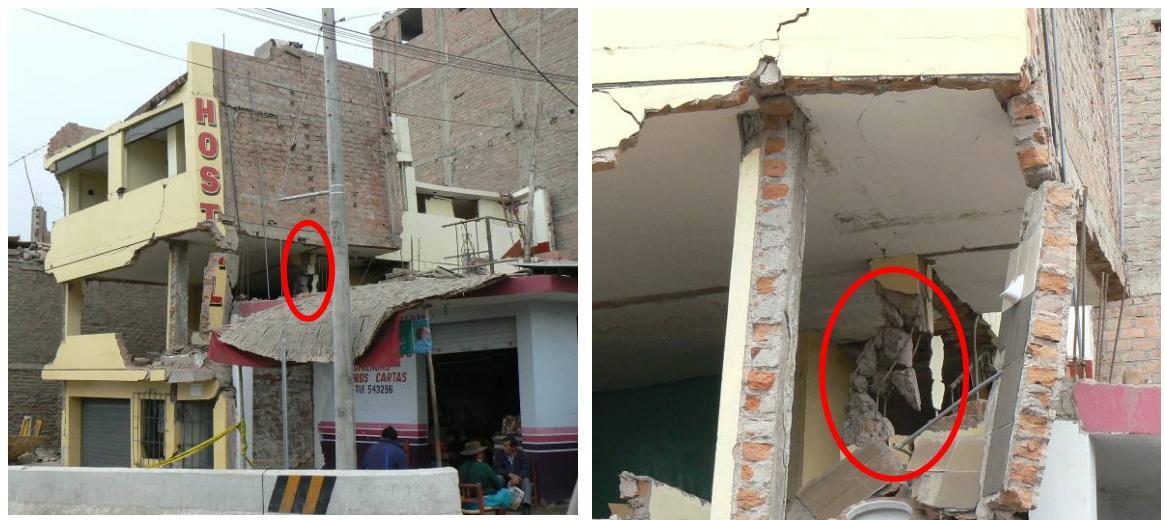
Fig. 4.62 and 4.63 show one small hotel that was observed during the field survey. Insufficient shear reinforcement in the columns among other deficiencies was observed.

Fig. 4.62 Heavily damaged hotel (San Fig. 4.63 Insufficient column shear Clemente, Ica) reinforcement.

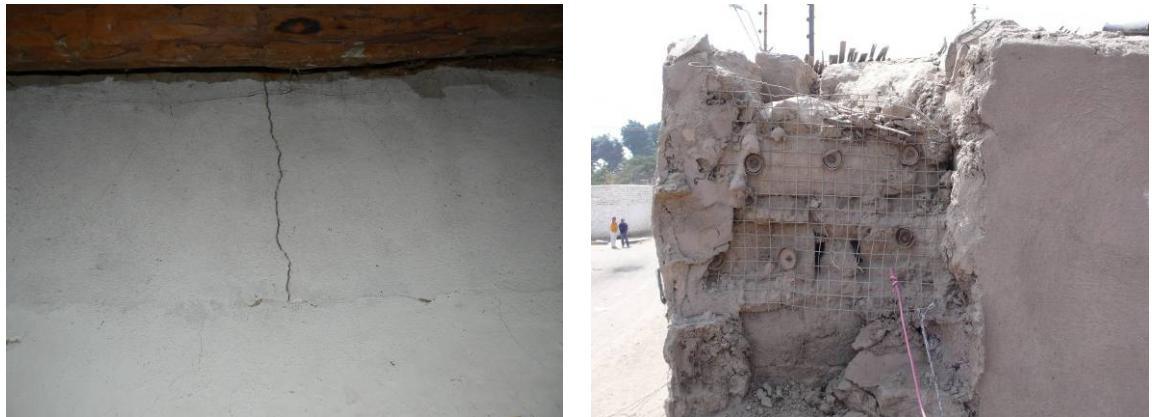
The inspection of the house showed that it suffered almost no damage due to the earthquake although the damage rate of adobe houses in Guadalupe was over 80%. A few vertical cracks were observed in the mortar cover of the "collar beams" inside the house. It is believed that they just affected the cover and did not pass through the walls. It is important to mention that the backyard wall, which was not retrofitted, collapsed due the shaking. A small portion of the steel wire mesh, without any corrosion signs, was exposed as shown in Fig. 4.68.

Fig. 4.68. Retrofitted house after the Pisco Earthquake
