3. GEOTECHNICAL ASPECTS

3.2. Large soil cracks in San Luis

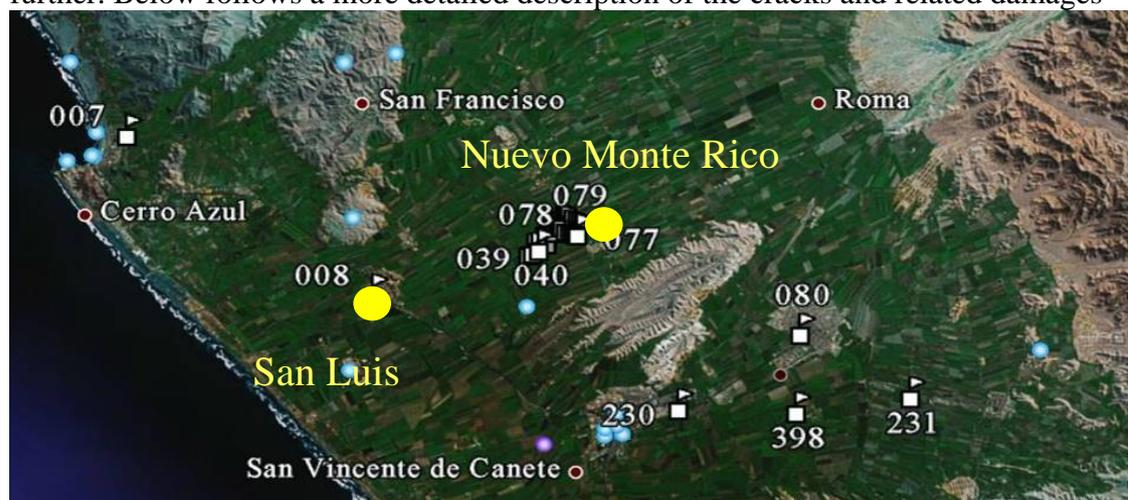
In the San Luis annex Nuevo Monte Rico, several large and long ground cracks were observed in an area of 1km² size. Fig. 3.1 shows view from Google earth of the location of the ground cracks and Fig. 3.2 shows geology the same area. Nuevo Monterrico is located on an alluvial plain, shown as green areas in Fig. 3.1, and as whitish color with open circles in Fig. 3.2, are spreading between granitic formation in the North at San Francisco (in Fig. 3.1) and a tertiary sandstone formation (Paracas Formation) in the south. The ground cracks cause by damage to buildings, agriculture, and also, according to the local people, 3 wells went dry in the area. We do not know presently if the cracks were caused by liquefaction induced lateral spreading, or if large scale tectonics might have created extension in this area. Such extension often occurs on the continental plates in subduction zones. This needs to be investigated further. Below follows a more detailed description of the cracks and related damages

Fig. 3.1. Google earth view of San Luis Annex Nuevo Monte Rico. GPS coordinates next to right yellow point shows location of large cracks.

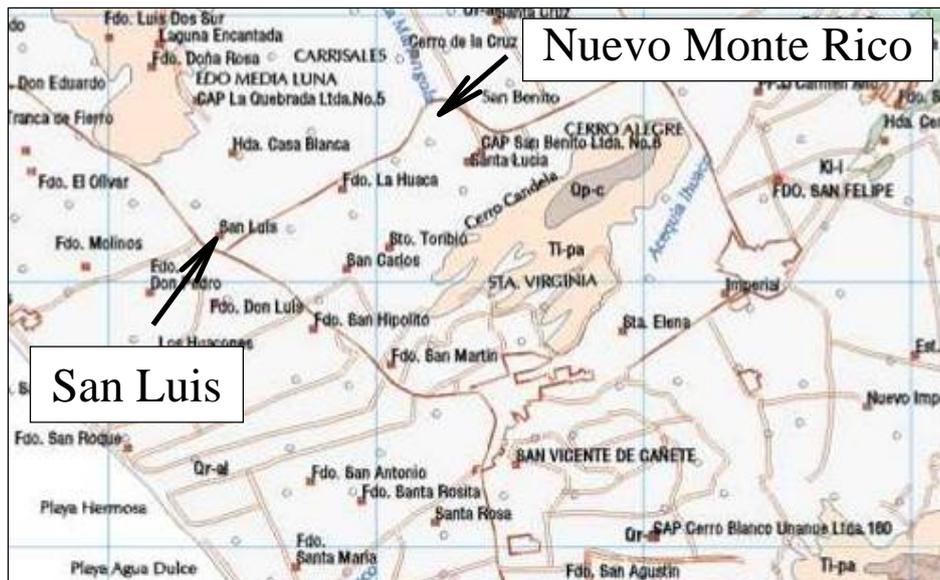
Fig. 3.2. Geological map (INGEMMET) view of San Luis Annex Nuevo Monte Rico.

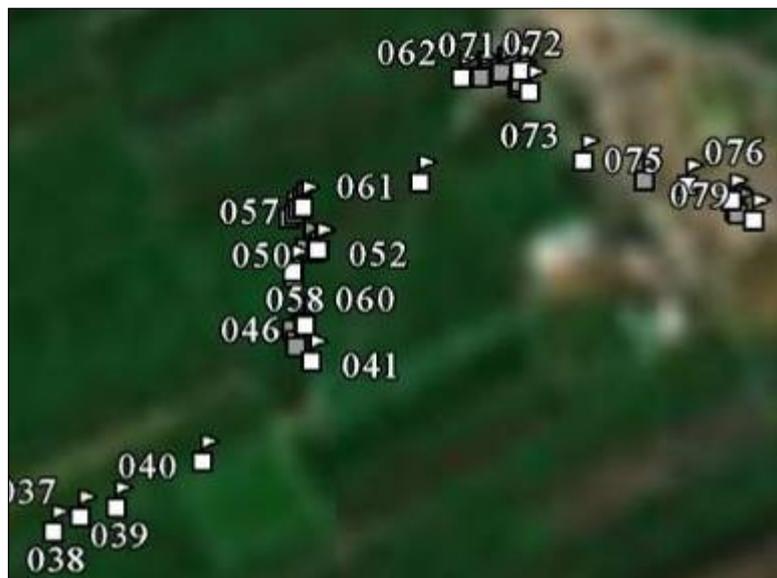
There are 3 clusters of cracks in Fig. 3.3. The first cluster of points 37 to 40 indicated smaller lateral spreading failures along the dirt road (road 746) leading from the Pan-American Highway to Nuevo Monte Rico. There was drainage ditch on the north side of the road towards which lateral spreading occurred over a length of over 200 meters. On the south side of the dirt road there was a sewage pipe, leading from Nuevo Monterrico towards the ocean, which broke, likely due to the lateral spreading, and related soil displacement induced a lot of cracks in the cotton field next to the road (see Fig. 3.4). These cracks cause a lot of trouble for the farmers to irrigate their fields, since the water went into ground through the cracks, instead of being distributed through small irrigation canals to the whole field.

Fig. 3.3. Google earth view of San Luis Annex Nuevo Monterrico with GPS points.

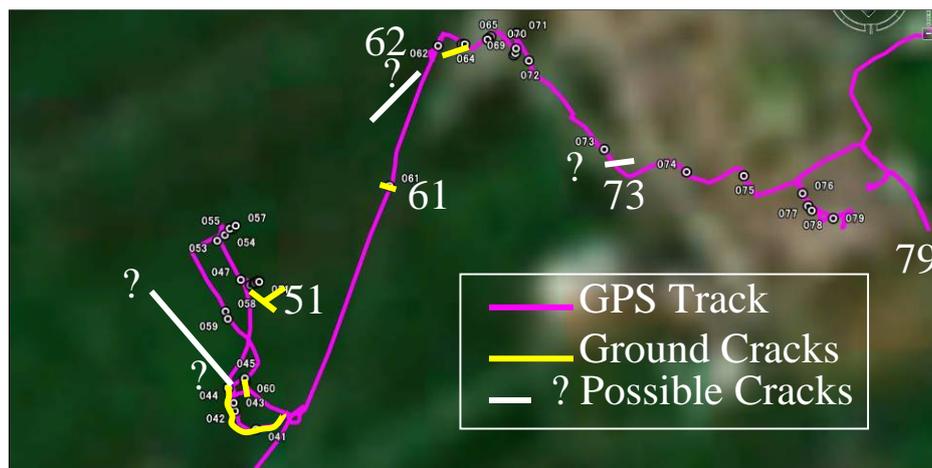
At the cluster of points 40-44 in Fig. 3.5, an approximately 70 meter long crack were found. A close up is shown in the map in Fig. 3.6 and photo in Fig. 3.7. Another shorter crack was also found nearby, at point 46 in Fig. 3.5, with large vertical offsets of up to 40 cm (see Fig. 3.8). There were some indications of liquefaction since soil seemed to have been fluidized and finer grains settled on the top, but we saw no clear sand boils in the area. These “liquefaction traces” might have rather been due to irrigation of field in the weeks after the earthquake. Some of the fields in this area had already been plowed so many cracks had been erased. This shows how important it is to get into the field directly after the earthquake hit.

Another farmer had also irrigation problems in an apple plantation at GPS point 57 in Fig. 3.5. due to large cracks (see Fig. 3.9)

Fig. 3.5. Google earth view of San Luis Annex Nuevo Monterrico with GPS tracks in purple. Yellow shows location of large cracks. White shows location of cracks reported by local people. White colored crack located close to point 62 we observed from the road only.

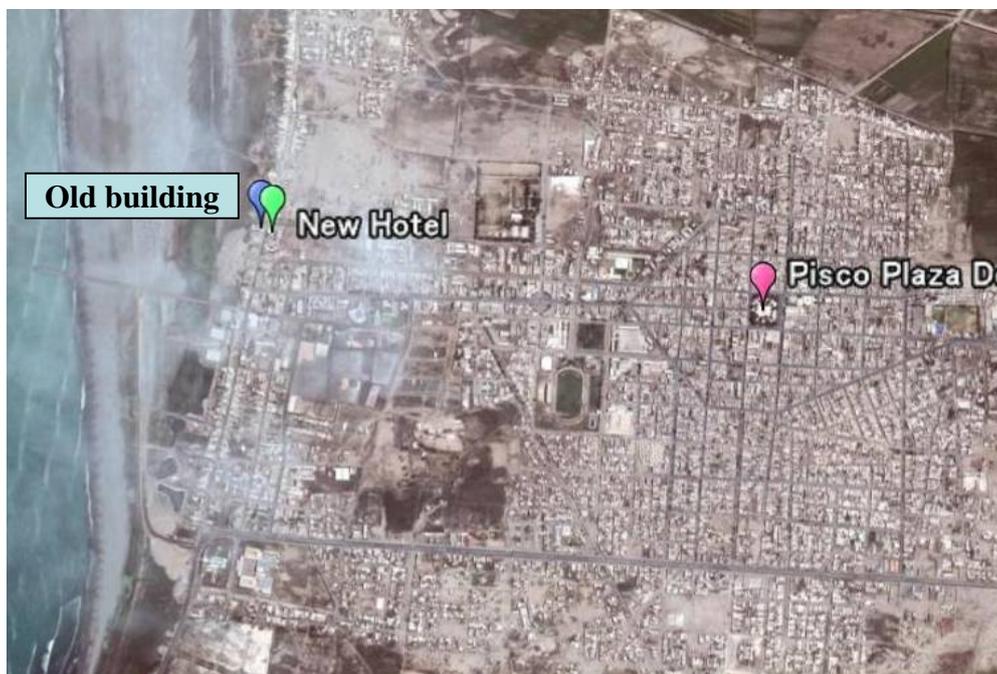
We found two buildings with good performance even though damage to buildings around them was severe. The location is indicated in Fig. 3.17. This area was severely damaged by liquefaction as seen in the ground cracks in Fig. 3.18. Lateral spreading caused the soil to displace towards the ocean and the creating some 10-15 cm wide cracks in the soil. The crack probably continues in front of and/or beneath the blue building and then up through the confined masonry wall as marked by the black arrow in Fig. 3.18. The soil settled some 10-15 cm next to the blue house as shown in Fig. 3.19.

Fig. 3.17. Google earth satellite view of location of buildings with pile foundation (blue mark) and strong foundations slab (green mark).
