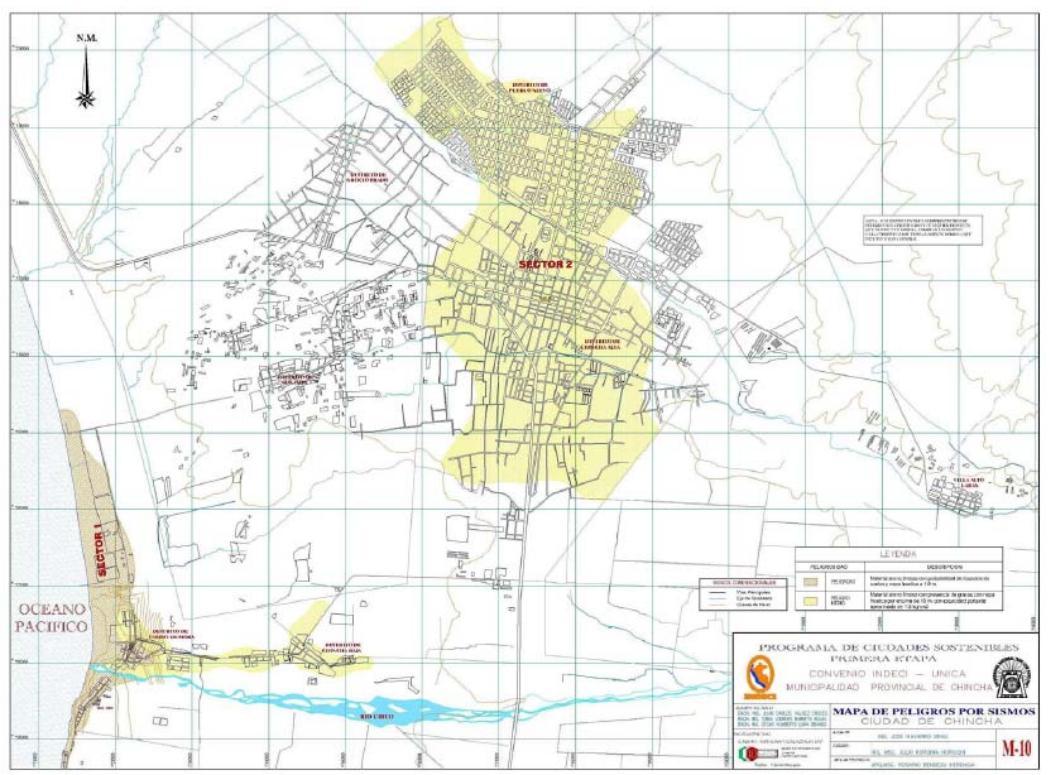
Under the program of Sustainable Cities, INDECI in association with the National University of Ica [15] present the Seismic Hazard of Chincha city (see Fig. 3.24). According to the hazard zoning map, Tambo de Mora (Zone 1) has the highest risk in the area.

Fig. 3.24. Seismic Hazard Areas City of Chincha. INDECI [1]. Brown colored area next to the ocean indicates "dangerous"s area.

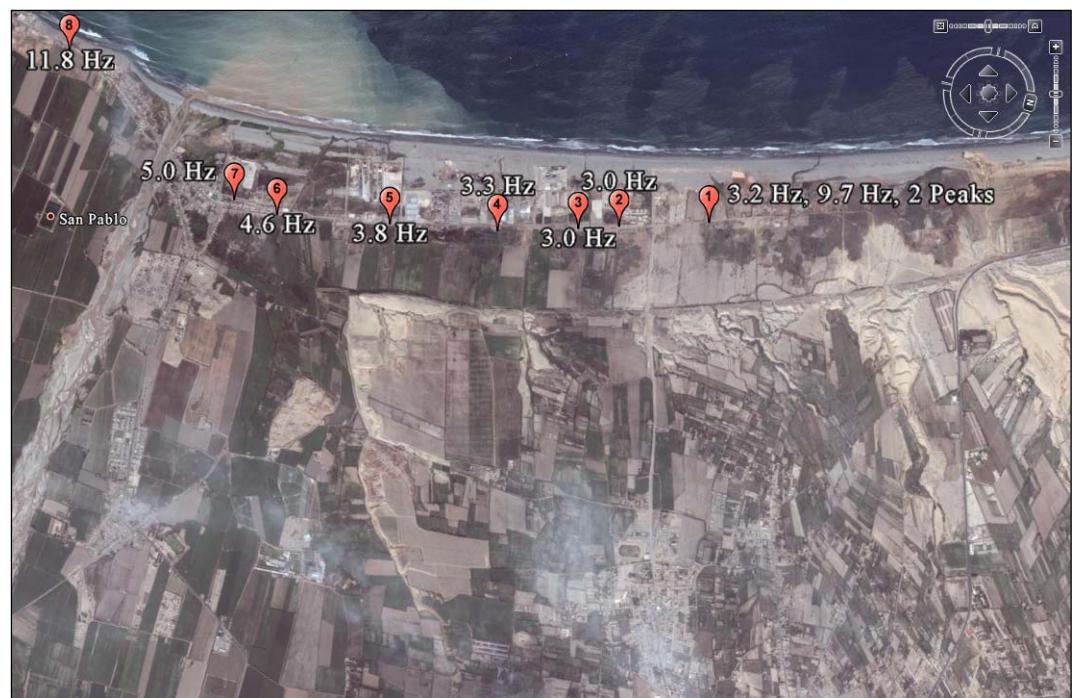
Tambo de Mora is located on an alluvial deposit in the south and a marine deposit in the north (see Fig. 3.32) and to the east of the marine deposit lies the Pleistocene Canete formation consisting of alternating layers of sand and silt stones [1]. Ground water level is very shallow in the marine deposit, surfacing at some locations. South of the river Chico, we found one well, close to microtremor point 8, where the water level was at approximately 2.5 meter.

Fig. 3.32. Google earth image of microtremor measurement locations and results.

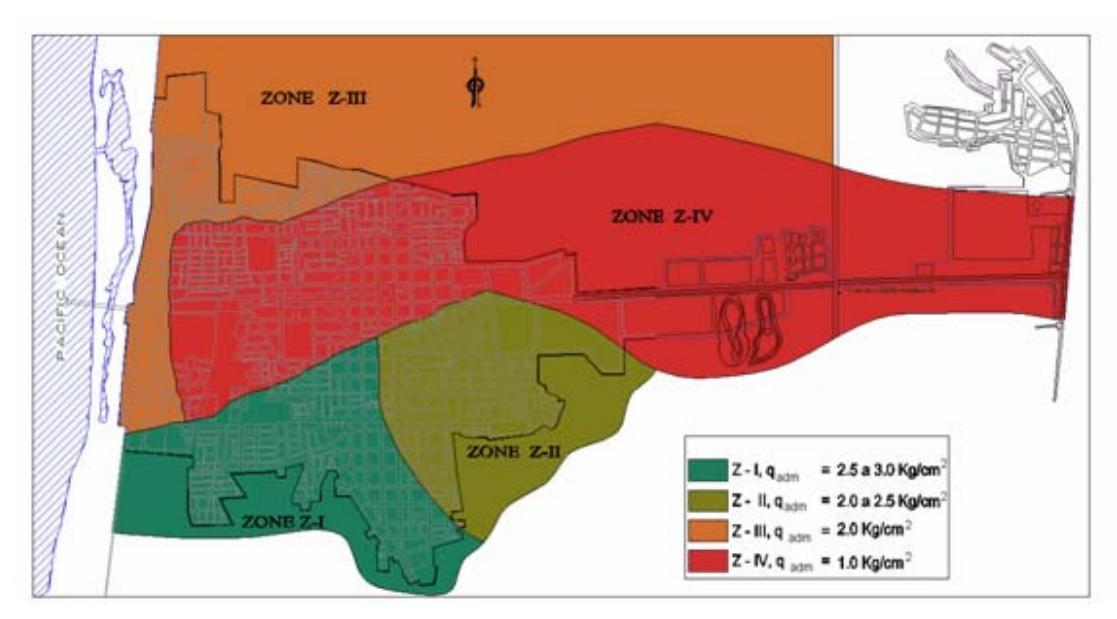
Fig. 3.35 shows the proposed geotechnical zonation based on bearing capacity. The characteristics of each zone can be briefly described as:

- Zone I: Southwest of Pisco. A 0.2 m thick layer of fill material composed of clay and round gravels, overlying gravel poorly graded (GP), maximum size of 12", 22% of sand and 1.5% of non plastic and slightly wet fines. No phreatic level was identified. Bearing capacity ranges from 2.5 to 3.0 kgf/cm² (Df=0.8 m).

- Zone II: Northern and central coast of Pisco. 0.5 m of sandy clay layer overlying fine silty sand with a thickness of 1.1 m, followed by poorly graded gravel (GP). The phreatic level was found northwards at a depth of 1.4 m. The estimated bearing capacity was 2.0 Kgf/cm² (Df=1.1 m)

- Zone III: Central Pisco. 1.2 m of sandy clay layer overlying fine silty sand up to depths between 2.0 to 4.25 m, followed by gravel poorly graded (GP). The phreatic level is located between depths ranging from 1.0 to 1.8 m. The estimated bearing capacity was 1.0 Kgf/cm² (Df=0.8 m)

- Zone IV: Southeast of Pisco. 0.8 to 1.2 m of filling material composed of clay mixed with rounded gravel and debris deposits. Phreatic level was not observed and the bearing capacity was estimated to range between 2.0 and 2.5 kgf/cm² (Df=0.8-1.2 m).

Fig. 3.35. Geotechnical zonation based on bearing capacity (Adapted from [13])

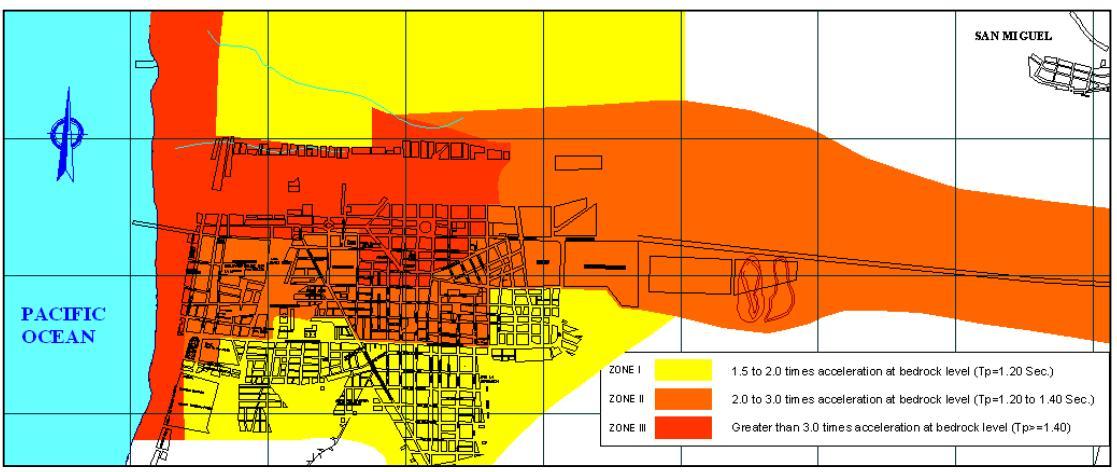
- Very high seismic amplification zone: Saturated lose sandy soils, with natural frequency periods greater than 1.4 sec that may amplify the bed-rock acceleration more than 3 times.
- High seismic amplification zone: Loose sandy and silty-sandy soils, slightly saturated with phreatic levels at 3.0 m depth. Natural periods between 1.2 and 1.4 sec that may amplify the bed-rock acceleration between 2.0 and 3.0 times.
- Intermediate seismic amplification zone: Sandy and gravely-sandy soils with medium levels of compaction, slightly saturated with phreatic levels at 3.0 m depth. Natural period around 1.2 sec and expected amplifications between 1.5 and 2.0.

Fig. 3.36. Expected amplifications of seismic waves (Adapted from [7])

The distribution of amplifications across the city seems to follow the pattern of soil distribution, suggesting that the natural period and the expected amplifications might be based on the available information of soil characterization and phreatic level location.

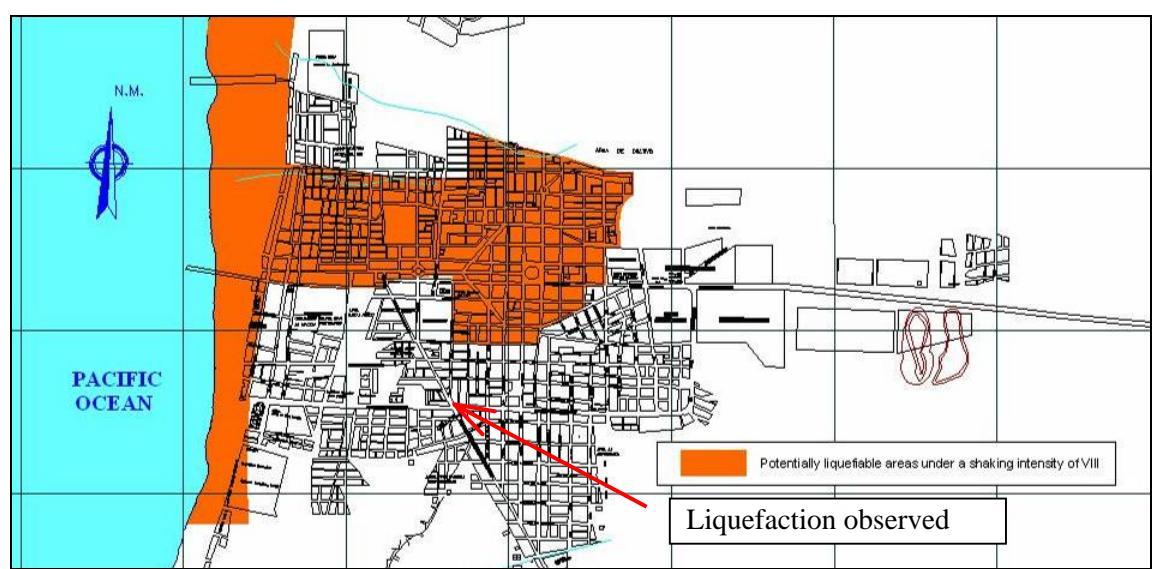
Based on this, it was suggested that widespread liquefaction may take place along the coastline of Pisco. Partially liquefiable soils were identified in the northern part of the city, which corresponds to the oldest part of the city. (See Fig. 3.37)

Fig. 3.37. Potentially liquefiable areas (Adapted from [7]). Liquefaction was observed outside this zone, one such location is indicated by the arrow and shown in Fig. 3.42.

These points located along the coast and central part of Pisco, are within the area presented in Fig. 3.36 as prone to liquefaction. However, we observed liquefaction outside this "liquefiable zone" as indicated with an arrow in Fig. 3.36 and shown in Fig. 3.42. The extent of potentially liquefiable areas may deserve further review.

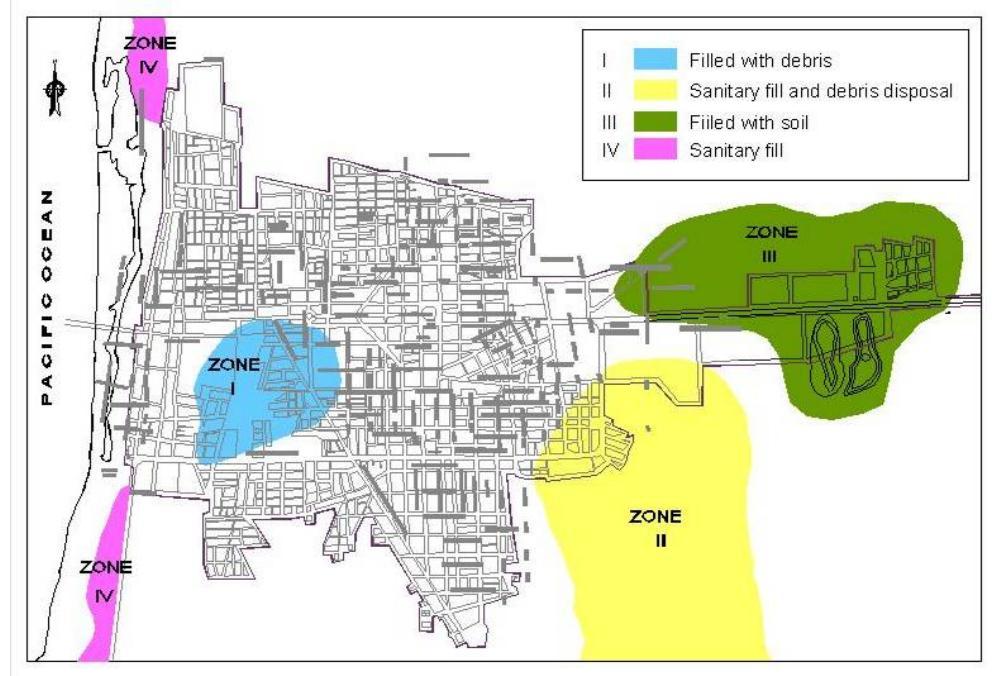
- Zone I: Located in the central and southern part of Pisco Playa. A lagoon left by the sea that later was leveled with debris aimed at future urbanization. Here soils are composed of crushed shells and construction wastes such as bricks, concrete, and sand
- Zone II: Southeast of Pisco. After being used for years as a sanitary filling, the current use of the area is the disposal of debris with similar characteristics to those of at Zone I.
- Zone III: East of Pisco. Leveled using the soil transported during the construction of the city's reservoir and the access road; nowadays it is a landfill occupied by factories and urban slums.
- Zone IV: Located in the Southern and Northern part of the coastline of Pisco, it has been filled with waste materials, but mostly, products of the fishing grounds and a variety of elements carried by sea currents.

Fig. 3.38. Distribution of landfills in Pisco (Adapted from [13])

The local high value obtained at the old sanitary fill in the southeast side deserves further analysis (classified as Zone II Fig. 3.38 in), especially if this area is located in an area towards which the city is growing.

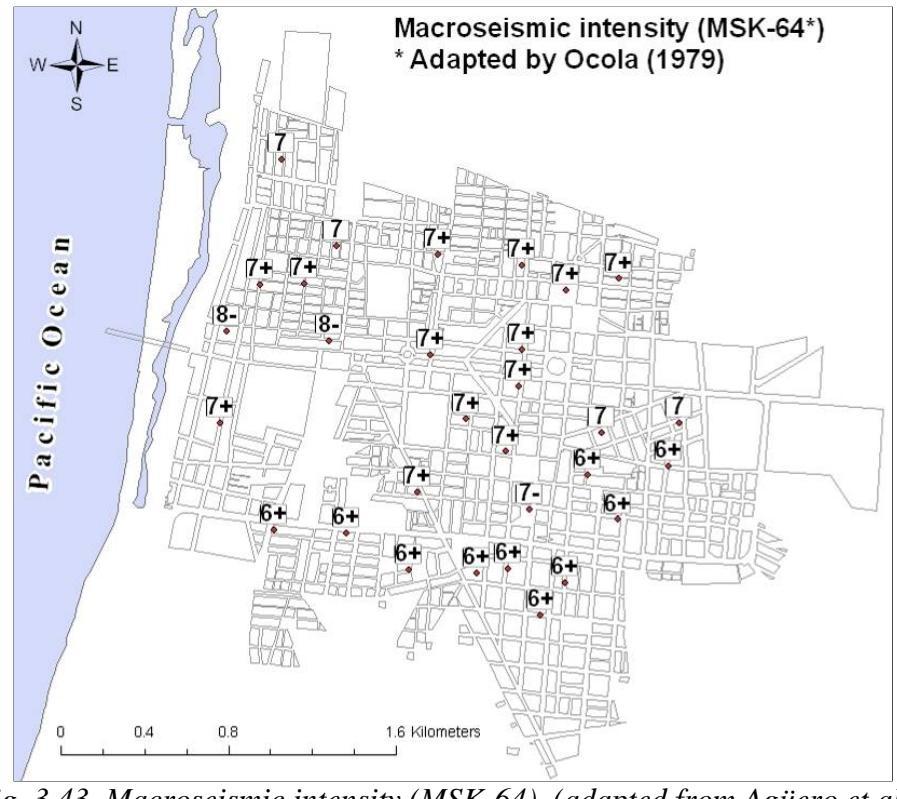
Agüero et al [6] has evaluated the macroseismic intensities based on the inspection of 30 buildings distributed throughout the city and using the MSK-64 scale adapted for Peru by Ocola (1979). Fig. 3.43 shows that high intensities are concentrated within the central part of the city, decreasing towards the south and southeast.

Fig. 3.43. Macroseismic intensity (MSK-64). (adapted from Agüero et al [6]

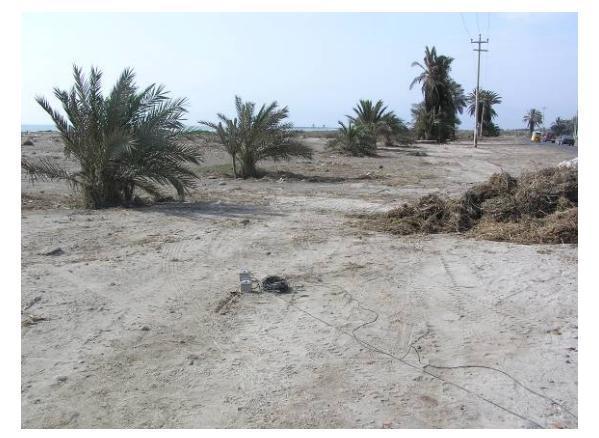
Fig. 3.49. (Point 7_UT) In front of the "Camino San Andres". Nonbeach inhabited area.

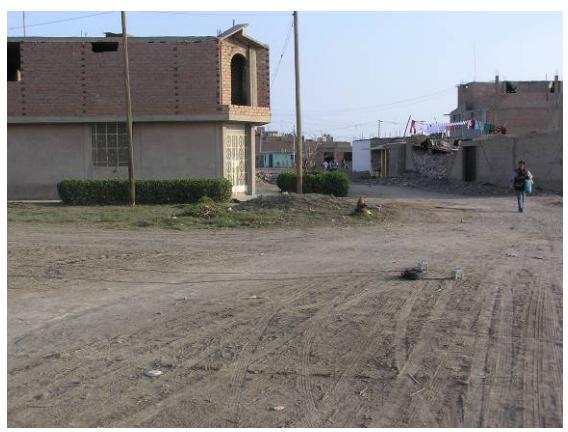
Fig. 3.50. (Point 13_UT) Less affected area with one and two story houses almost undamaged

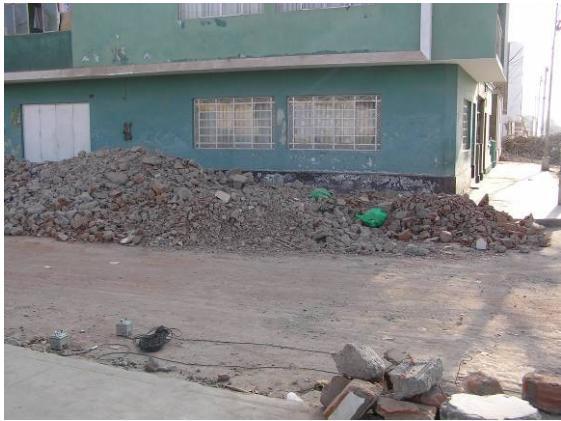
Fig. 3.51. (Point 11_UT) At the intersection with San Martin Av, close to

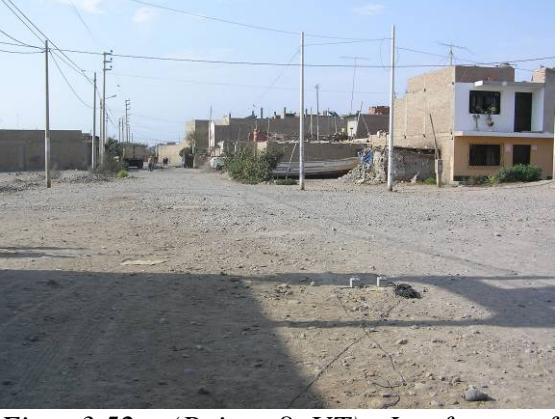
Fig. 3.52. (Point 8_UT) In front of Communal gathering place. Few damages

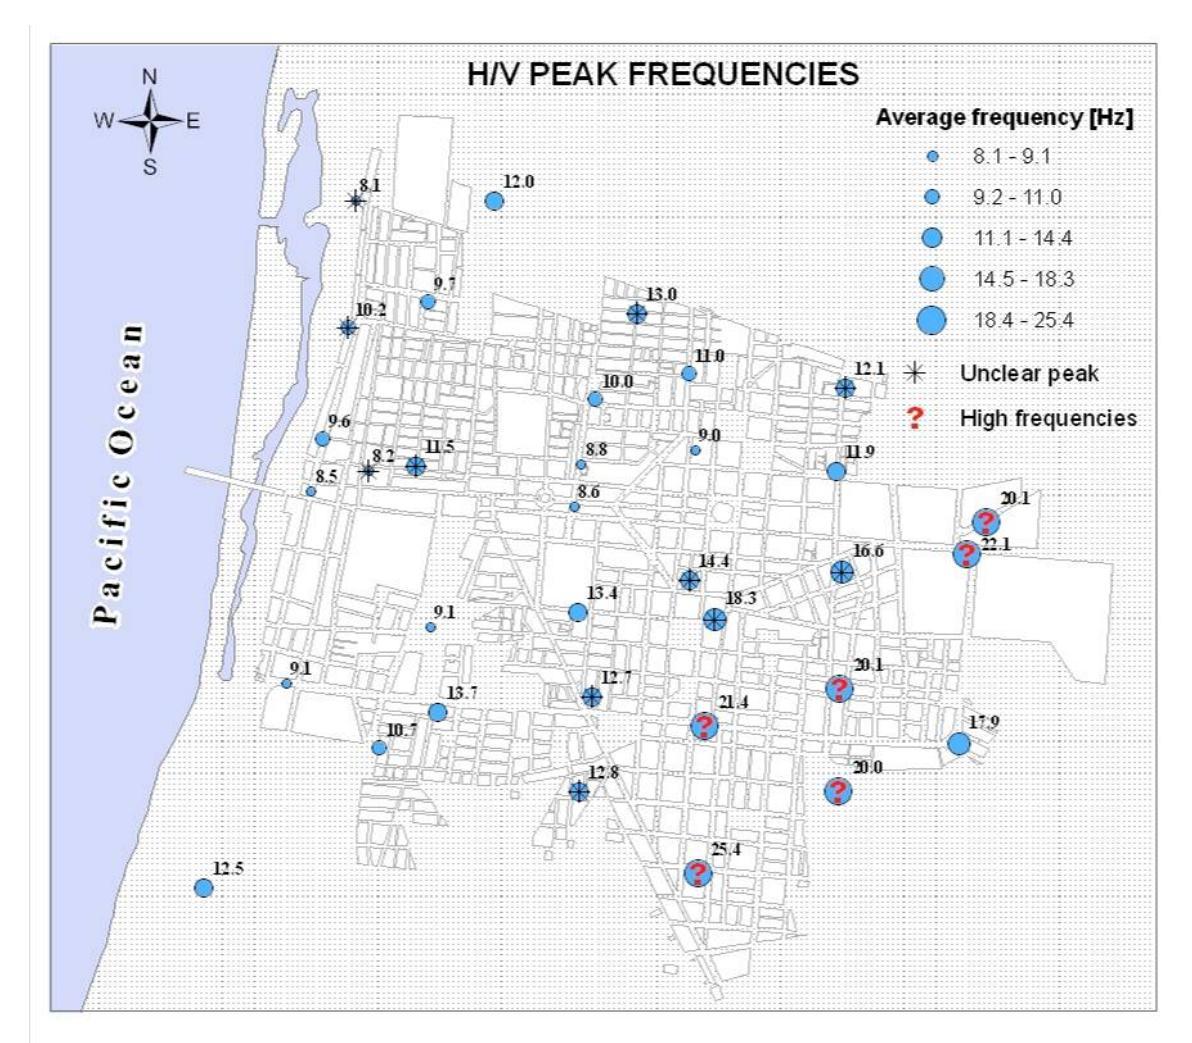
In order to be consistent all the data was processed with same criteria using the software Geopsy [2] and Fig. 3.55 shows the H/V ratio determined frequencies for all points. 11 out 34 points did not show any clear peak, e.g. the zone of amplification was too broad to distinguish a peak, or the peak was split into two or three parts, or the amplification was less then 2. Examples of these three categories can be found in Fig. 3.56. Out of the remaining 23 points, 6 points had frequency peak beyond the sensor range, however may be accepted to a certain level since we are using the ratio of the horizontal and vertical fourier spectra. Furthermore, for neighbouring locations with such high frequencies, we obtained similar results to the UNI team.

Fig. 3.55. H/V peak frequencies

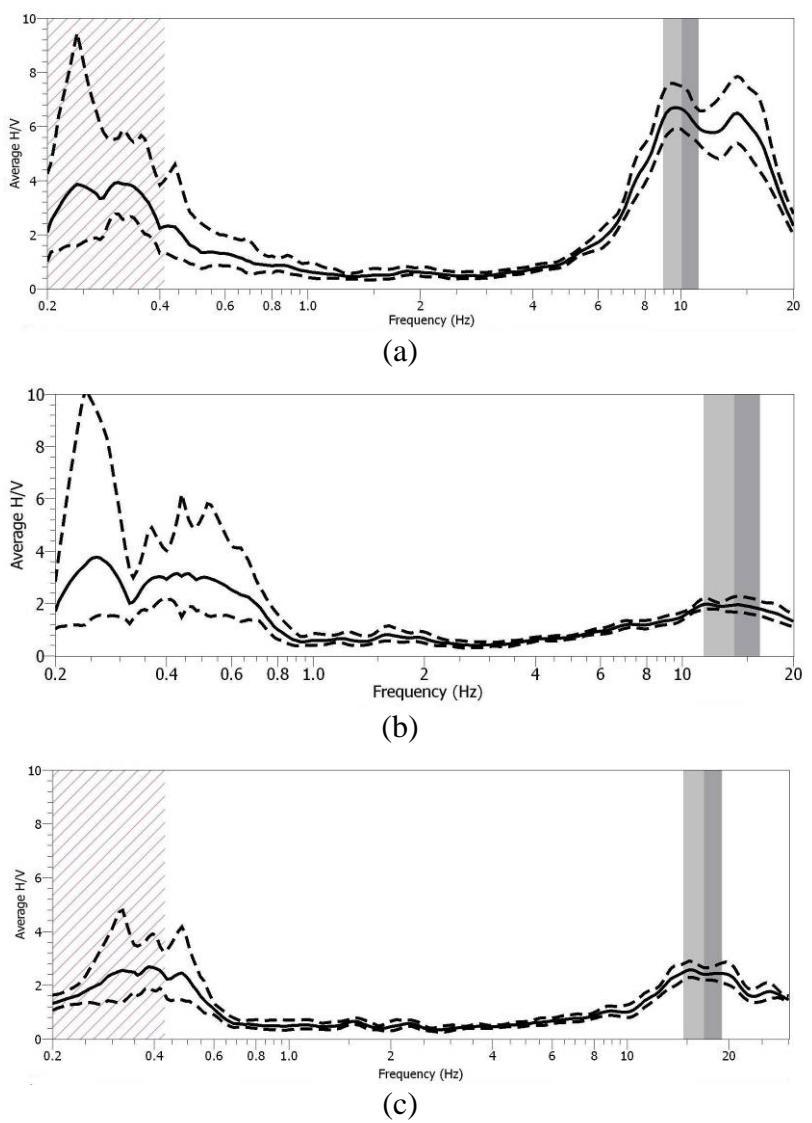
Fig. 3.56. Examples of H/V spectral ratios regarded as non reliable

- a. Pont ID: 6_UNI. Clear amplification but the peak is split into two parts having similar amplitudes.
- b. Point ID: 8_UT. Low amplification
- c. Point ID: 13_UNI. Amplification exists but the possible range is too broad to pick up one single frequency

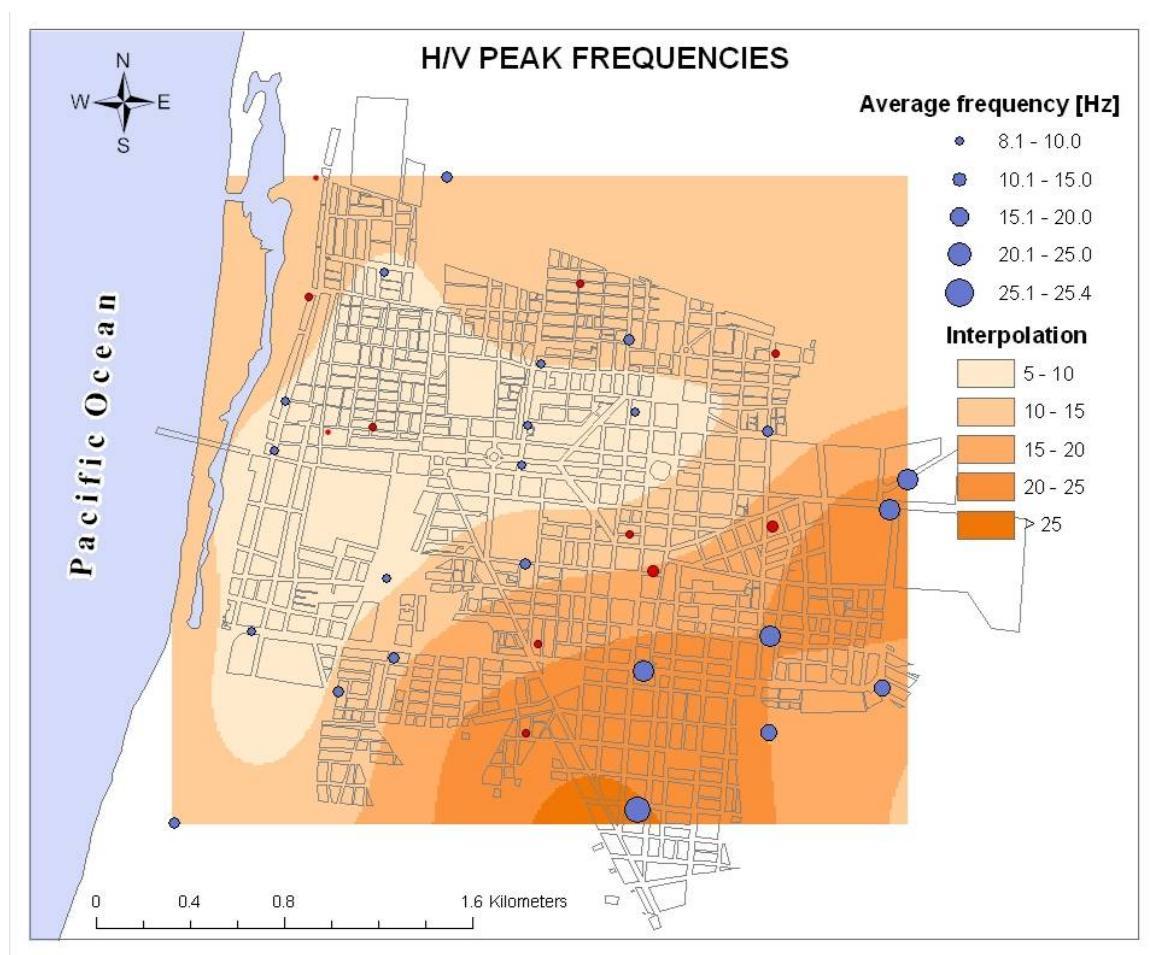
Keeping that in mind, Fig. 3.57 presents the data using blue circles for easily identified peaks while the red one represents those difficult to identify. Based on the reliable points, a straightforward spline-type interpolation was made aimed at depicting the general trend of the peak frequencies. These results suggest that there is a North-West to South-East trend of increasing frequencies.

Fig. 3.57. H/V peak frequencies. Local values and contours.

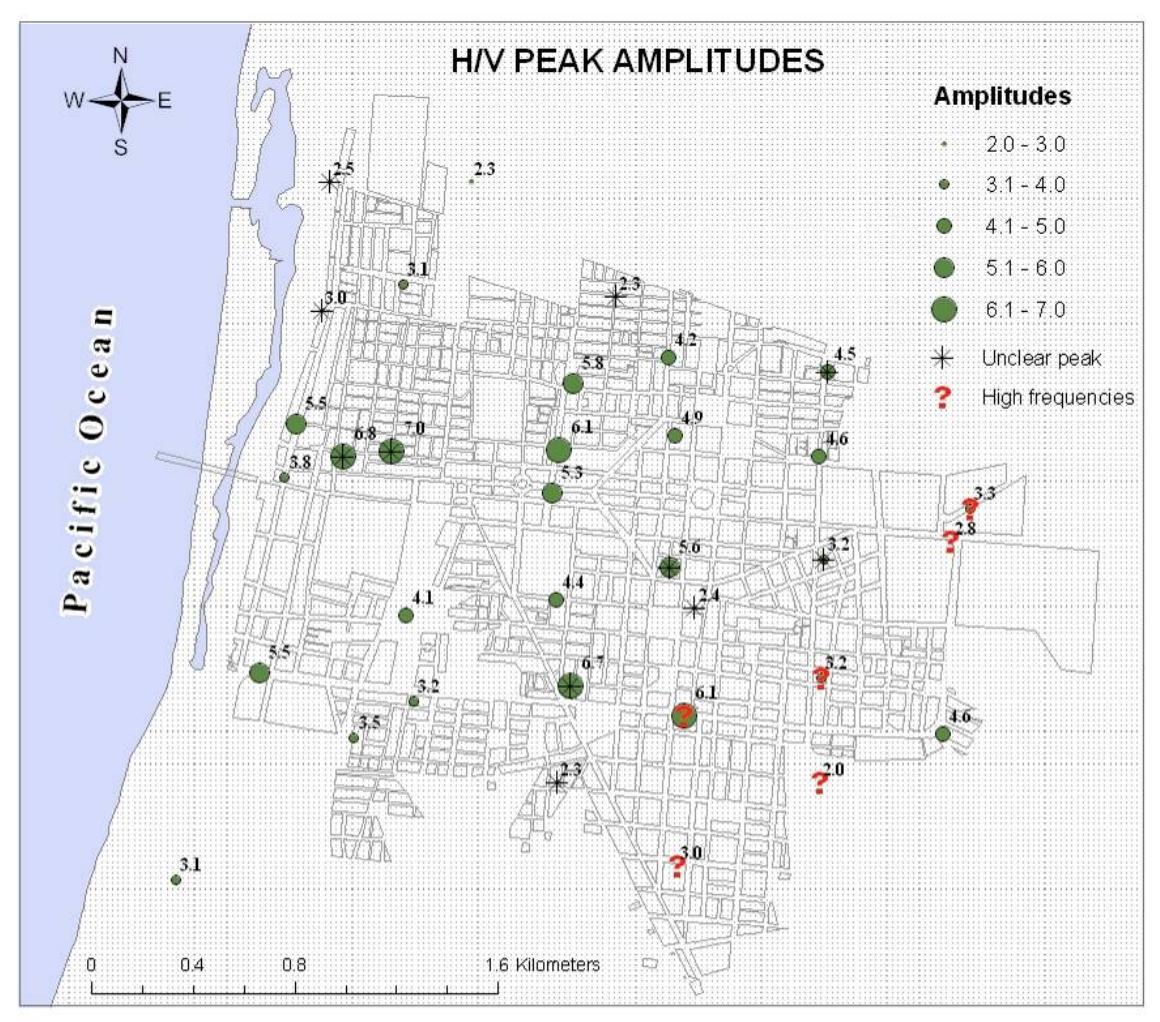
Fig. 3.58 shows the local values of peak amplitudes, using asterisks (with amplification values) to mark the location of points for which it was difficult to identify the peak, while a question mark for those points where the peak frequency is out of the sensor range.

Fig. 3.58. H/V peak amplitudes

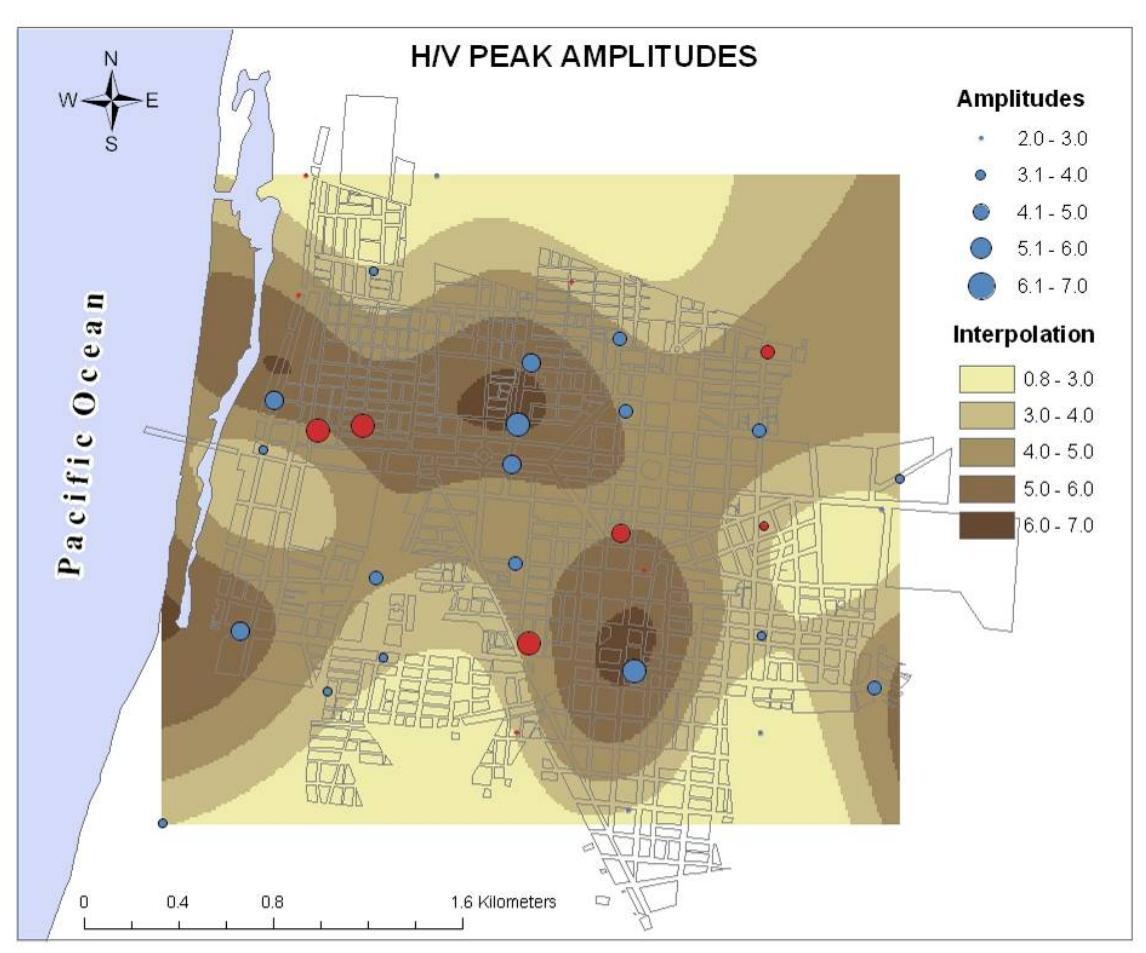
Fig. 3.59 shows the interpolated contours. It is difficult to identify a general pattern and the influence of the non-reliable points may change the geometry of these contours, thus stressing on the necessity of a denser mesh of measurements.

Fig. 3.59. H/V peak amplitudes. Local values and contours.

Regarding H/V maximum amplitudes, there is a sort of good agreement between the areas of maximum expected amplification in Fig. 3.36 and the H/V peak amplitudes of microtremor measurements (Fig. 3.59). Maximum values are close to the coastline and extend toward the east along the centre of Pisco, though there some areas of concentration of higher values in the southeast.

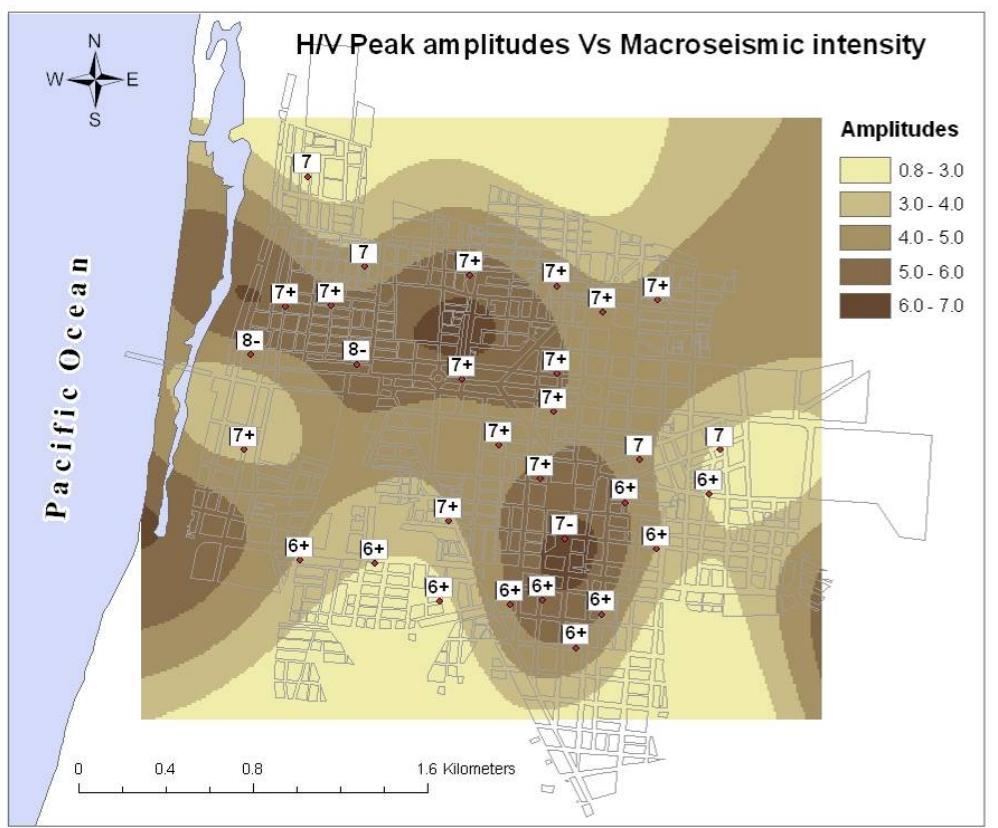
Finally, the data provided by Agüero et al [6] were plotted overlapping the peak amplitudes in Fig. 3.60. Despite of the fact that the microtermor data describe partially characteristics of the ground, while the macroseismic intensity encompasses the combined effect of building damage, ground deformations and people's perception; there is some consistency in terms of the high values observed in central and southeast Pisco in both studies. Nevertheless, it ought to be emphasised that additional site response estimations are required.

Fig. 3.60. Contours of H/V peak amplitudes and Macroseismic intensity (MSK-64, Adapted from[6].)
