4. BUILDING DAMAGE

4.2. Building damage

4.2.2. Housing damage

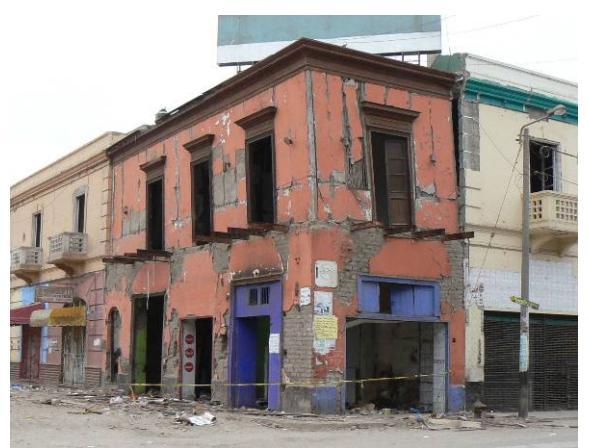
Another type of traditional hybrid system is the one in which the first floor is made of adobe and the second is made of *quincha*. This system is very common in old 2-story houses and has had a relatively good seismic performance. However, due to poor maintenance and aging, these structures have become very vulnerable. Although this system has not been used lately, some experts are trying to revalue it.

Fig. 4.7 Old traditional structure with 1^{st} story made of adobe and 2^{nd} story made of quincha

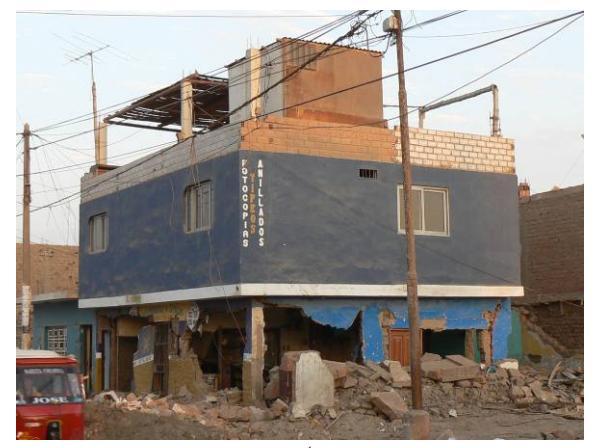
Fig. 4.8 House with 1^{st} story made of adobe and 2^{nd} story made of confined masonry. In this case, RC columns were cast in the existing adobe walls to support the 2^{nd} story.

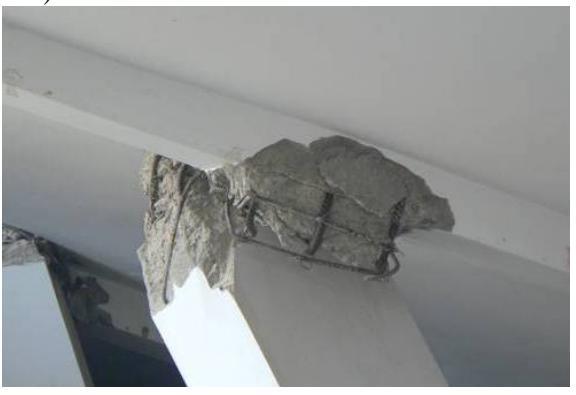
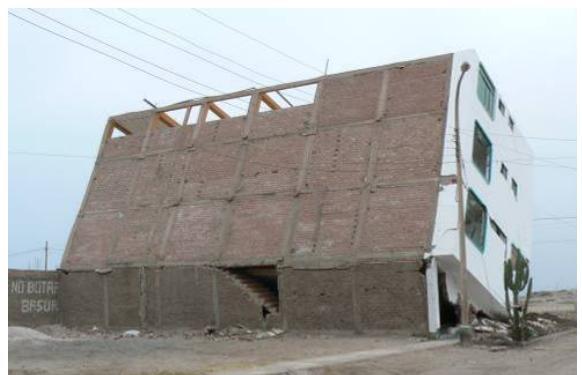
A few apartment buildings made of RC were found in the affected areas and in some of the cases, the structure was a mixture of confined masonry and RC. Fig. 4.32 shows an apartment building with a car parking in the first floor. The RC columns used to leave space for the cars to access had smaller stiffness than the back wall, a solid

Fig. 4.33 Back view of the building shown in previous picture

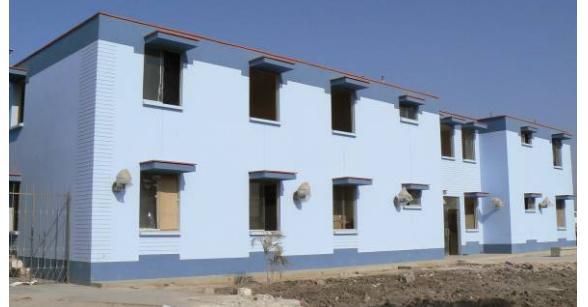
Fig. 4.38 to 4.41 show the conditions of the San Juan de Dios Hospital after the earthquake. At the time of the survey, most of the heavily affected buildings were being or had been already demolished. The only permanent operational facility was the Emergency Building which suffered no damage. It was constructed with funding of UN Health Organization and started operations the night of August 15. According to the interview survey, 200 badly injured people were evacuated to Lima for treatment. The hospital hyperbaric chamber, the only one in this region, is not functioning because the building where it operated collapsed.

Fig. 4.38 Newly constructed Emergency Building

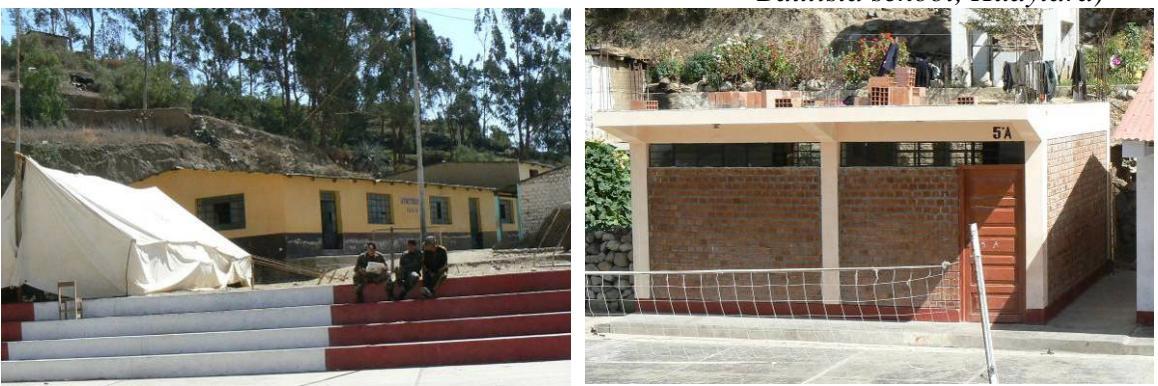
that had this situation were not operational. In this school, the hall was made of adobe and did not present considerable damage. Classes were been held in this building.

Fig. 4.44 Non-reinforced adobe building Fig. 4.45 Confined masonry building did normally used as a hall, (San Juan Bautista school, Huaytara)

not suffer any damage, (San Juan Bautista school, Huaytara)

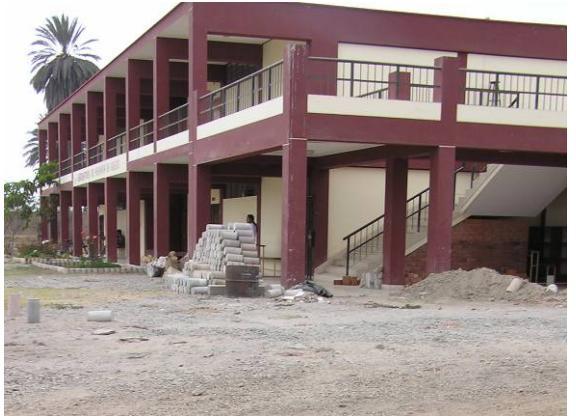
The RC frame structure was built in two stages: the first floor in 1998 and the second floor in 2002. Although it did not suffer major structural damage, some of the brick partitions cracked and needed repairing. In the 1st story, where partitions suffered more damage, the joint left between structure and wall was not wide enough in some cases and in others filled with mortar. This limited the freedom of the structure to deform. The joints in the second floor were wider and thus partition damage here was less.

Fig. 4.54 Soil Mechanics Laboratory Building

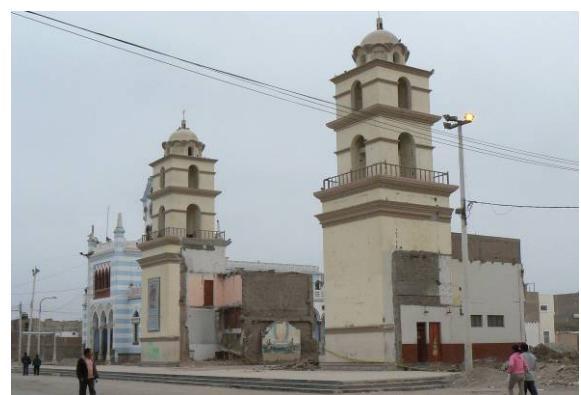
This survey did not focus in surveying churches in detail. However, it was obvious from our field work that these structures performed very badly. Reportedly, more than 30% of the fatalities due to this earthquake were caused by the collapse of the San Clemente Church in Pisco. In this church, only the portion which had been rebuilt recently did not collapse. A block away from it, only a couple of the 850mm-thick adobe walls of the Compania de Jesus Church were left standing.

Fig. 4.60 San Clement Church (Pisco)

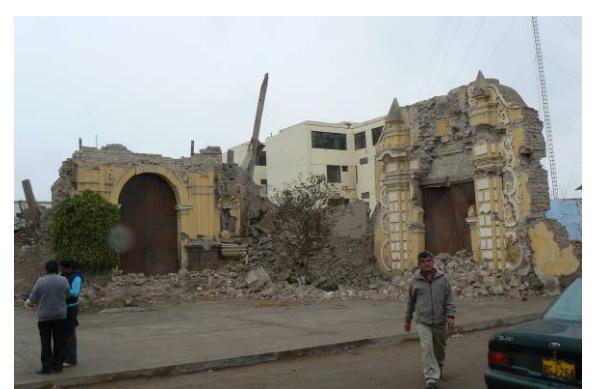
Fig. 4.61 Compania de Jesus Church (Pisco)

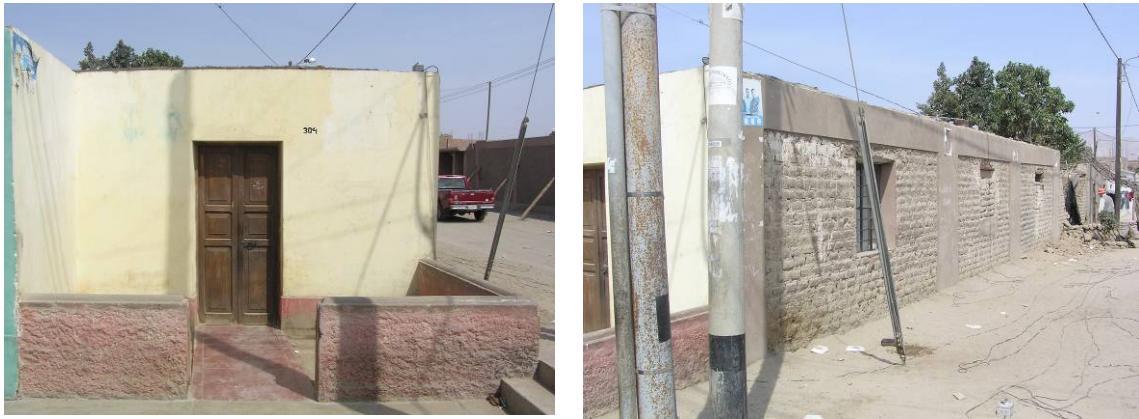
The fairly symmetric house is a one story building with a shared wall, two façade walls aligned with Callao Street and Rimac Street, respectively, and three internal walls. The roof is made of straw mat with bamboo joists. There was no evidence of foundation, however, based on an interview survey, it was found that, in this region, it is common to dig a 60cm-deep trench, place thick adobes inside, and then build walls on top of them. It may be possible that this "foundation" was used when the house was originally constructed.

Fig. 4.66. Front and side of Guadalupe retrofitted adobe house.

The inspection of the house showed that it suffered almost no damage due to the earthquake although the damage rate of adobe houses in Guadalupe was over 80%. A few vertical cracks were observed in the mortar cover of the "collar beams" inside the house. It is believed that they just affected the cover and did not pass through the walls. It is important to mention that the backyard wall, which was not retrofitted, collapsed due the shaking. A small portion of the steel wire mesh, without any corrosion signs, was exposed as shown in Fig. 4.68.

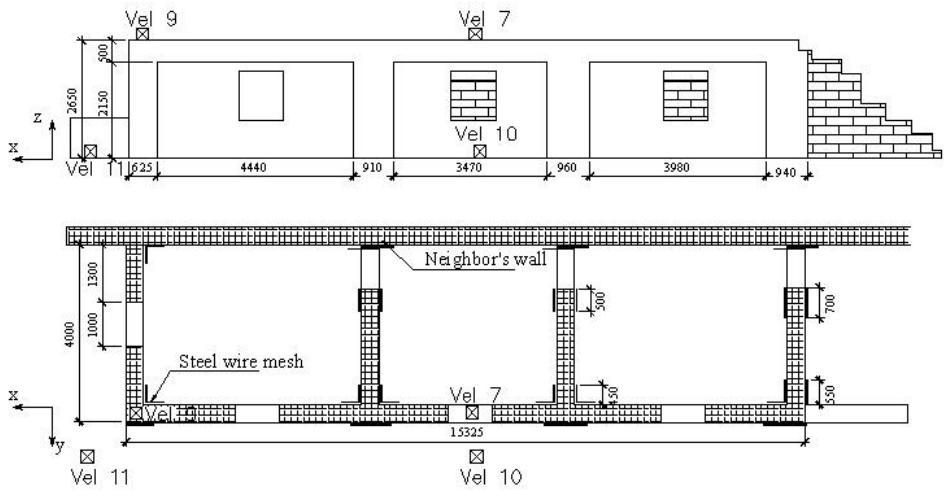
Fig. 4.67. Layout of Guadalupe adobe retrofitted house.

The house was retrofitted based on the guide shown in Fig. 4.65, and the details of the construction for the wire steel mesh are shown in Fig. 4.67. The mesh was set in all house's corners and in the intersection of internal and external walls. In the internal walls additional mesh was installed beside the doors, the backyard wall was not retrofitted at all due to budget constraint. No mesh was installed on the main entrance wall.

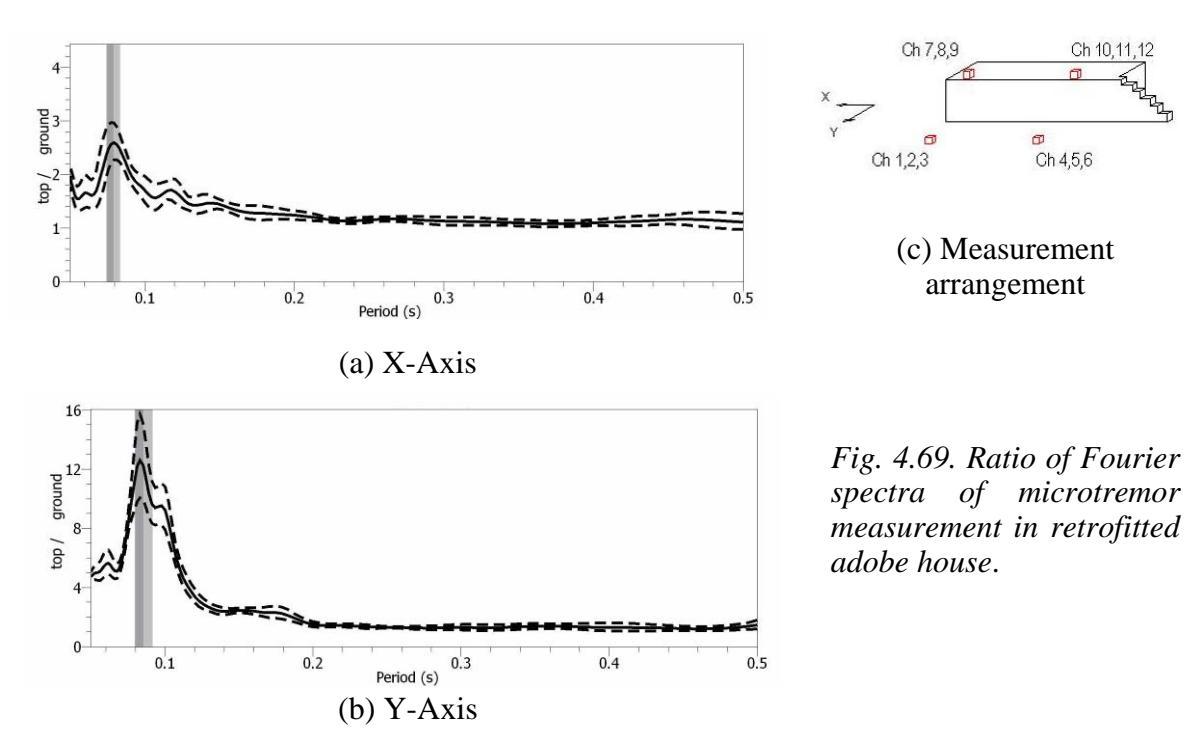
In order to identify the dynamic properties of the structure, microtremors were measured on the house roof and at the ground as shown in Fig. 4.69. Two 300sec-long measurements, sampled at 100Hz, were taken. The spectral ratios were calculated and they are shown in Fig. 4.69. A clear peak at 0.08sec is observed. This predominant period is similar to those measured in non reinforced adobe structures with similar characteristics suggesting that, as expected, the retrofitting procedure, did not affect the natural period of the structure.

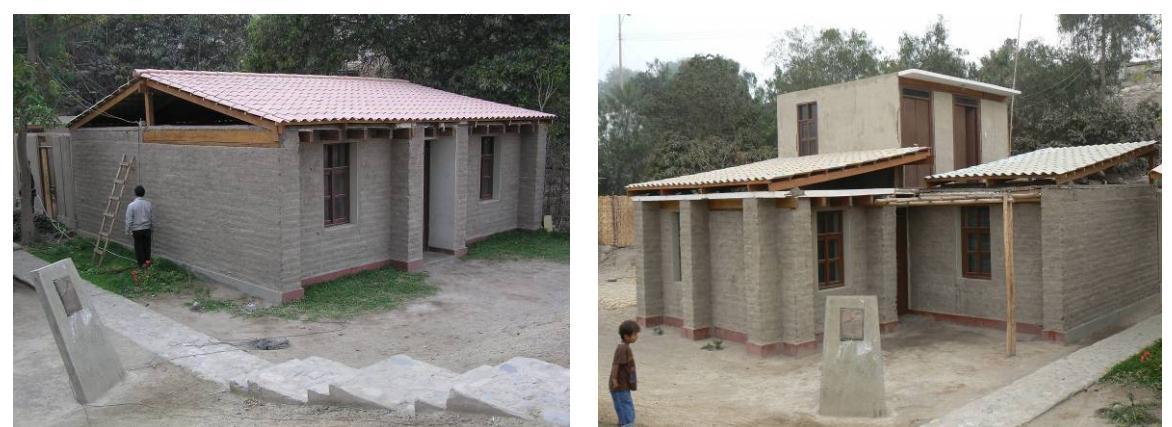
(a) 1-story house (b) 2-story house *Fig. 4.72. Pacaran reinforced adobe houses.*

Three reinforced adobe houses, 1- and 2-story, inside of the affected area were visited and two of them were evaluated in detail. These are located near Pacaran city, in a flat area with a small hill at the backside (S 12° 51.719' W 76° 03.271').

After the Pisco Earthquake, the houses seemed to be in good condition, although some cracks in the plastering of the *quincha* panels on the second floor were observed. It is important to mention that the number of damaged houses in Pacaran was not as large as other cities inside of the affected area. However, some nearby public buildings made of adobe collapsed due to the shake.

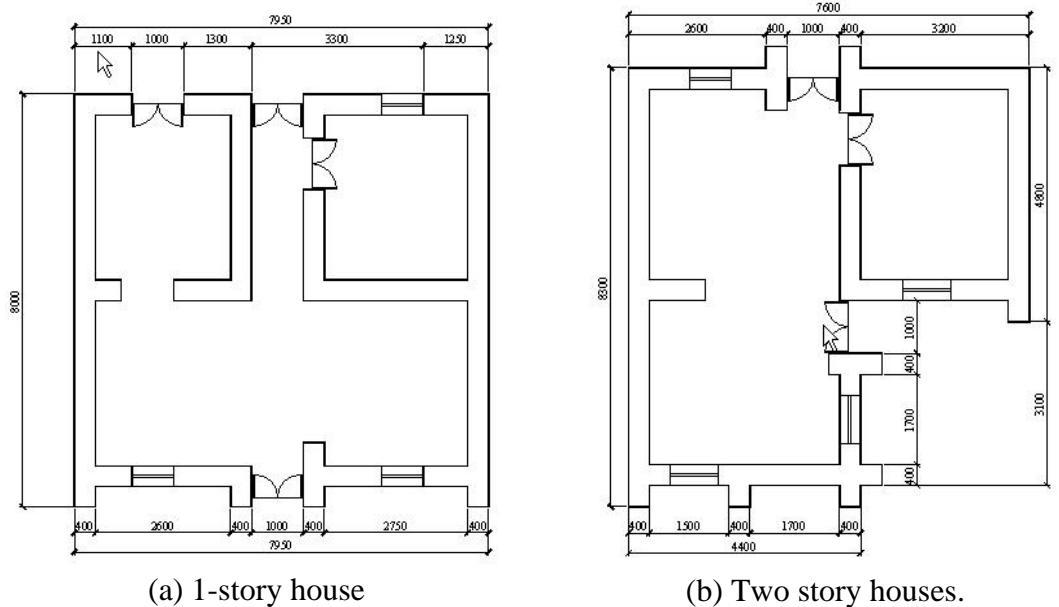
Fig. 4.73. Pacaran reinforced adobe houses layout.

The plan view of both houses is shown in Fig. 4.73. Both of the reinforced houses were constructed following the procedure shown in Fig. 4.71. The roofs are light and well connected and the foundations were made of unreinforced concrete. The 2^{nd} floor of the 2-story house was made of light prefabricated quincha panels.

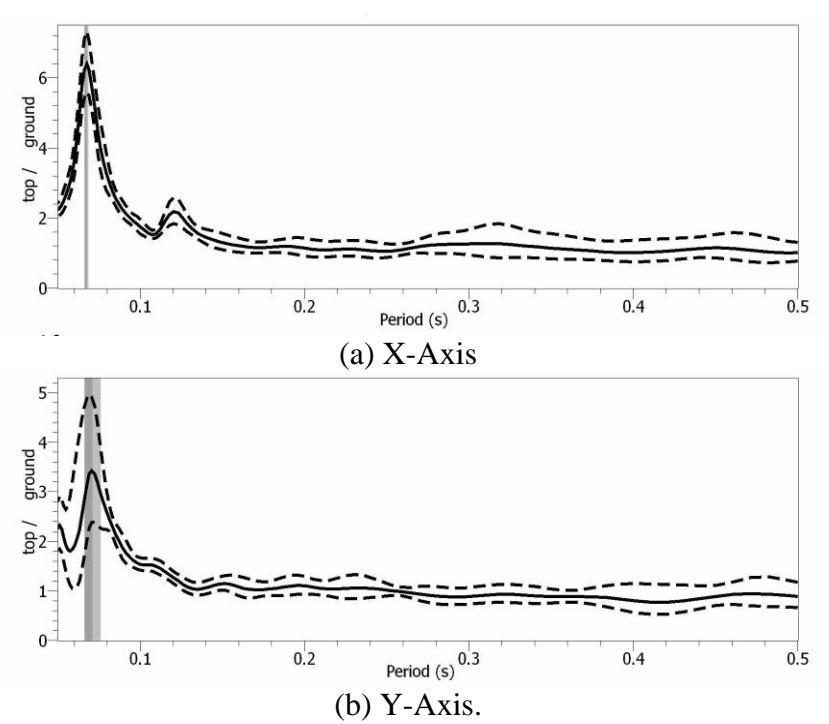
Fig. 4.75. Ratio of Fourier spectra of microtremor measurement in reinforced 1-story adobe house.

Three measurements were taken at 100Hz during 300 sec. The spectral ratio was calculated and it is shown in Fig. 4.75 for the 1-story house. A clear peak at approximately 0.07 sec is observed in both X- and Y-directions. Compared to the house measured at Guadalupe, Ica, this structure is stiffer. This may be due to the buttresses which are used in this structure and the stiffer roof.

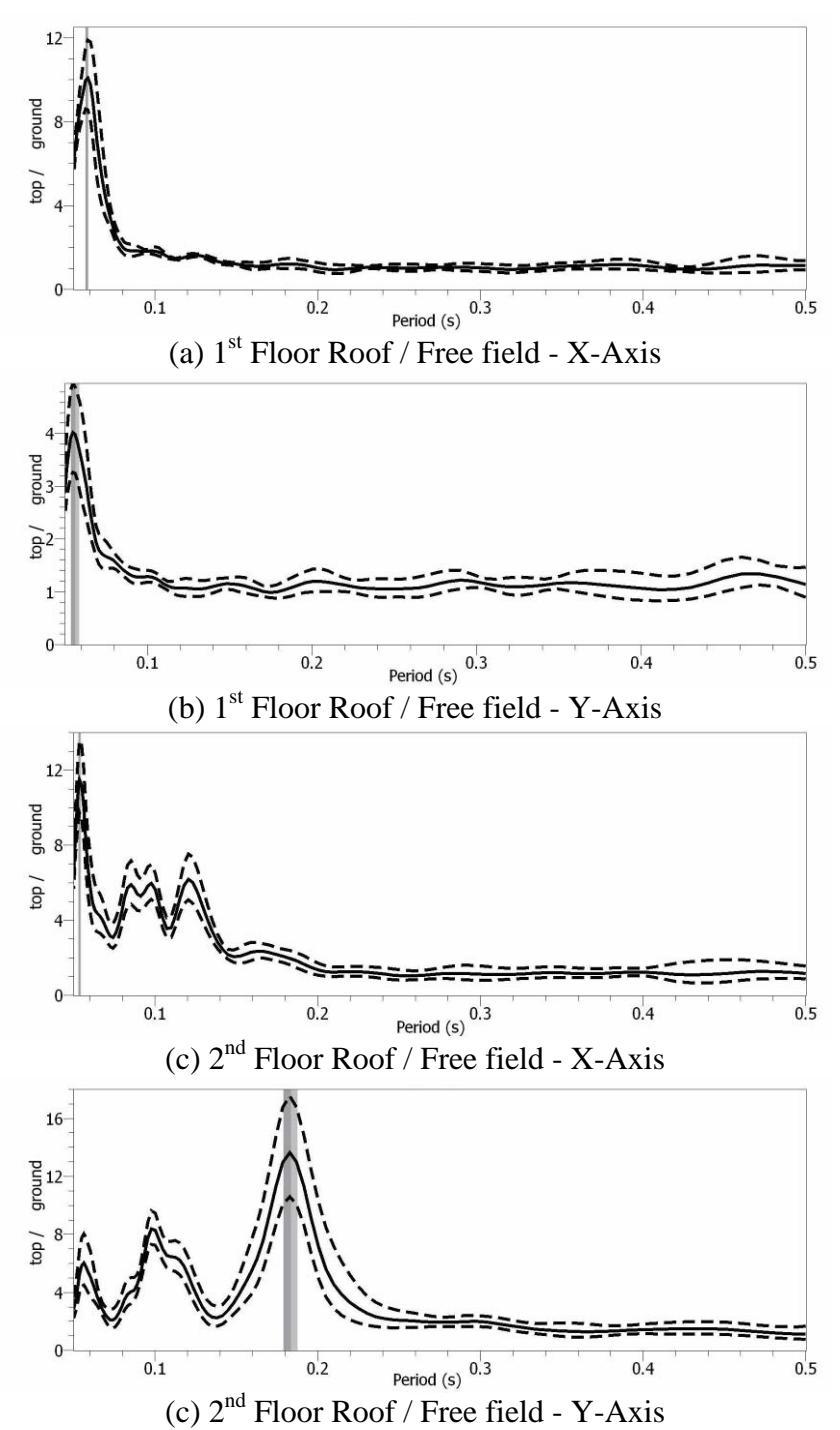
Fig. 4.76. Ratio of Fourier spectra of microtremor measurement in reinforced 2-story adobe house

For the 2-story house, spectral ratios 1^{st} Floor Roof / Free field and 2^{nd} Floor Roof / Free field were calculated and are shown in Fig. 4.76. Although the response at the 1^{st} floor roof shows one clear peak at 0.06s in X- and Y- directions, the response at the 2^{nd} Floor roof is more complex and shows multi peaks. The lowest period corresponding to one of these peaks is 0.06s, in both X- and Y-directions, which coincides with the natural period of the 1^{st} floor roof response. This may suggest that it is the effect of the 1^{st} floor on the 2^{nd} . The remaining peaks may indicate additional vibration modes active for the 2^{nd} floor, which are not transmitted to the 1^{st} floor. Further analysis is necessary to confirm these interpretations.
