## 5. ROADS AND BRIDGES

## 5.2. Road Damage

### **5.3. Bridge Damage**

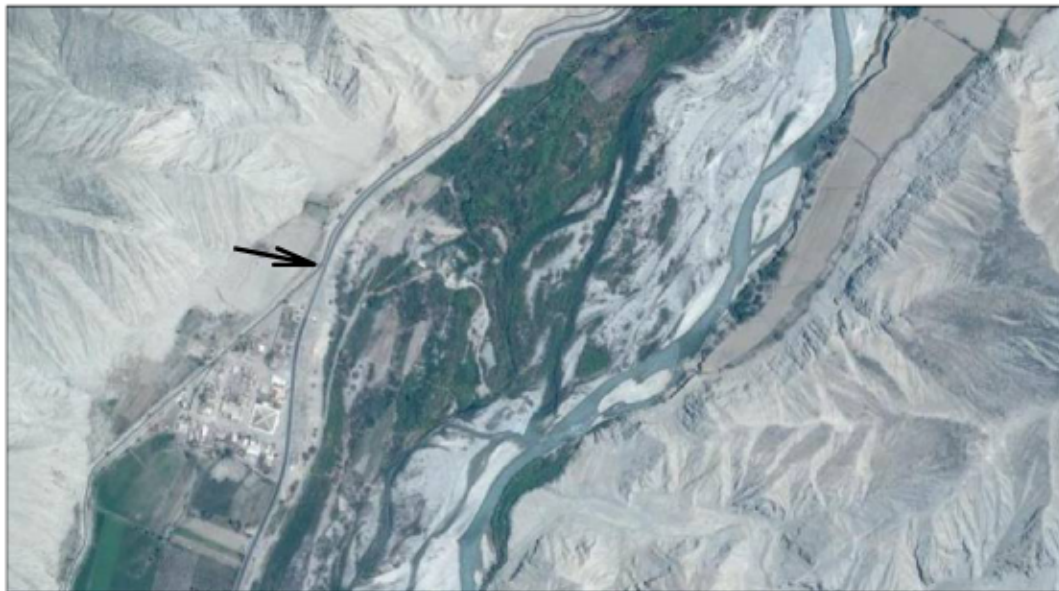
A slope failure was observed at the Km.23 of the Canete-Yauyos road. This is the exact point where the road and an irrigation channel meet. Although there was no evidence suggesting channel damage or water leakage, the possibility that its presence may have somehow affected the slope stability needs further assessment.

*Fig. 5.11. Google earth view with black arrow indicating the slope failure at Canete-Yauyos road (Km. 23) (13° 3'3.08"S, 76°13'32.85"W).*

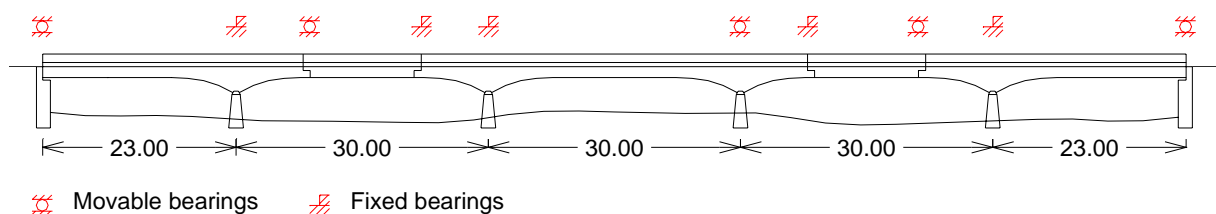
The 136-m long Huamani bridge follows the configuration of a typical Gerber bridge. Two rather slender abutments (typical Base/Height = 0.3) and four intermediate pillars are supported on 5.4m-deep and 7.3m-deep caissons, respectively. According to the bridge drawings, there is no connection between the abutments/pillars and the caissons, i.e. the pillars could slide/rock upon the caisson top. Fig. 5.16 shows the layout of the bridge. The superstructure consists of five sections.

*Fig. 5.16 Layout of the Huamani bridge (downstream direction)*

The bridge superstructure is supported on fixed and movable bearings as shown in Fig. 5.16. The movable bearings are made of steel rollers as shown in Fig. 5.22 and Fig. 5.23. Note the steel stoppers installed to prevent the movement in the bridge transverse direction. The steel bearings were quite corroded.

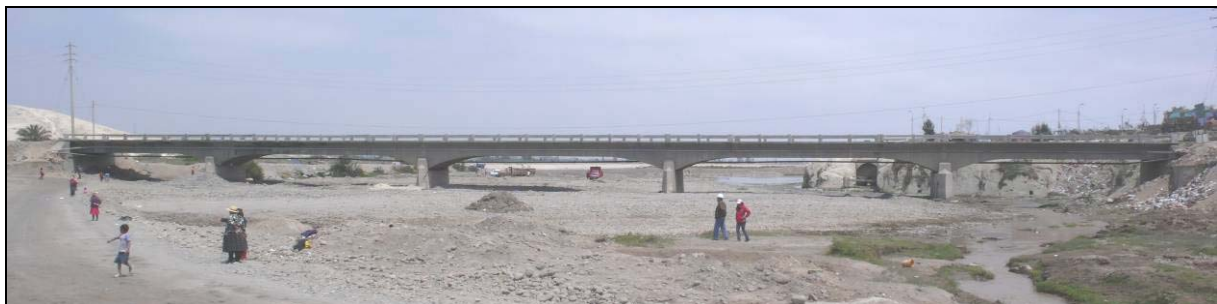
*Fig. 5.17 Overview of the bridge (downstream direction)*

Liquefaction induced lateral spreading was observed in the northern upstream bank of the Pisco River and also south of the south embankment. Evidence of liquefaction was also found around the bridge pillars.

The southern abutment tilted towards the north some 7% due to the Pisco earthquake [5] and settlement and cracking of the embankment also occurred. The intermediate pillars also rotated. Although the north abutment was not as damaged as the southern, settlement of the backfill was observed there. The geological formation at the bridge north access belongs to the Miocene/early Pliocene age whereas alluvial deposits are found in the south.

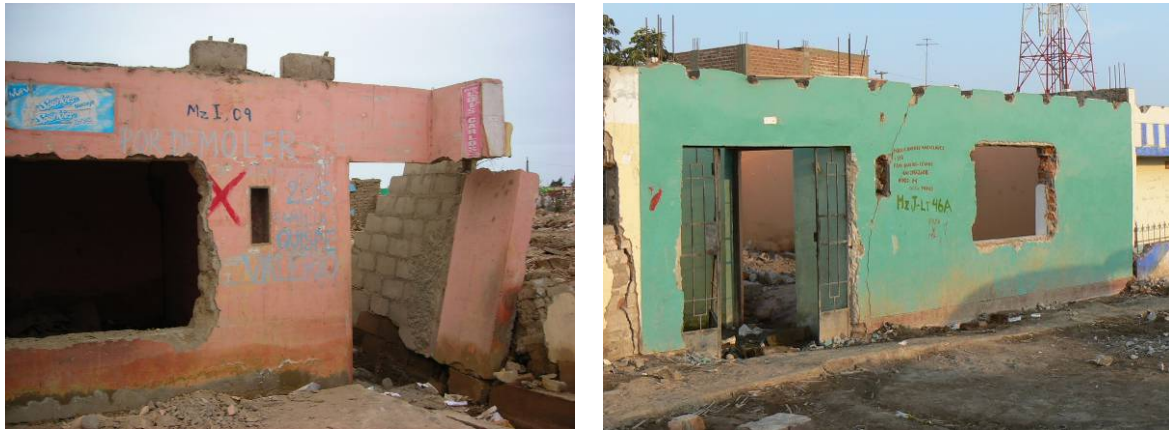
Because irregularities in the land property in Peru are the rule, not the exception, the Commission for the Formalization of the Informal Property (COFOPRI) was created to deal with this problem before the earthquake. COFOPRI's main mission is to give land property titles to those that do not have it and who are eligible according to COFOPRI standards. After the earthquake, COFOPRI started working in the affected areas to try to solve the problems of land property. It estimated that approximately 30% of all the lots in Pisco were not registered [6]. Furthermore, of the more than 75,000 houses that are estimated will be reconstructed, 50% do not have property title [5].

*Fig. 6.10 The only way left to establish property rights is writing the resident name and address on the walls left standing (Tambo de Mora, Ica)*

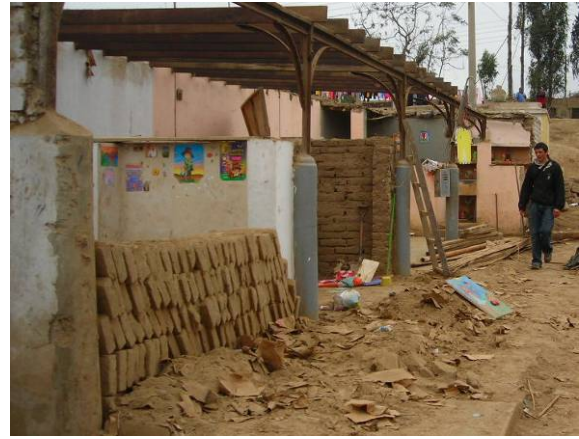
During the survey it was observed that at many places, adobe blocks from the collapsed houses were neatly piled next to the lots suggesting that they may soon be used for reconstruction. In other places, people were trying to reuse the few walls that were left standing as the first walls of their new constructions.

*Fig. 6.12 Adobes from collapsed walls are kept to be used as construction material*

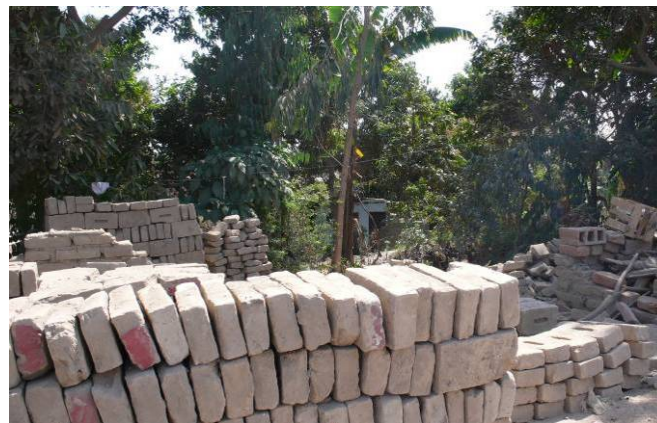
*Fig. 6.13 Units from collapsed walls piled up ready to start the reconstruction*
